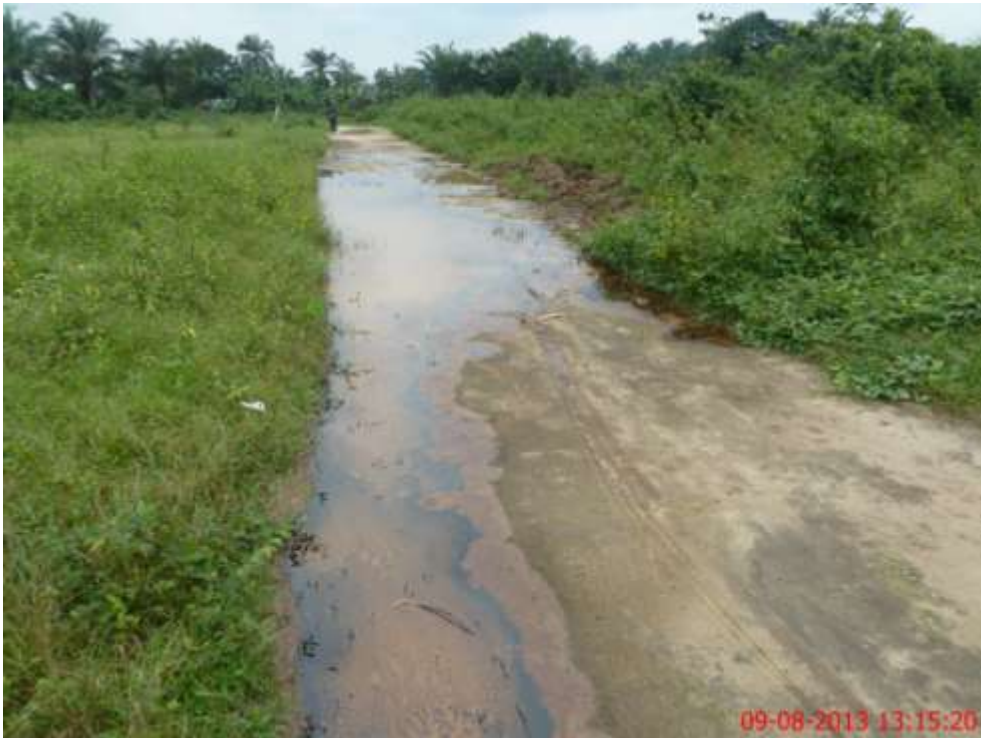
Overview: Part of spill impact on 8" Isimiri-Imo River pipeline right of way at Obiakpu. Picture was taken during Joint Investigation of 9<sup>th</sup> August 2013.

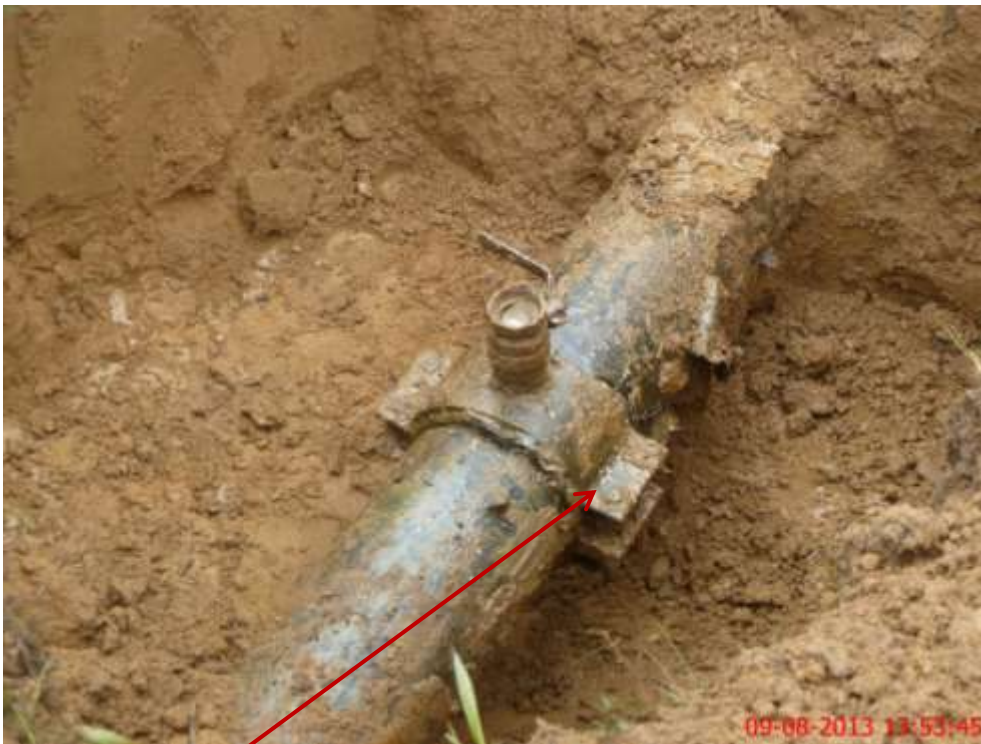
Close up: Illegal fitting on 8" Isimiri-Imo River pipeline at Obiakpu. Picture was taken during Joint Investigation of 9<sup>th</sup> August 2013.
