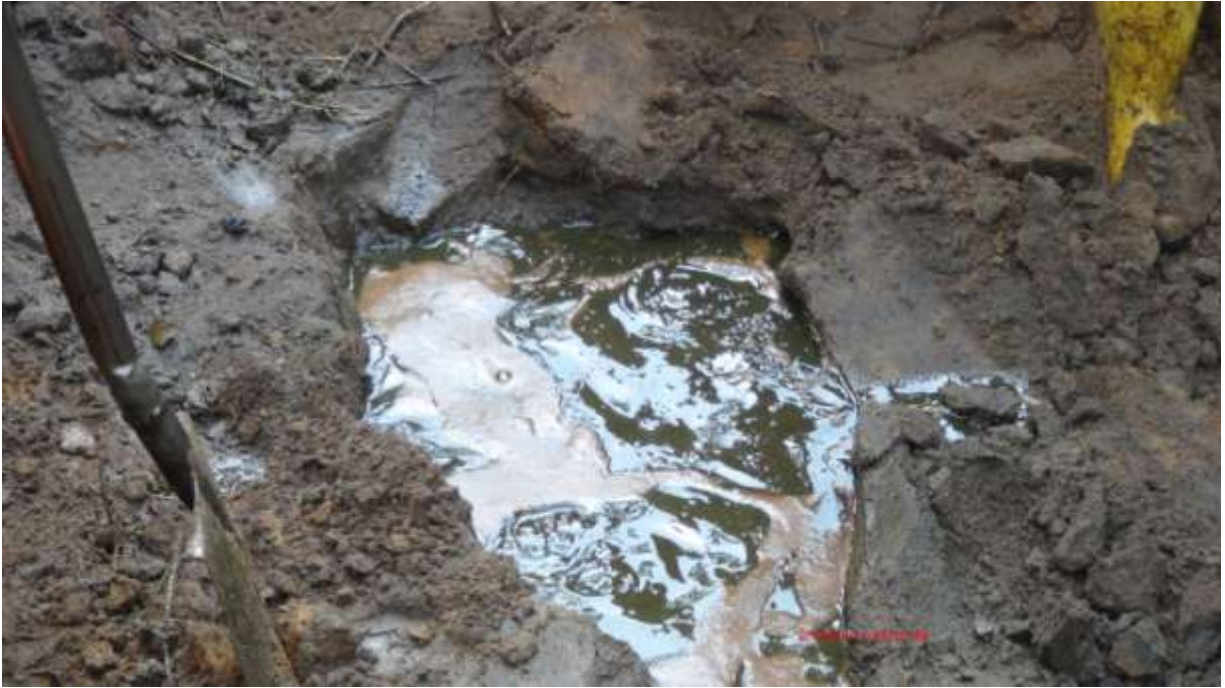
Overview: Part of spill impact on 4" Well69S Flowline right of way at Umuokwa. Picture was taken during Joint Investigation of 3rd January 2014.

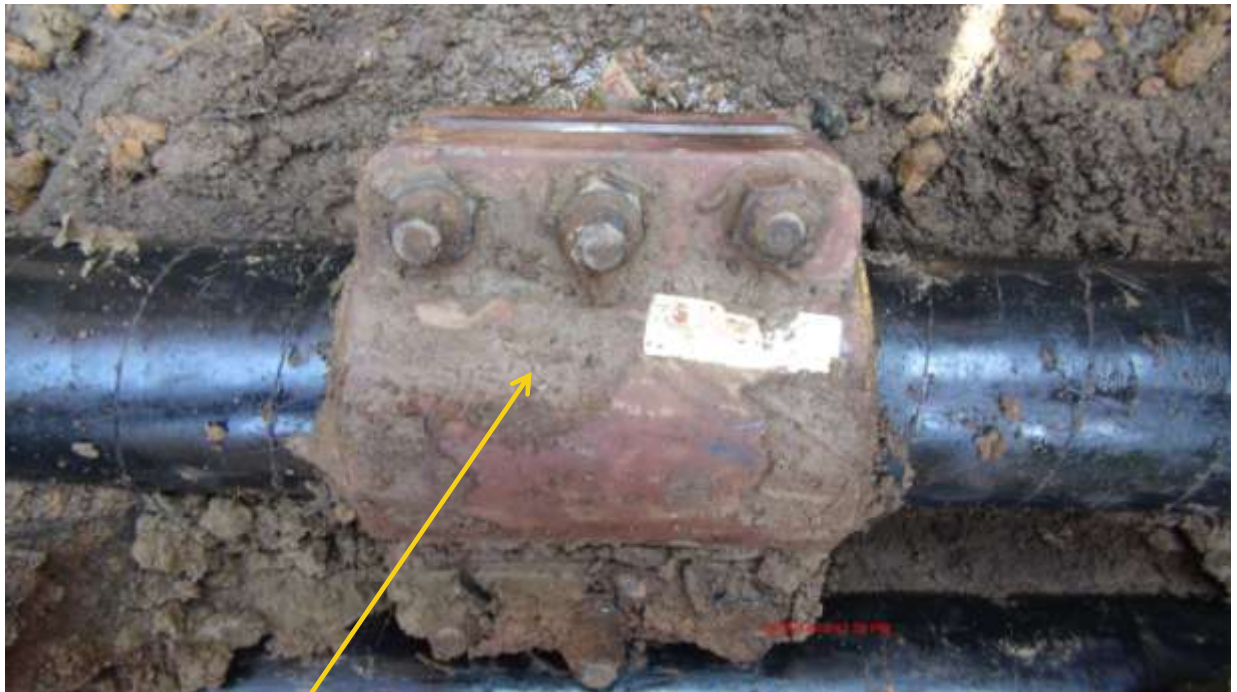
Close-up: Failed clamp on 4" Well69S Flowline at Umuokwa. Picture was taken during Joint Investigation of 3rd January 2014.
