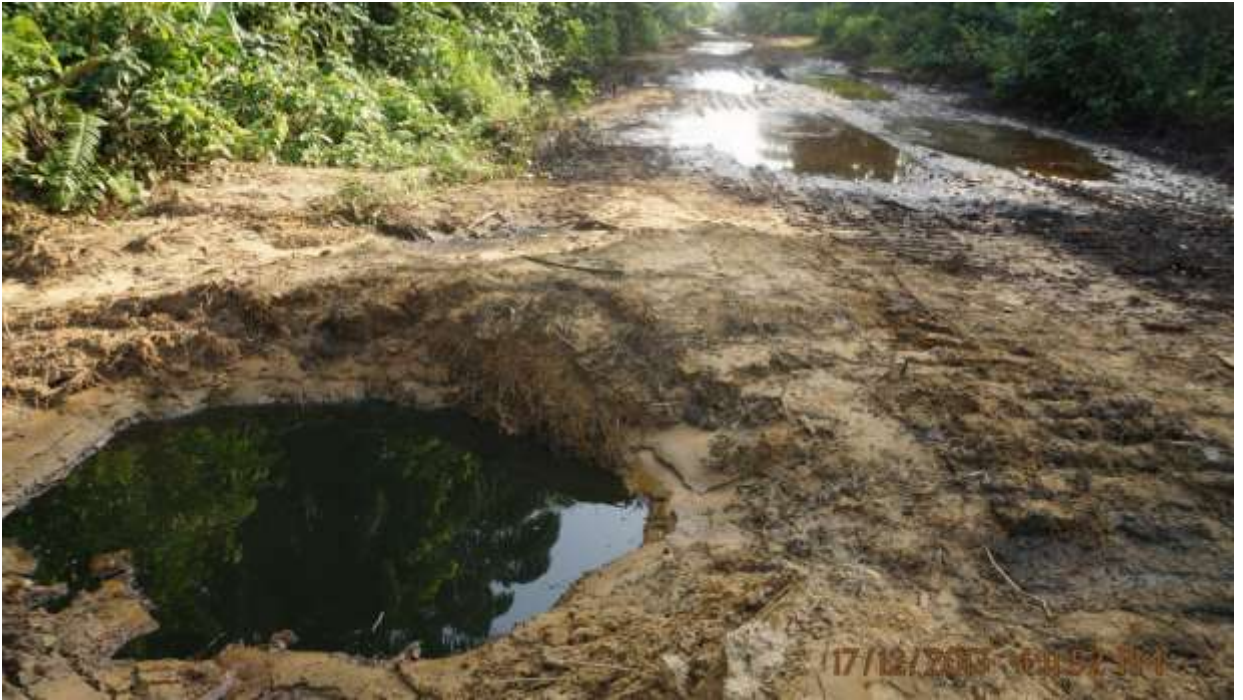
Overview: Part of spill impact on 20" Otumara – Escravos Pipeline right of way at Adjudaibo. Picture was taken during Joint Investigation of 17<sup>th</sup> December 2013.

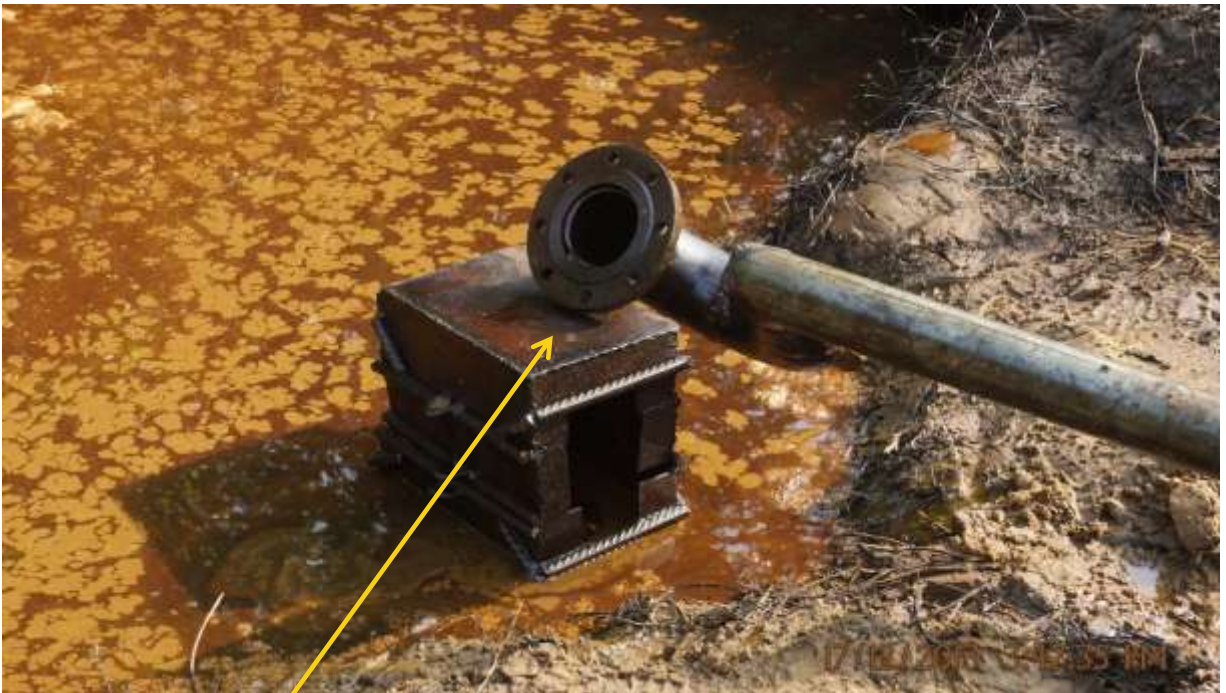
Close-up: Illegal fitting on 20" Otumara – Escravos Pipeline at Adjudaibo. Picture was taken during Joint Investigation of 17<sup>th</sup> December 2013.
