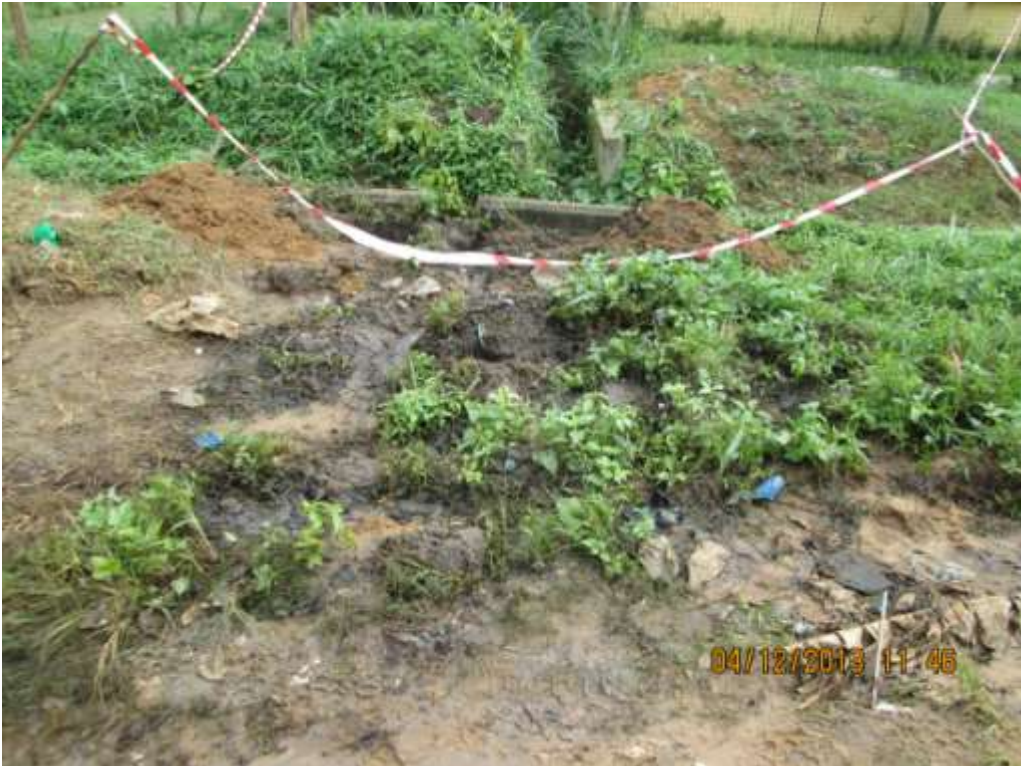
Overview: Part of spill impact on 6" Obigbo North – Ebubu Pipeline right of way at Obolo. Picture was taken during Joint Investigation of 6<sup>th</sup> December 2013.

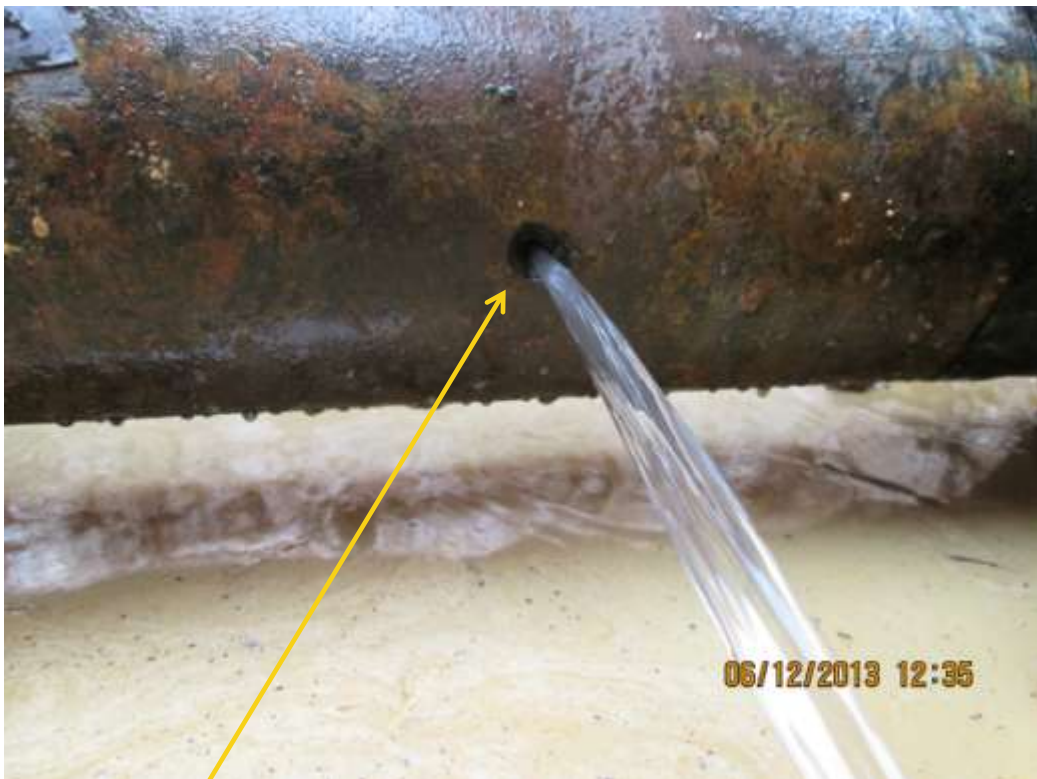
Close-up: Spill due to corrosion on 6" Obigbo North – Ebubu Pipeline at Obolo. Picture was taken during Joint Investigation of 6<sup>th</sup> December 2013.
