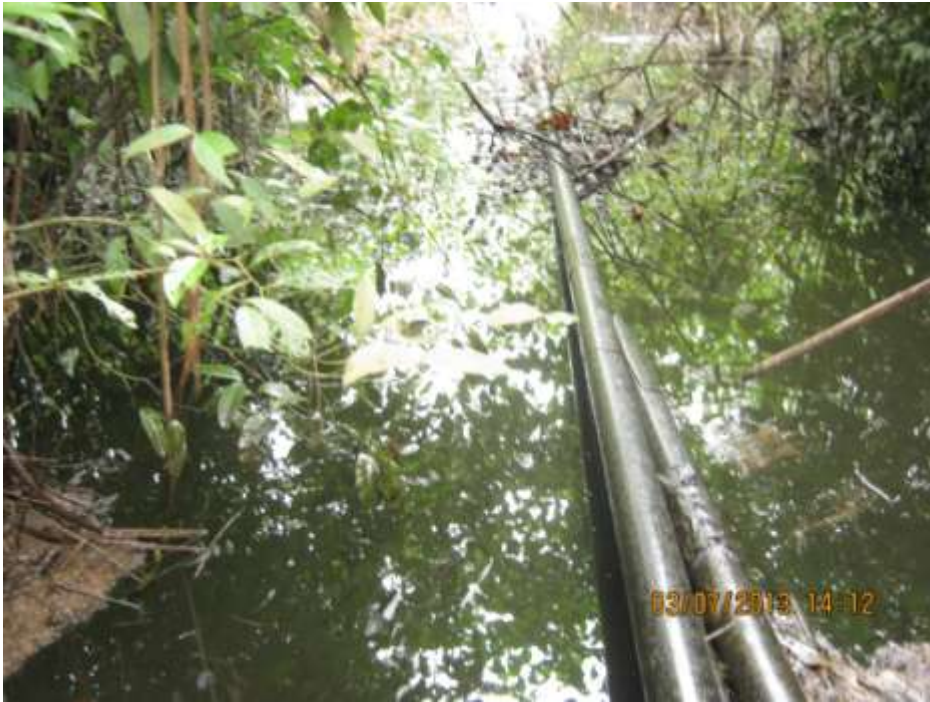
Overview: Part of spill impact on Imo River Well22S flowline right of way at Igirukwu. Picture was taken during Joint Investigation of 3<sup>rd</sup> July 2013.

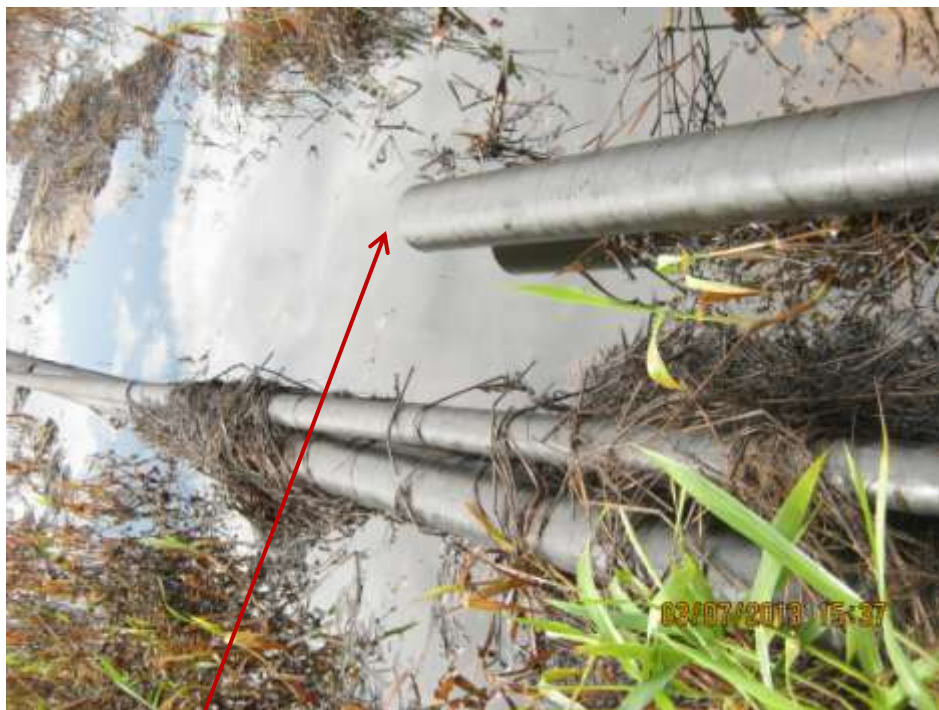
Close up: Cut section on Imo River Well22S flowline at Igirukwu. Picture was taken during Joint Investigation of 3<sup>rd</sup> July 2013.
