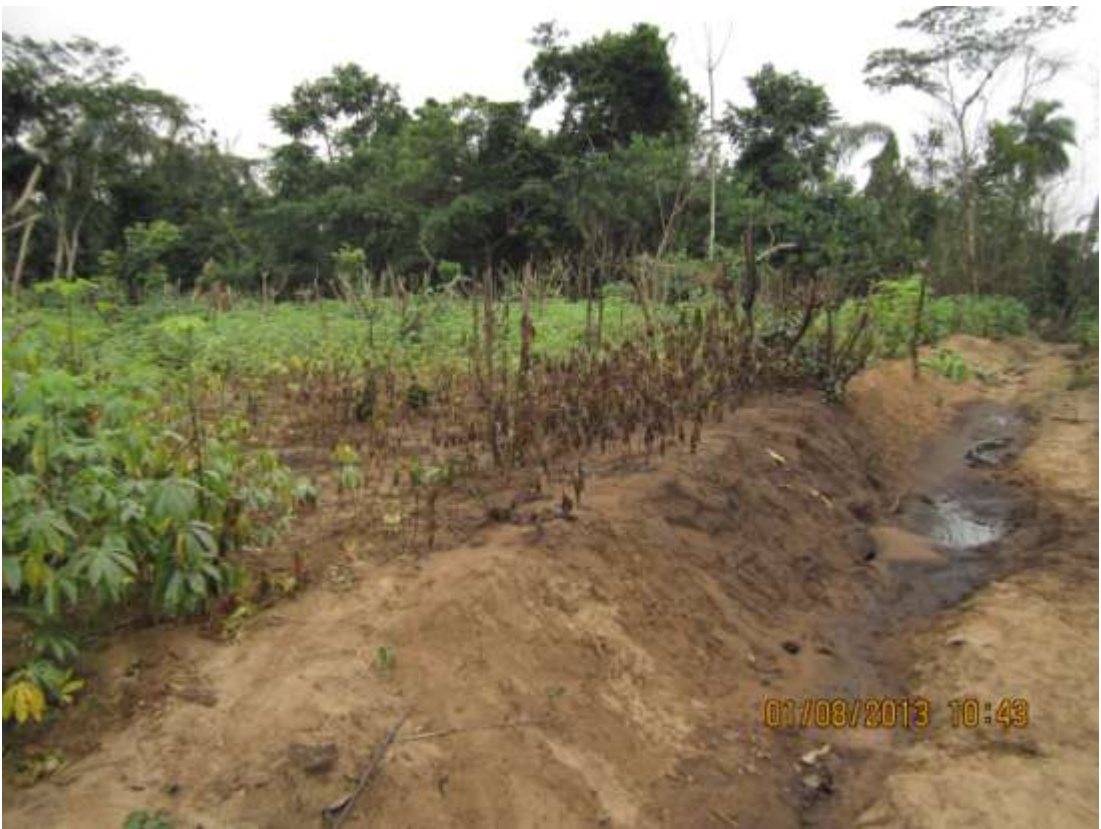
Overview: Part of spill impact on 3" Imo River Well5L flowline right of way at Igiriukwu. Picture was taken during Joint Investigation of 1<sup>st</sup> August 2013.

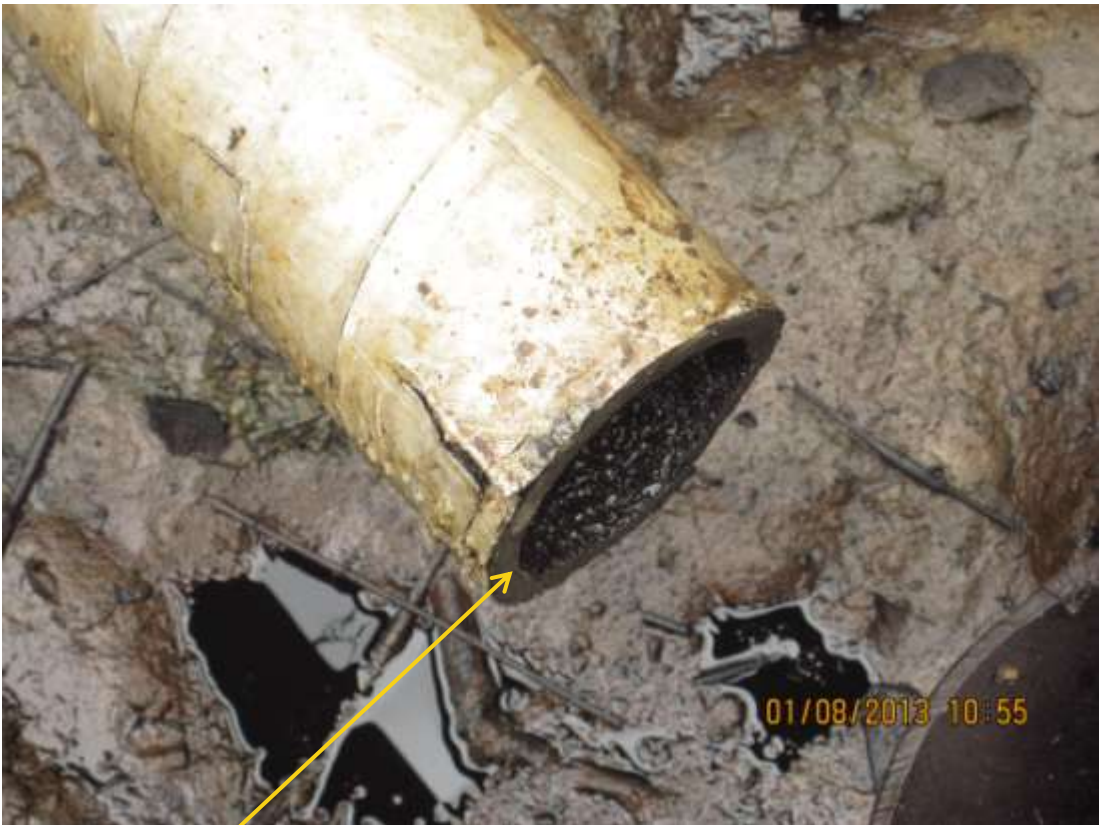
Close up: Cut section on 3" Imo River Well5L flowline at Igiriukwu. Picture was taken during Joint Investigation of 1<sup>st</sup> August 2013.
