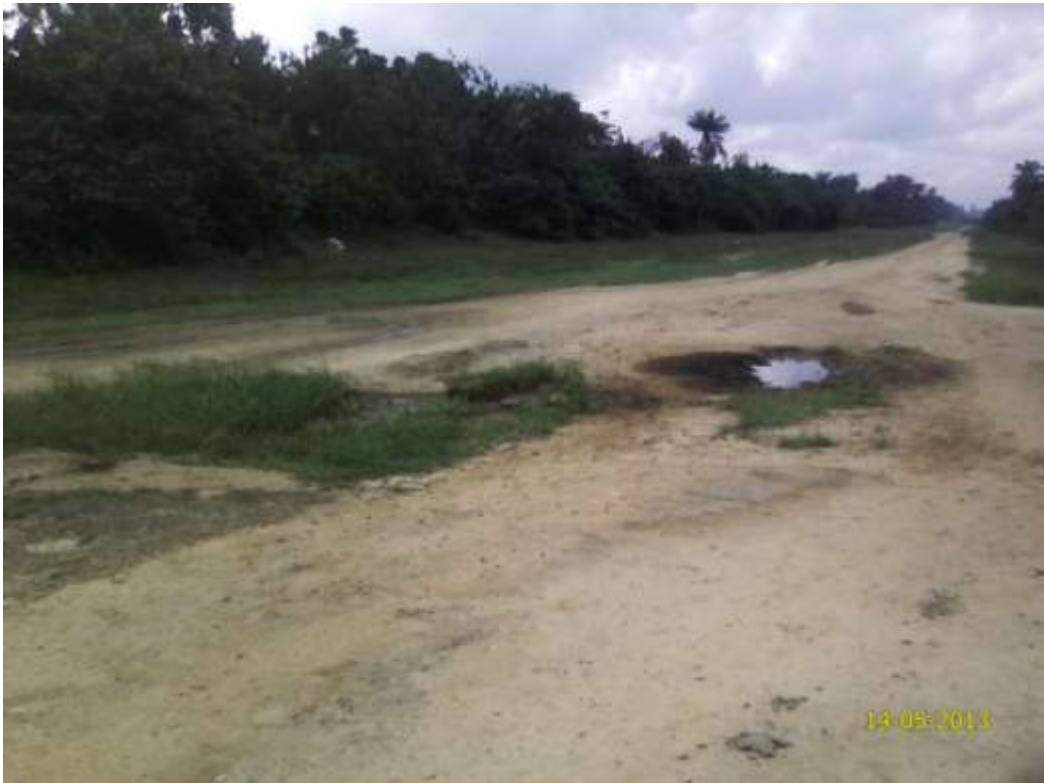
Overview: Part of spill impact on 36" Nkpoku-Bomu pipeline right of way at Akpajo. Picture was taken during Joint Investigation of 14<sup>th</sup> May 2013.

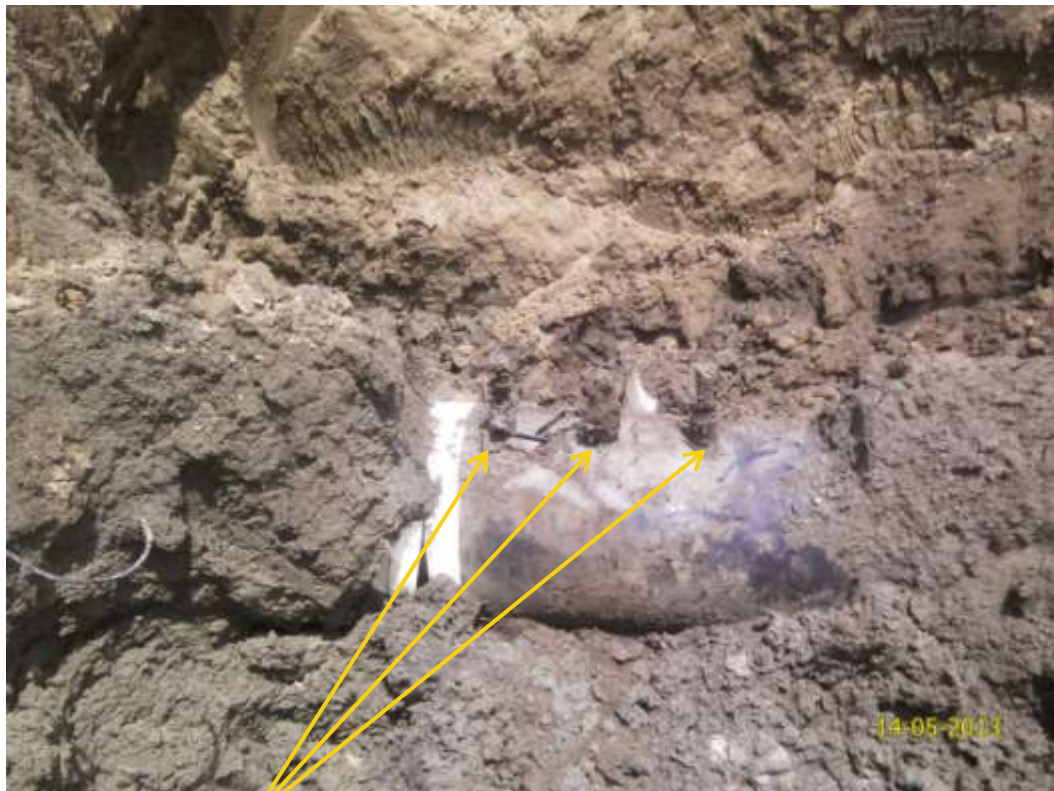
Close up: Illegal fittings on 36" Nkpoku-Bomu pipeline at Akpajo. Picture was taken during Joint Investigation of 14<sup>th</sup> May 2013.

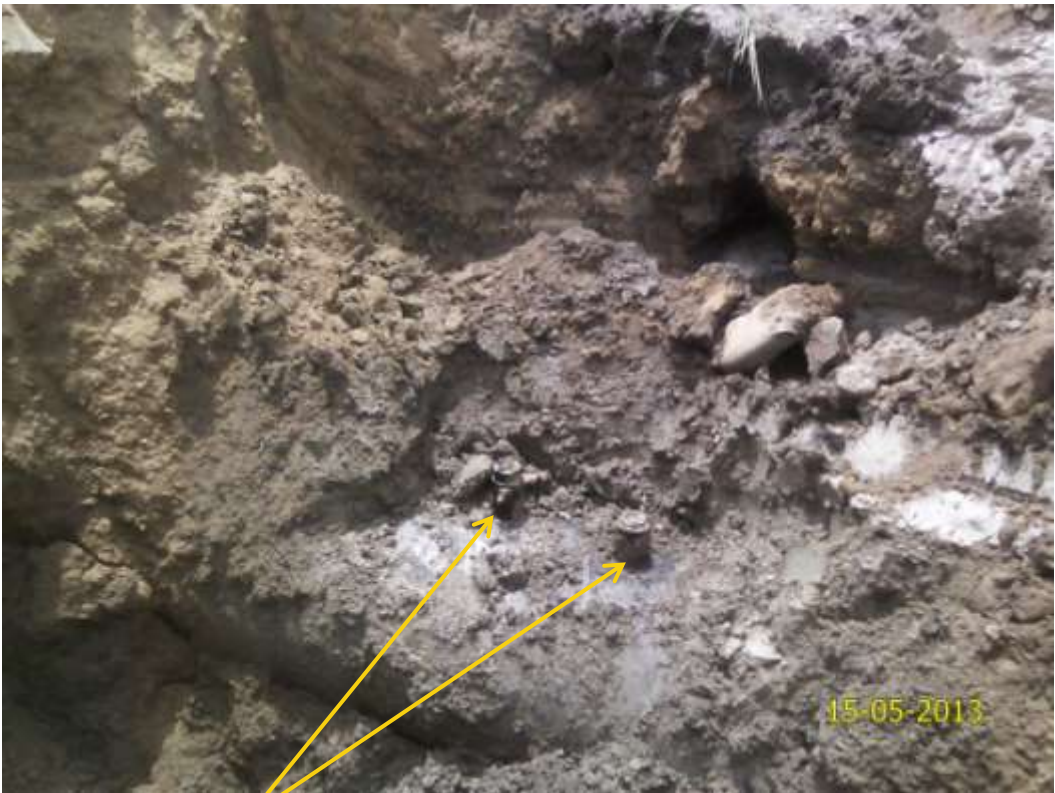
Close up: Illegal fittings on 36" Nkpoku-Bomu pipeline at Akpajo. Picture was taken during Joint Investigation of 15<sup>th</sup> May 2013.
