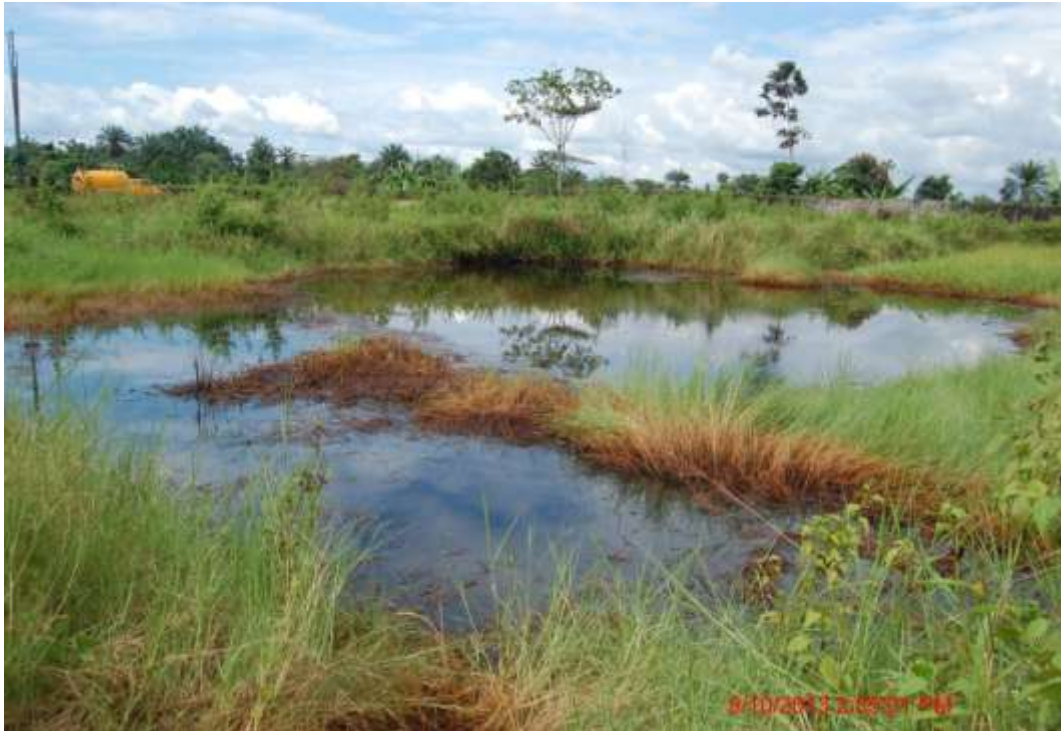
Overview: Part of spill impact on 4" Imo River Well 53L/56L Flowline at Etitioha-lpu  
Picture was taken during Joint Investigation of 9<sup>th</sup> October 2013.

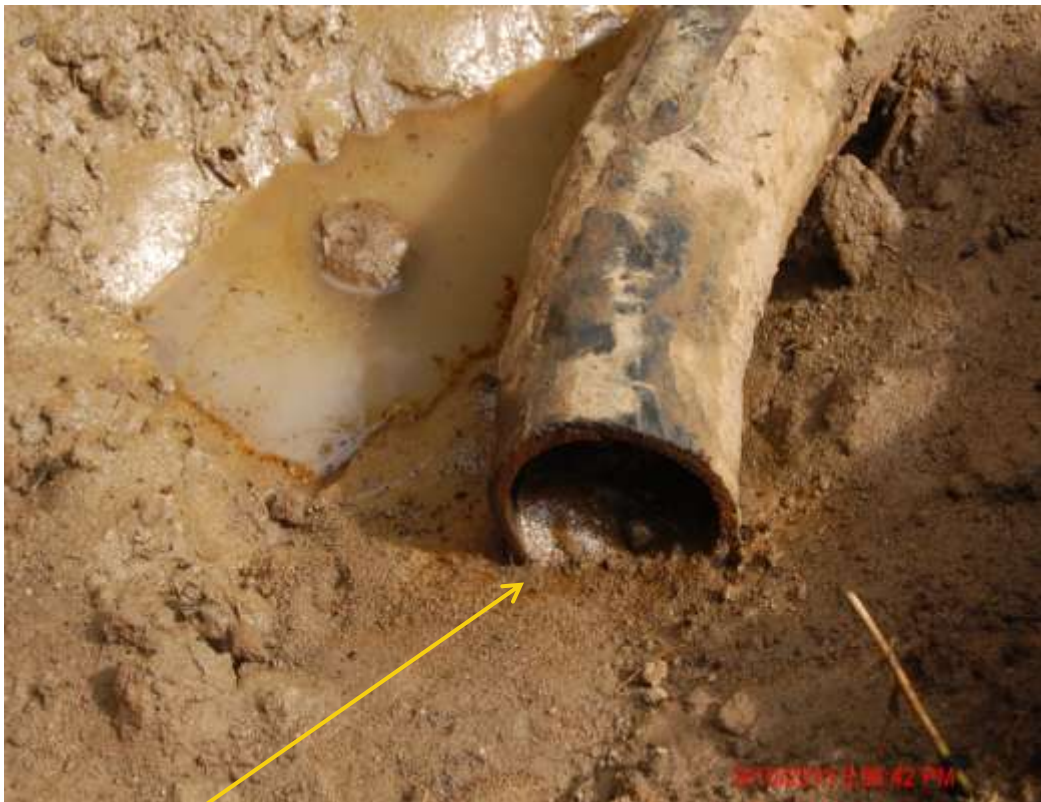
Close up: Missing flowline on 4" Imo River Well 53L/56L Flowline at Etitioha-lpu .  
Picture was taken during Joint Investigation of 9<sup>th</sup> October 2013.
