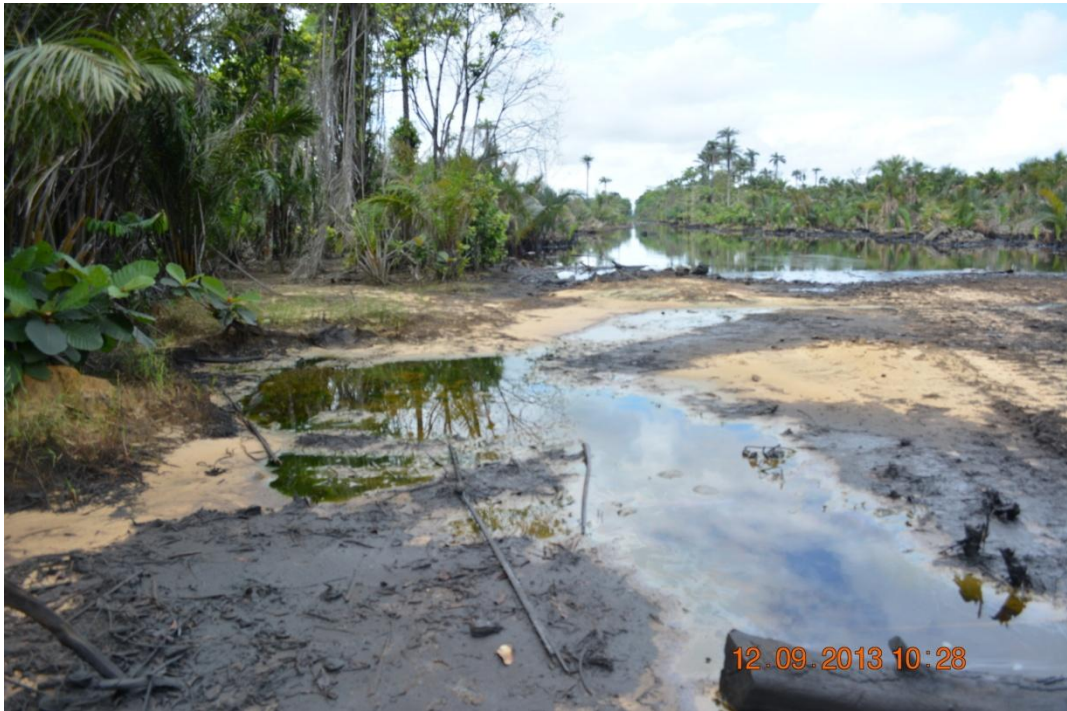
Overview: Part of spill impact on 20" Otumara-Escravos trunkline right of way at Adjudaibo. Picture was taken during Joint Investigation of 12th September 2013.

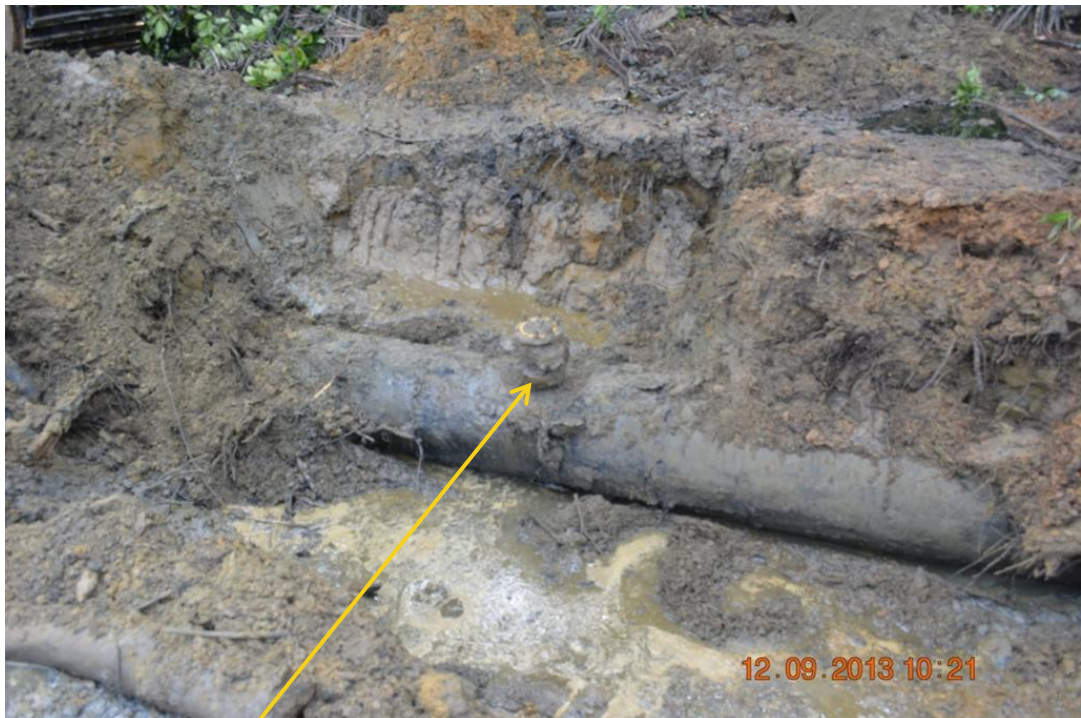
Close up: Illegal fitting on 20" Otumara-Escravos trunkline at Adjudaibo. Picture was taken during Joint Investigation of 12th September 2013.

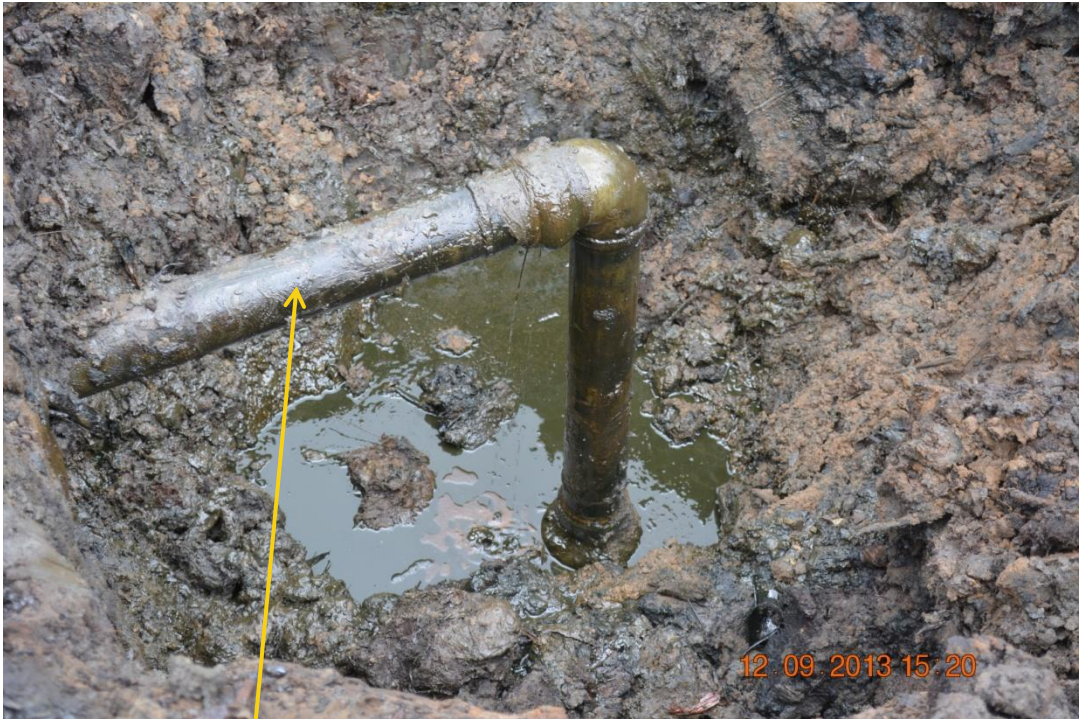
Close up: Illegal fitting on 20" Otumara-Escravos trunkline at Adjudaibo. Picture was taken during Joint Investigation of 12th September 2013.
