Overview: Part of spill impact on 4" Adibawa Well10S Flowline right of way at Adibawa. Picture was taken during Joint Investigation of 10th April 2014.

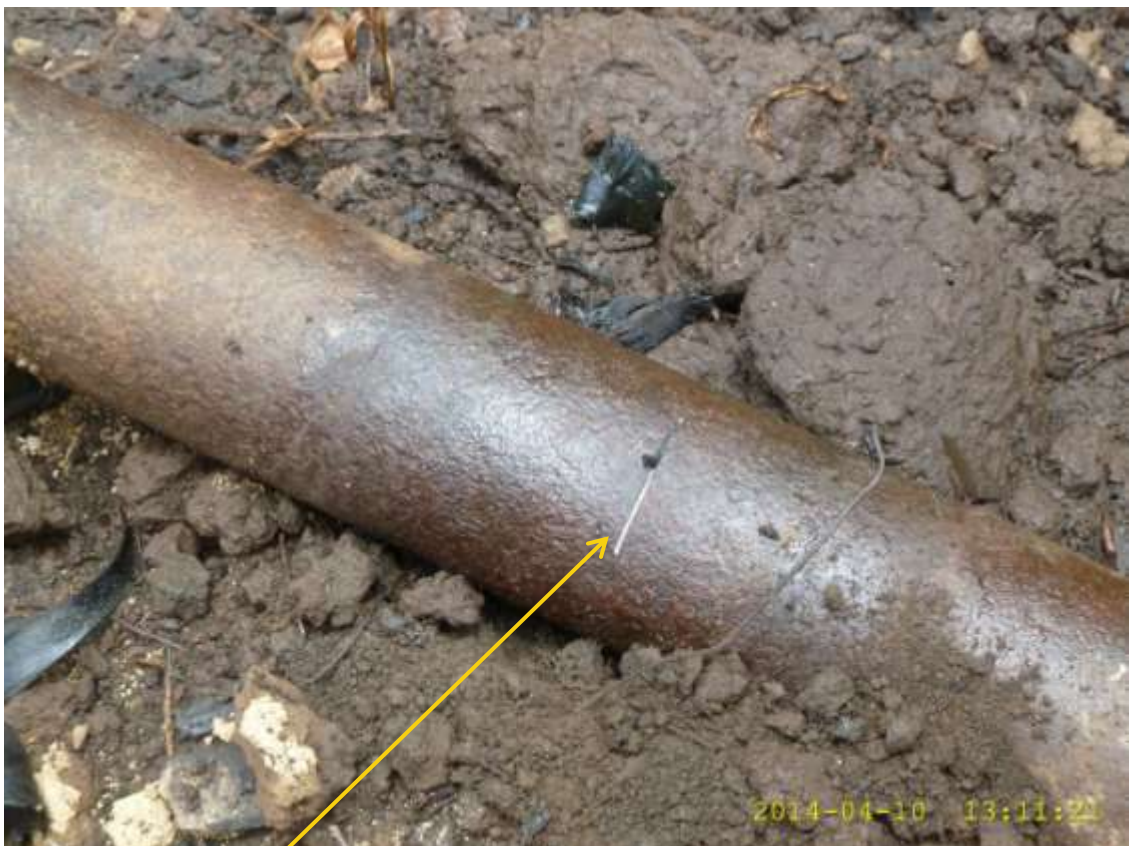
Close-up: Hacksaw cut on 4" Adibawa Well10S Flowline at Adibawa. Picture was taken during Joint Investigation of 10th April 2014.
