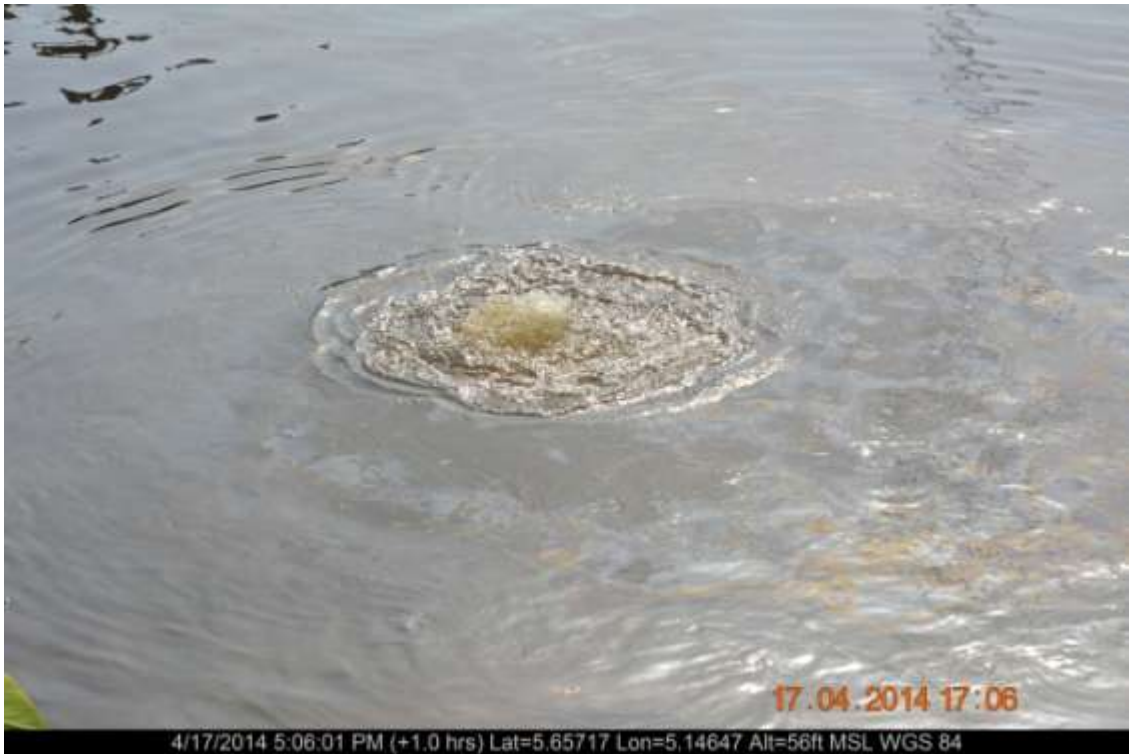
Overview: Bubbling and oil sheen observed on Otumara Well41S Flowline right of way at Ugboegungun. Picture was taken during Joint Investigation of 17th April 2014.

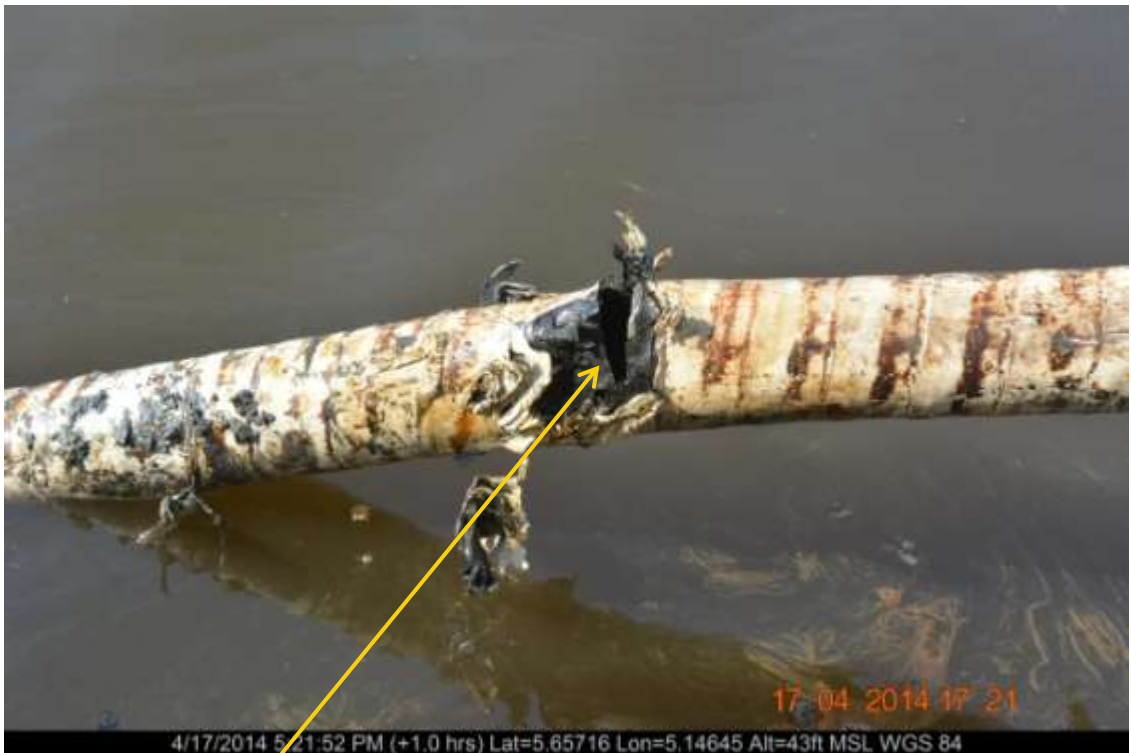
Close-up: Tear on Otumara Well41S Flowline at Ugboegungun. Picture was taken during Joint Investigation of 17th April 2014.
