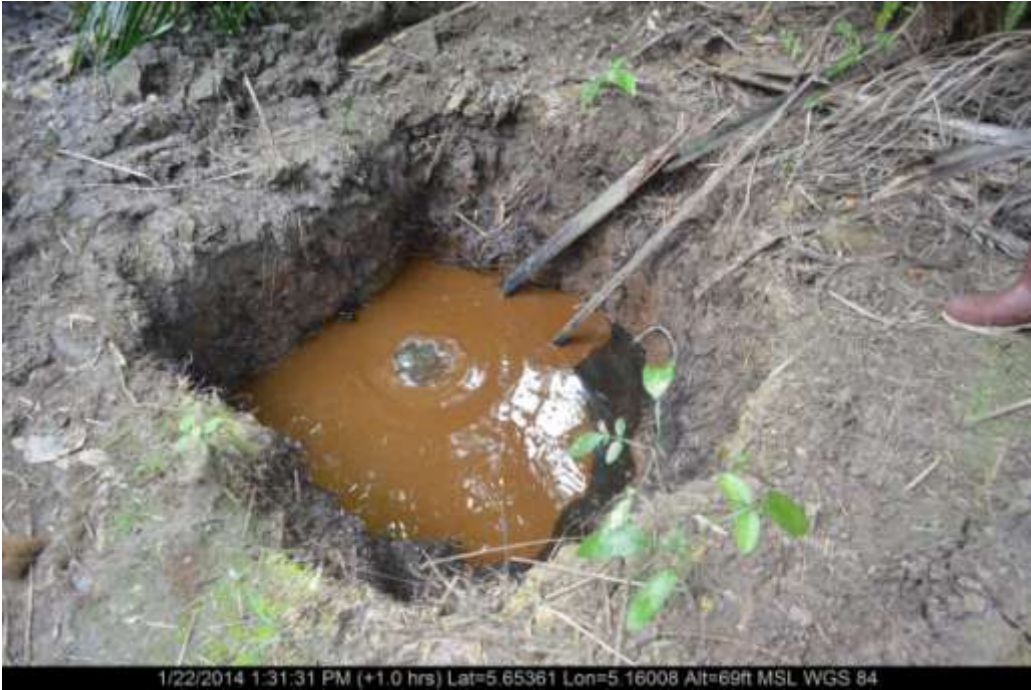
Overview: Part of spill impact on Otumara Well34L/S Flowline right of way at Ugboegungun. Picture was taken during Joint Investigation of 22nd January 2014.

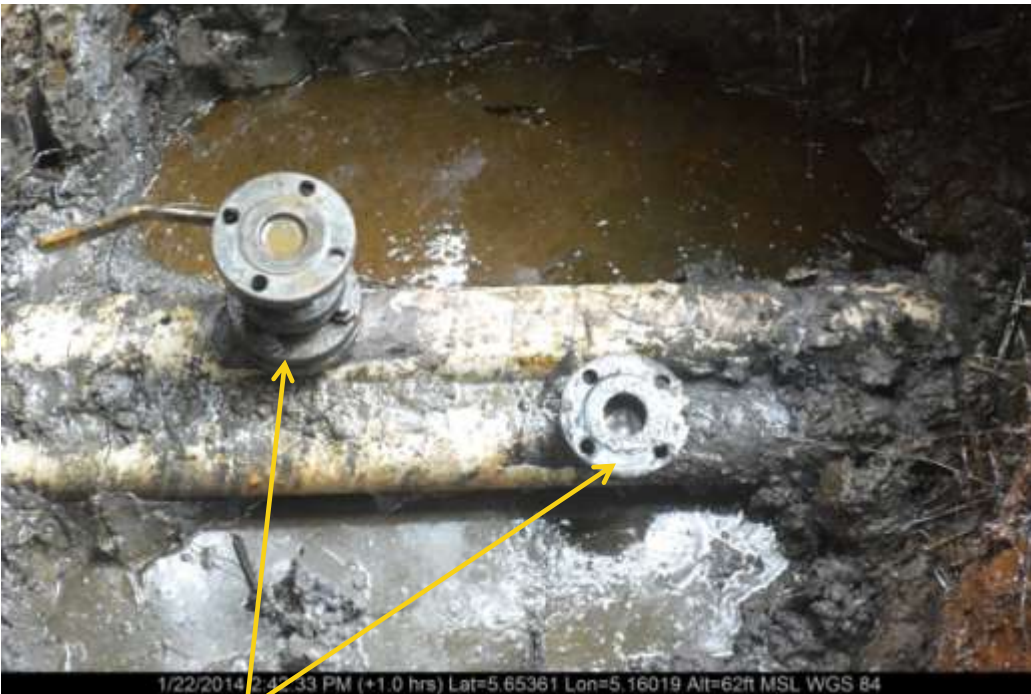
Close-up: Illegal fittings on Otumara Well34L/S Flowline at Ugboegungun. Picture was taken during Joint Investigation of 22nd January 2014.
