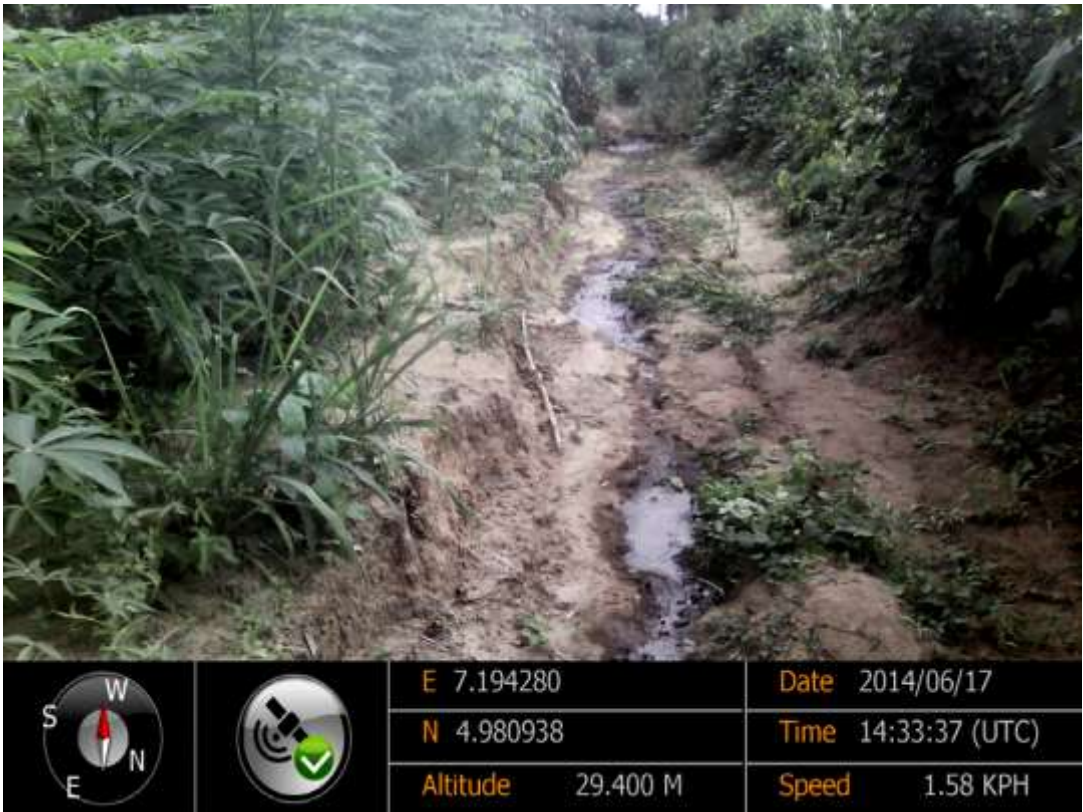
Overview: Part of spill impact on Imo River Well1T Flowline Right of Way at Igiriukwu (Owaza). Picture was taken during Joint Investigation of 17th June 2014.

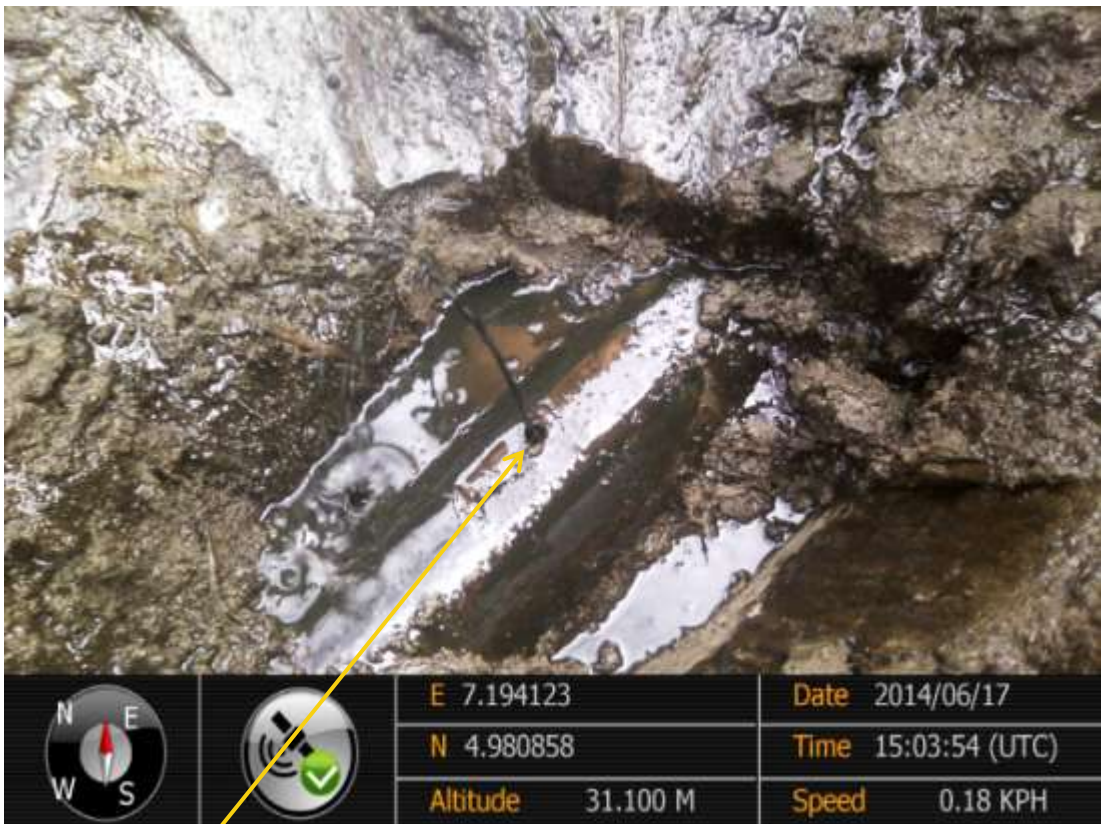
Close-up: Drilled hole on Imo River Well1T Flowline at Igiriukwu (Owaza). Picture was taken during Joint Investigation of 17th June 2014.
