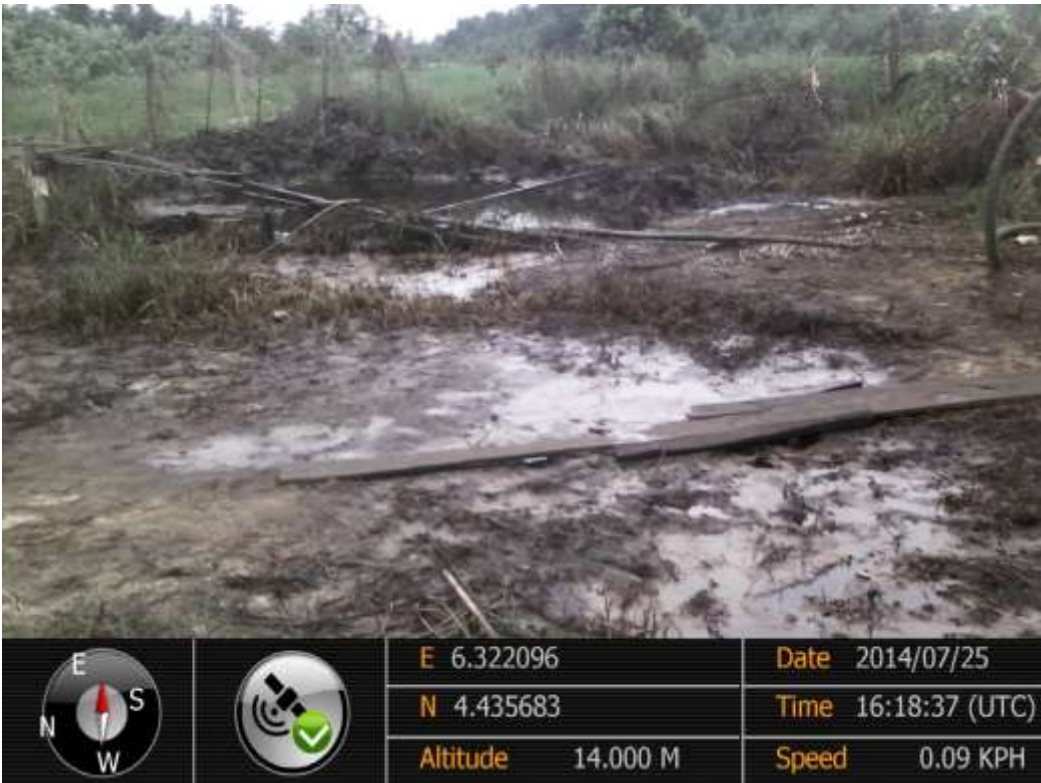
Overview: Part of spill impact on Nembe 1 Well 23T Flowline at Nembe Creek. Picture was taken during Joint Investigation of 25<sup>th</sup> July 2014.

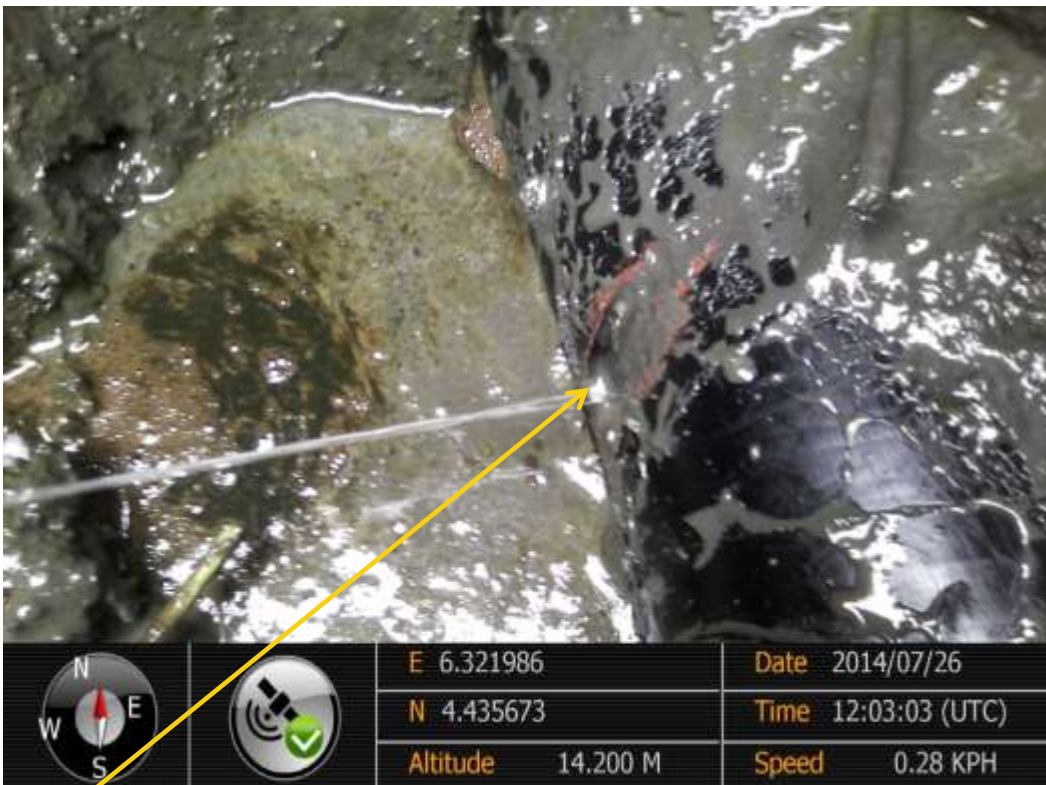
Close-up: Spill due to corrosion on Nembe 1 Well 23T Flowline at Nembe Creek . Picture was taken during Joint Investigation of 26<sup>th</sup> July 2014.
