Overview: Part of spill impact on Opukushi Well24T Flowline at Egbemo-Angalabiri. Picture was taken during Joint Investigation of 20<sup>th</sup> March 2014.

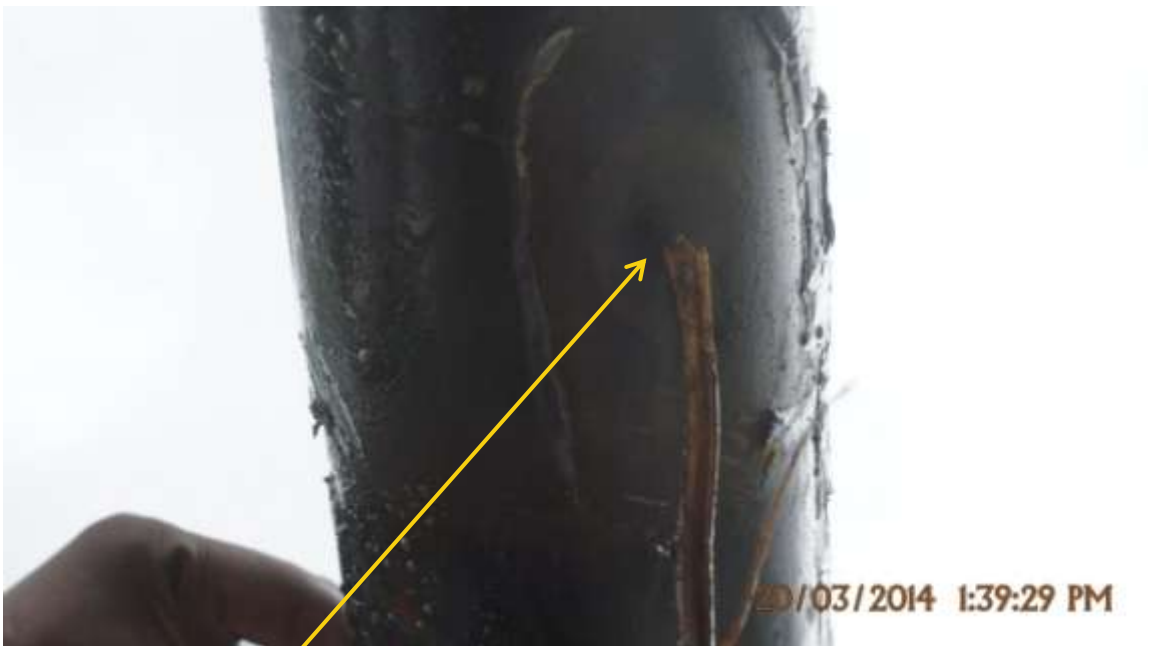
Close-up: Spill due to corrosion on Opukushi Well24T Flowline at Egbemo-Angalabiri. Picture was taken during Joint Investigation of 20<sup>th</sup> March 2014.
