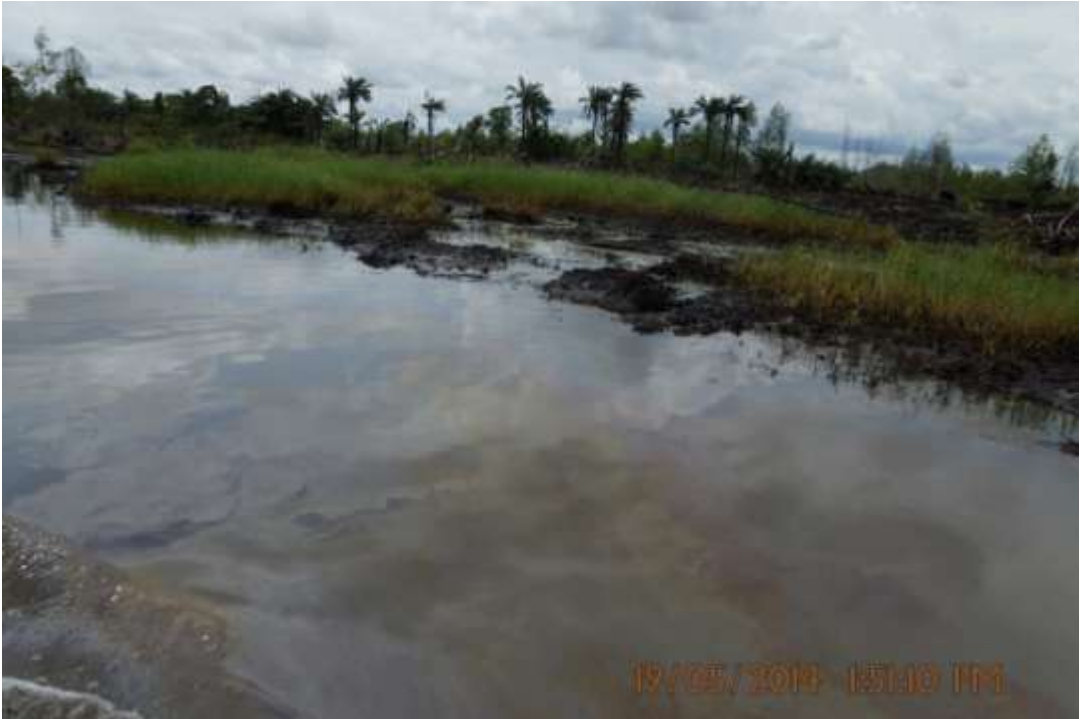
Overview: Part of spill impact on Otumara Well22L Flowline Right of Way at Ugboegungun. Picture was taken during Joint Investigation of 19<sup>th</sup> May 2014.

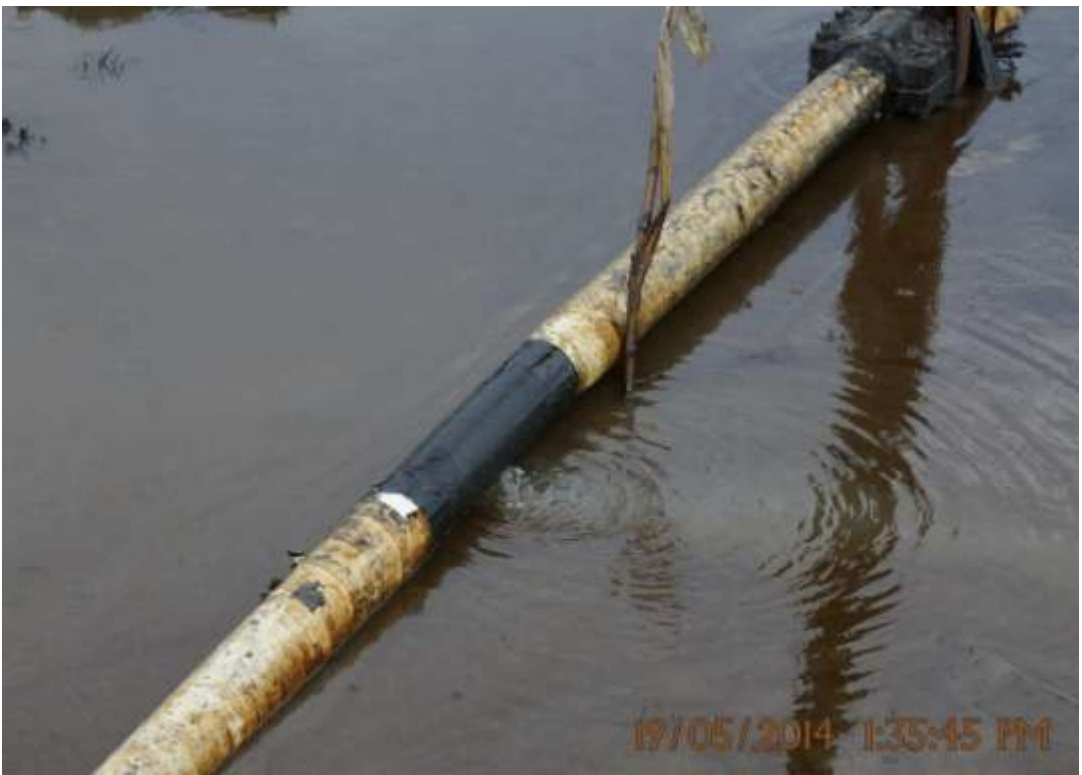
Close-up: Bubbling from pinhole on Otumara Well22L Flowline at Ugboegungun. Picture was taken during Joint Investigation of 19<sup>th</sup> May 2014.
