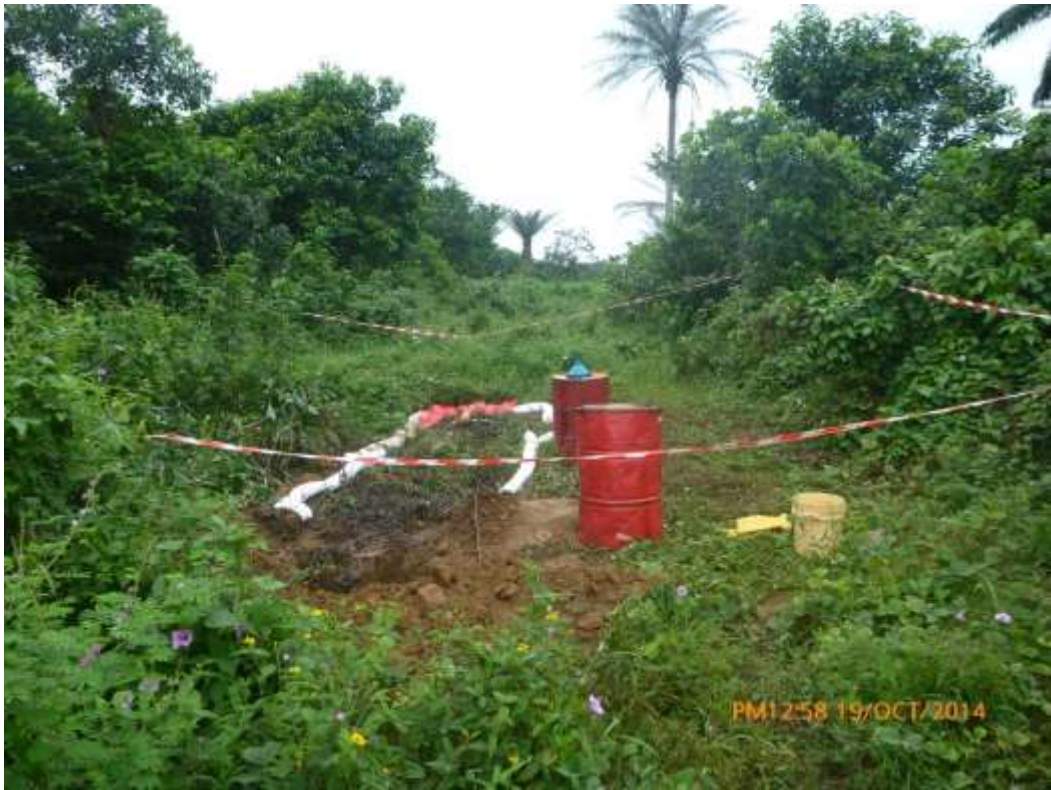
Overview: Part of spill impact on 4" Agbada 2 Well2 Gaslift Flowline Right of Way at Omuohia. Picture was taken during Joint Investigation of 19th October 2014.

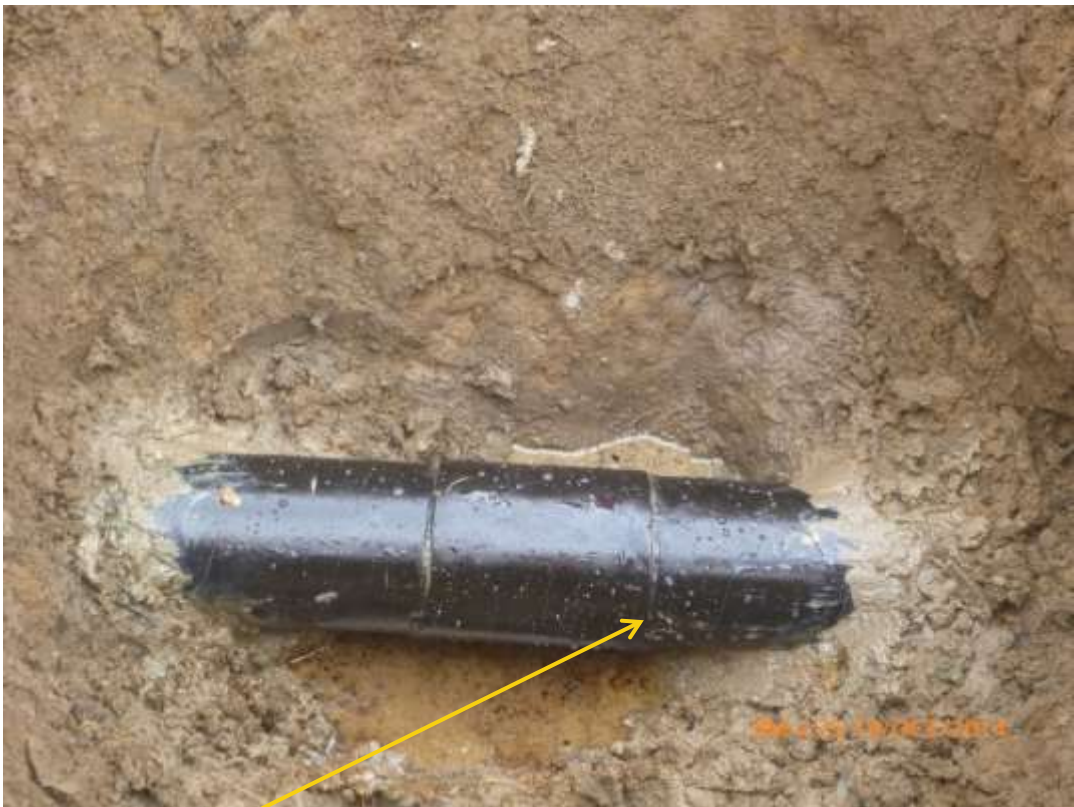
Close-up: Failed weld on 4" Agbada 2 Well2 Gaslift Flowline at Omuohia. Picture was taken during Joint Investigation of 19th October 2014.
