JOINT INVESTIGATION REPORT

INCIDENT NO: 1469473 JIV report S/N: Nº 0000046

1. Spill incident Number: 1469473 2. Type of incident* OIL SPILL
3. Name of Location DIEBU CREEK WELL 1S WELL HEAD
4. Name of nearest community PEREMABIRI 5. State: BAYELSA 6. LGA SOUTHERN IJAW
7. Type of Production facility/Installation WELL HEAD
8. Asset owner/District SPDC / LAND 2

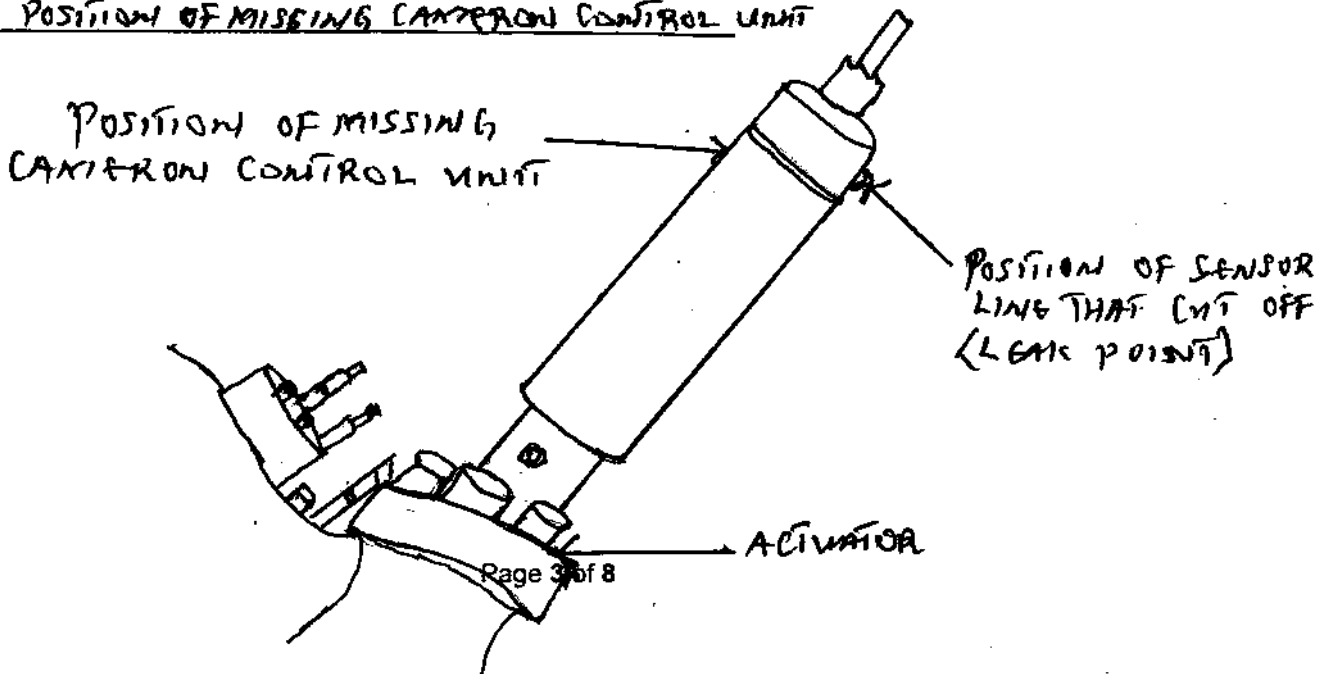
SECTION OF DIEBU CREEK WELL IS WELL HEAD AS
 BREMBERI POSITION OF MISSING CAMERON CONTROL UNIT

Additional observations around the spill point: DURING THE JOINT INVESTIGATION VISIT, OIL STAINS WERE OBSERVED ON THE BODY OF THE WELL HEAD. LIGHT IMPACT WAS ALSO NOTICED.

| <input checked="" type="checkbox"/> Others (specify) <u>CAMERON CONTROL UNIT WAS REMOVED BY UNKNOWN PERSON. SENSOR LINE WAS ALSO CUT OFF</u> | | |

REPAIR WORK PLANNED.
