JOINT INVESTIGATION REPORT

INCIDENT NO: 1469818 JIV report S/N: Nº 0000009

1. Spill incident Number: 1469818 2. Type of incident* OIL SPILL
3. Name of Location DESTRUCTION OF GEEPEE TANKS AT OBEJUM EVACUATION POINT.
4. Name of nearest community OBEJUM 5. State: RIVERS 6. LGA ABUA/ODUAL
7. Type of Production facility/Installation CONTAINMENT FACILITY (GEEPEE TANKS)
8. Asset owner/District THE SHELL PETROLEUM DEVELOPMENT COMPANY OF NIG LTD.

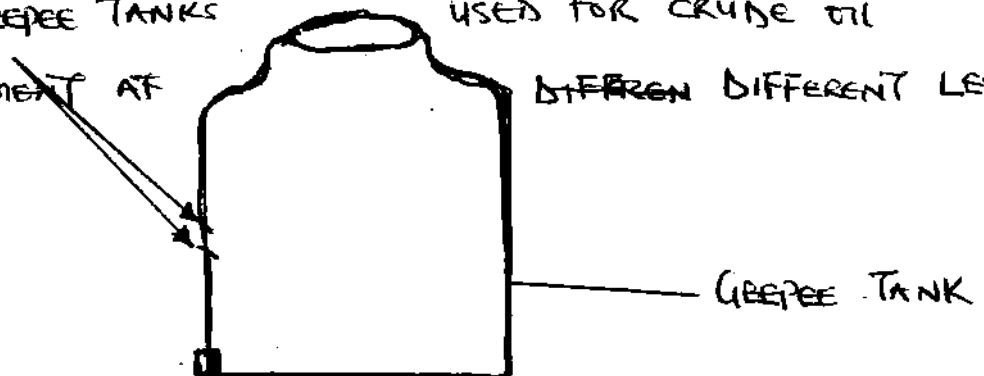
SECTIONAL VIEW OF DESTRUCTION OF GREEPEE TANKS AT OBEDUM EVACUATION

POINT AT OBEDUM SHOWING PUNCTURED WITH KNIFE CUTS.

SPILL IS DUE TO PUNCTURED WITH KNIFE CUTS ON EACH OF THE SIX (6) GREEPEE TANKS USED FOR CRUDE OIL

CONTAINMENT AT

DIFFEREN DIFFERENT LEVEL.

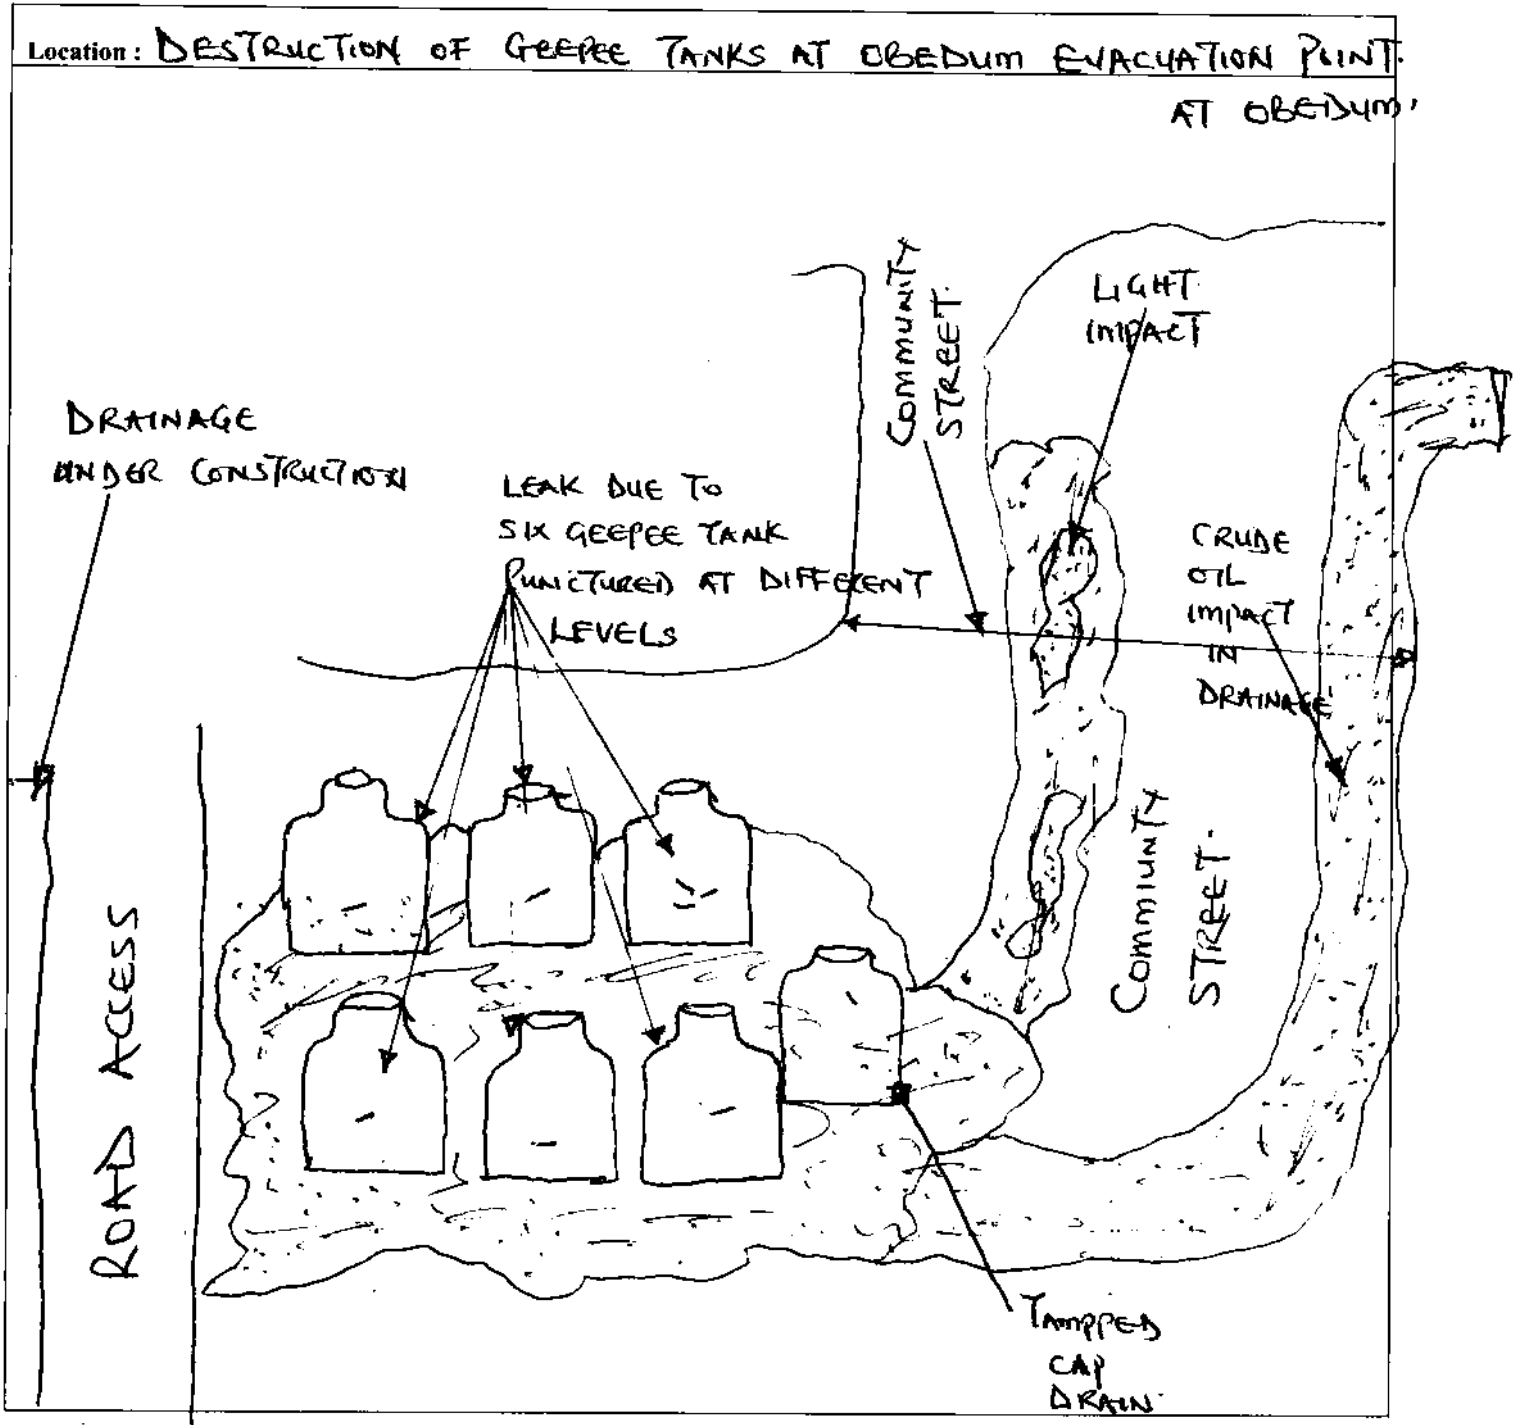
f. Appendix 1: Overview sketch of the site

Additional observations around the spill point: THE JOINT INVESTIGATING TEAM OBSERVED A TOTAL NUMBER OF SIX (6) GEEPEE TANKS PUNCTURED WITH KNIFE CUTS WHILE THE CAP OF THE SEVENTH TANK WAS TAMPED.

* CHANNELS WERE DELIBERATELY CREATED TO AID OIL SPREAD. OR IMPACT.
