JOINT INVESTIGATION REPORT

INCIDENT NO: 1475866 JIV report S/N: Nº 0000054

1. Spill incident Number: 1475866 2. Type of incident* OIL SPILL
3. Name of Location 8" AFAM WELL 25 FLOWLINE
4. Name of nearest community EGBERU 5. State: RIVERS 6. LGA OBIGBO
7. Type of Production facility/Installation OIL FLOWLINE
8. Asset owner/District THE SHELL PETROLEUM DEVELOPMENT COMPANY OF NIGERIA (SPDC)

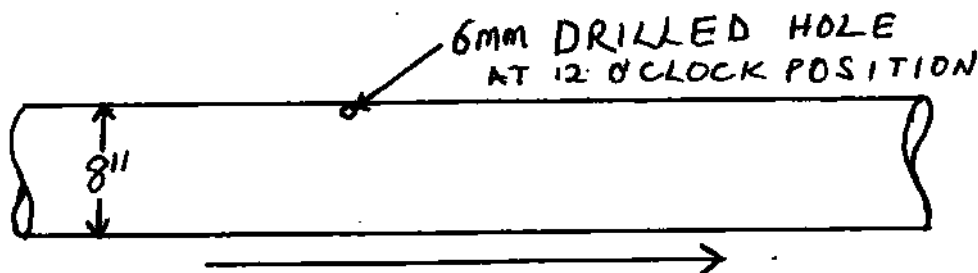
A SECTION OF 8" AFAM WELL 25 FLOWLINE AT EGBERU SHOWING A 6MM DRILLED HOLE AT 12 O'CLOCK POSITION, DONE BY UNKNOWN PERSONS.

SOURCE OF SPILL STOPPED AND REPAIR PLANNED.
