JOINT INVESTIGATION REPORT

INCIDENT NO: 1461320 JIV report S/N: N^o 0000071

1. Spill incident Number: 1461320 2. Type of incident* OIL SPILL
3. Name of Location 12" ADIBAWA - OKORDIA PIPELINE
4. Name of nearest community IKARAMA 5. State: BAYELSA 6. LGA YENAGOA
7. Type of Production facility/Installation OIL PIPELINE
8. Asset owner/District THE SHELL PETROLEUM DEVELOPMENT COMPANY OF NIGERIA LIMITED / PIPELINE

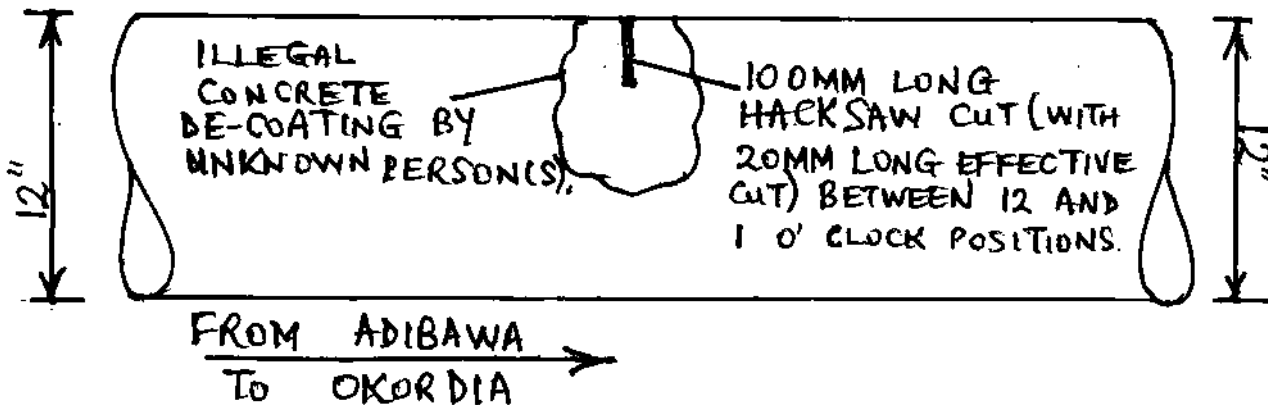
Additional observations around the spill point: A DITCH DIG BY UNKNOWN PERSON(S) WAS OBSERVED AROUND THE SPILL POINT WHEN THE JOINT INVESTIGATION TEAM ARRIVED AT SITE. UPON EXCAVATION DURING JIV TO ASCERTAIN LEAK CAUSE, A SECTION OF THE CONCRETE COATING AROUND THE SPILL POINT WAS NOTICED REMOVED, OFF THE PIPELINE, BY UNKNOWN PERSON(S).

SECTION OF 12" ADIBAWA - OKORDIA PIPELINE AT IKARAMA SHOWING POSITION OF HACKSAW CUT.

SOURCE OF LEAK WAS STOPPED AND THEREAFTER REPAIRS WERE EFFECTED ON THE AFFECTED SECTION OF PIPELINE BY CLAMPING.
