# JOINT INVESTIGATION REPORT

INCIDENT NO: 1457280 JIV report S/N: Nº 0000038

1. Spill incident Number: 1457280 2. Type of incident\* OIL SPILL  
3. Name of Location EIELEBON WELL 6 FLOWLINE  
4. Name of nearest community OGBOLOMA 5. State: BAYELSA 6. LGA TENAGOA  
7. Type of Production facility/Installation FLOWLINE  
8. Asset owner/District SPDC / LAND 2.

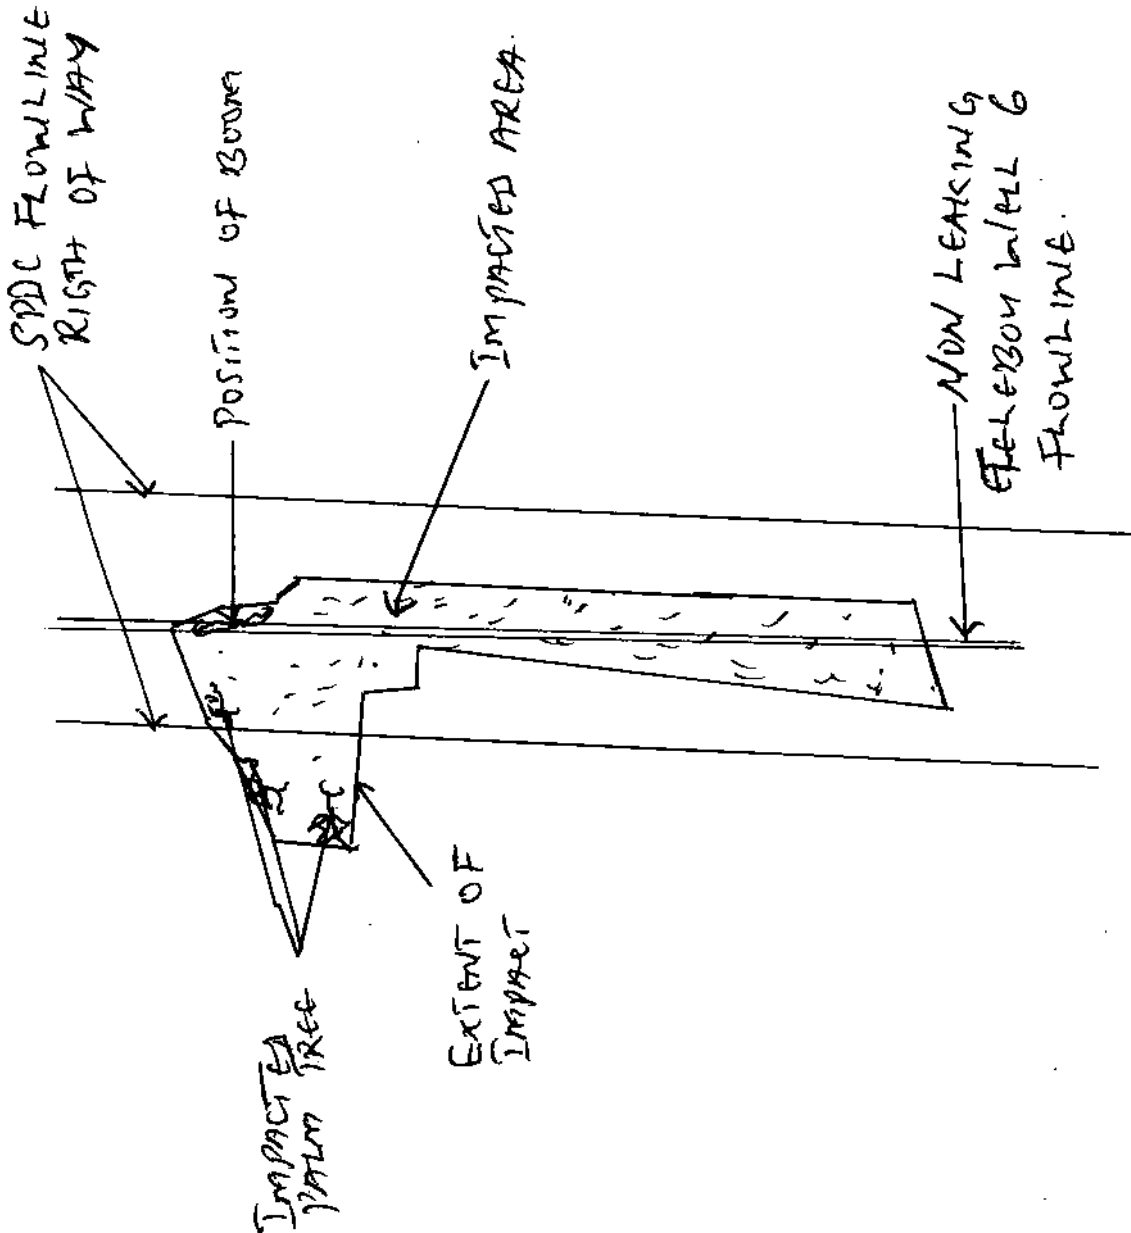
f. Appendix 1: Overview sketch of the site

Location: EFELEBOU WELL 6 FLOWLINE AT OGBOLOMA
