JOINT INVESTIGATION REPORT

INCIDENT NO: 1473411 JIV report S/N:

1. Spill incident Number: 1473411 2. Type of incident* OIL SPILL
3. Name of Location 6" SEIBOU BULKLINE - 4
4. Name of nearest community AZAGBENE 5. State: BAYELSA 6. LGA EKEREMOR
7. Type of Production facility/Installation FLOWLINE
8. Asset owner/District THE SHELL PETROLEUM DEVELOPMENT COMPANY OF

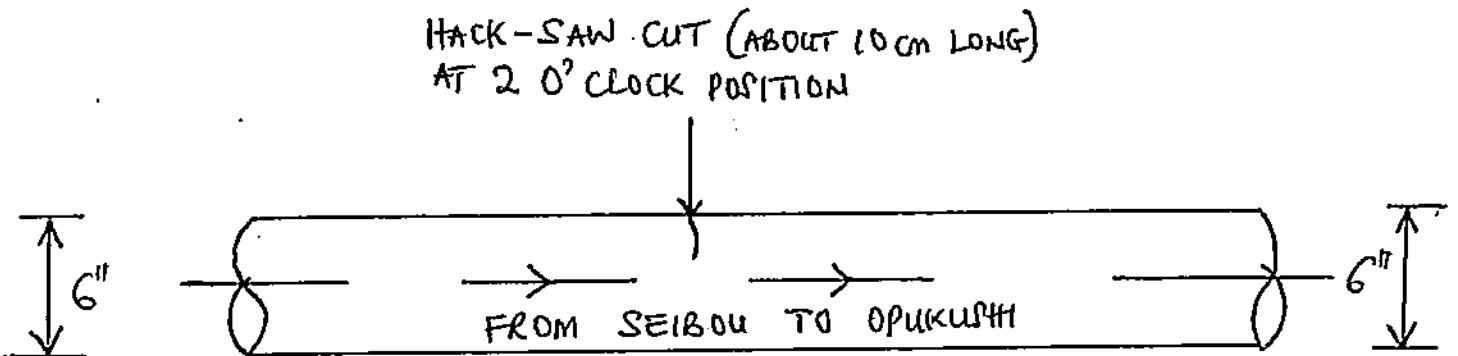
Additional observations around the spill point: UPON EXCAVATION, THE JOINT INVESTIGATION TEAM OBSERVED A HACK-SAW CUT (ABOUT 10CM LONG) ON SEIBOU BULKLINE - 4 AT 2 O' CLOCK POSITION.

A SECTION OF 6" SEIBOU BULKLINE - 4 AT AZAGBENE AXIS
SHOWING; POSITION OF HACK-SAW CUT (ABOUT 10CM LONG)
