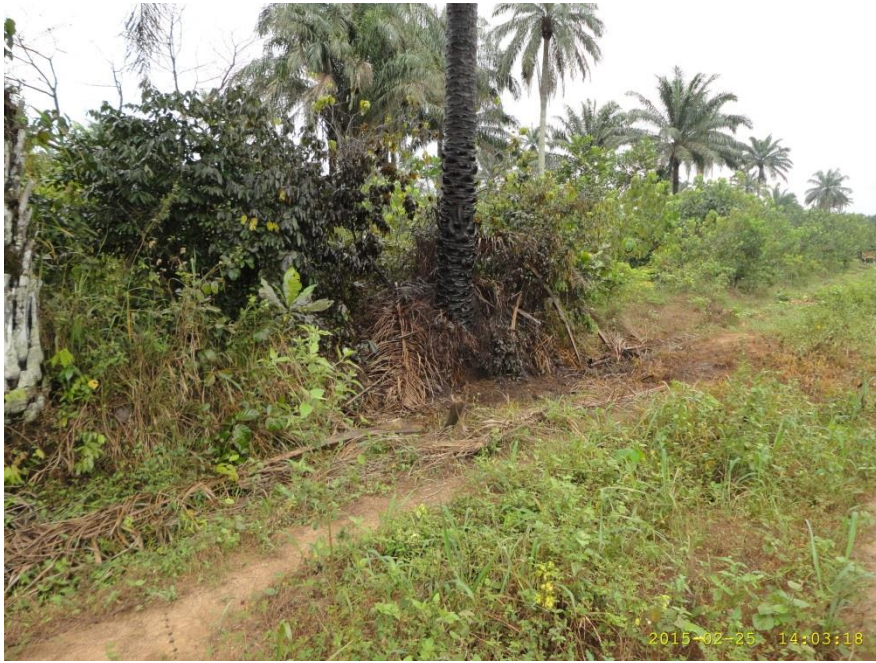
Overview: Part of spill impact from Imo River Well 59T Flowline at Igirukwu. Picture was taken during Joint Investigation of 25th February 2015.

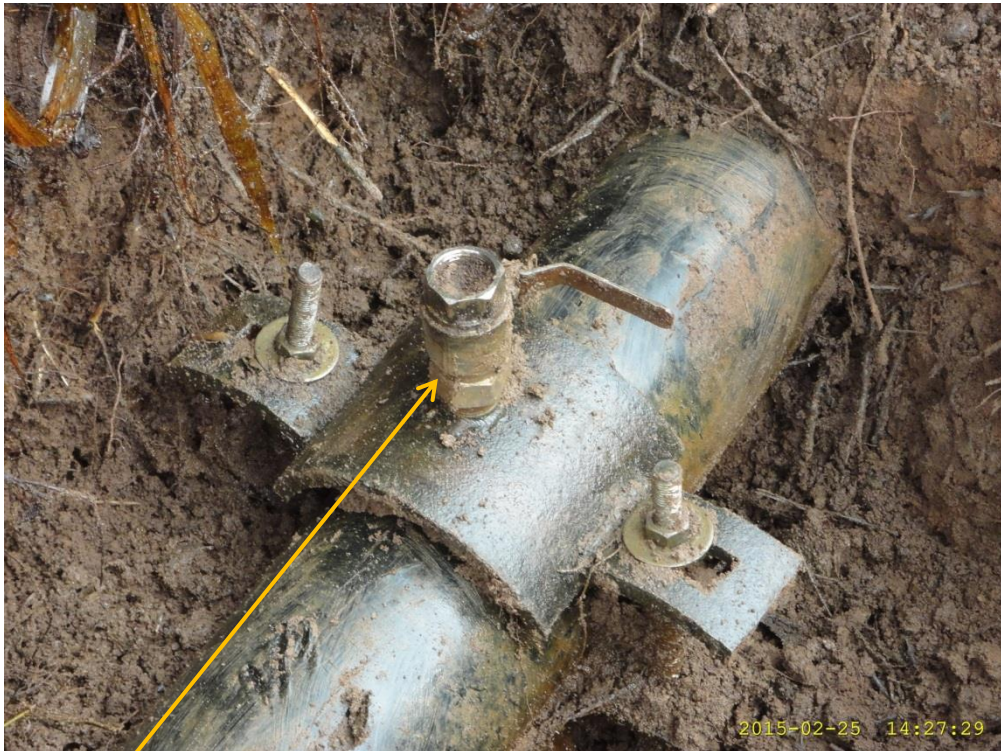
Close-up: Illegal fitting on Imo River Well 59T Flowline at Igirukwu. Picture was taken during Joint Investigation of 25th February 2015.
