JOINT INVESTIGATION REPORT

INCIDENT NO: 1433813 JIV report S/N: Nº 0000343

1. Spill incident Number: 1433813 2. Type of incident* OIL SPILL
3. Name of Location 20" OTUMARA - ESCRAVOS PIPELINE
4. Name of nearest community OGIDIGBEN 5. State: DELTA 6. LGA WARRI SOUTH - WEST
7. Type of Production facility/Installation OIL PIPELINE
8. Asset owner/District THE SHELL PETROLEUM DEVELOPMENT COMPANY OF NIG. LIMITED

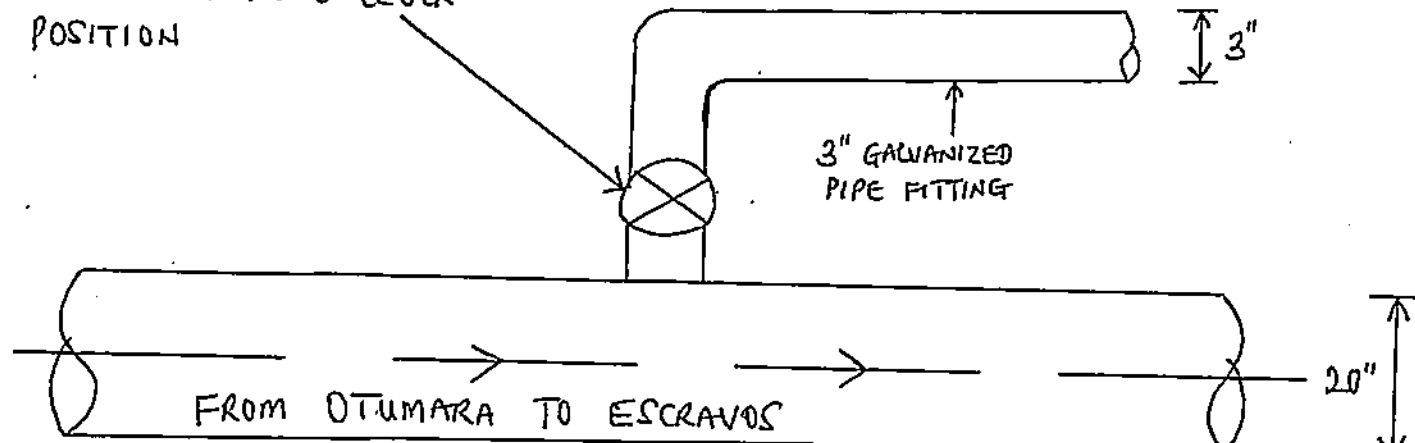
20" OTUMARA - ESCRAVOS PIPELINE AT OGIDIGBEN

Additional observations around the spill point: ON EXCAVATION, A 4" FAILED ILLEGAL HOT-TAP VALVE CONNECTED TO A 3" GALVANIZED PIPE FITTING WAS OBSERVED WELDED ON THE -20" OTUMARA - ESCRAVOS PIPELINE AT 12 O'CLOCK POSITION. THOUGH, THE LEAK HAS STOPPED AT THE SPILL POINT AS AT THE TIME JIT GOT TO SITE.

4" FAILED ILLEGAL HOT-TAP VALVE
 WELDED AT 12 O' CLOCK
 POSITION

REPAIR IS BEING PLANNED
