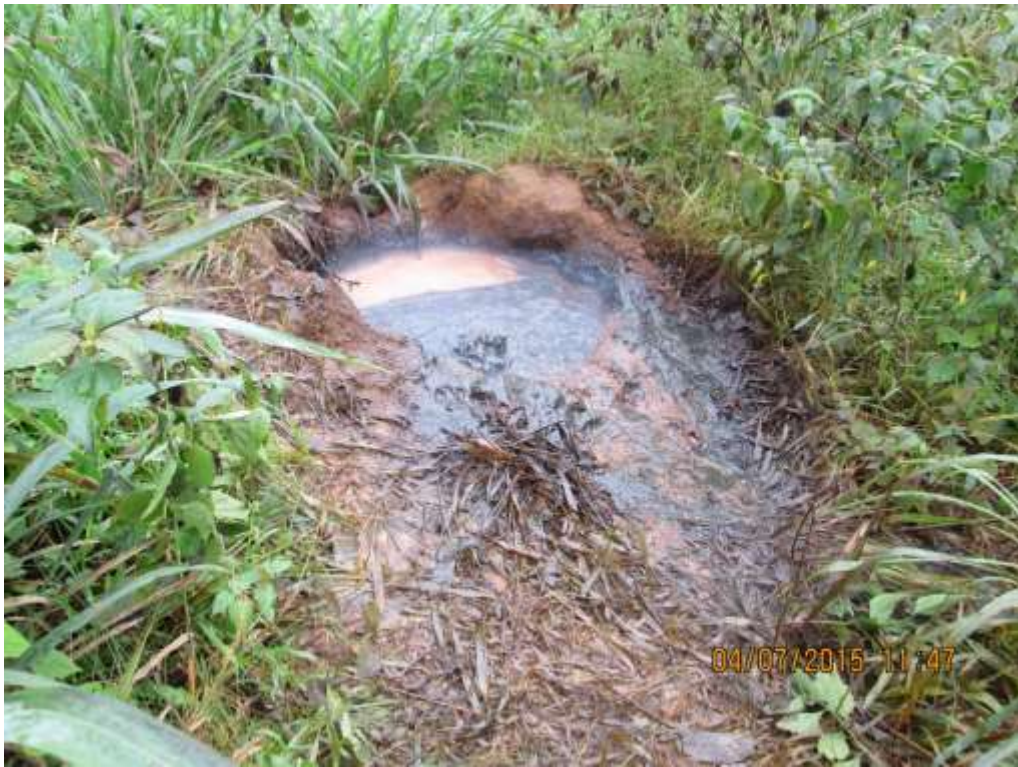
Overview: Part of spill impact on 8" Afam Well27 Flowline Right of Way at Egberu. Picture was taken during Joint Investigation of 4th July 2015.

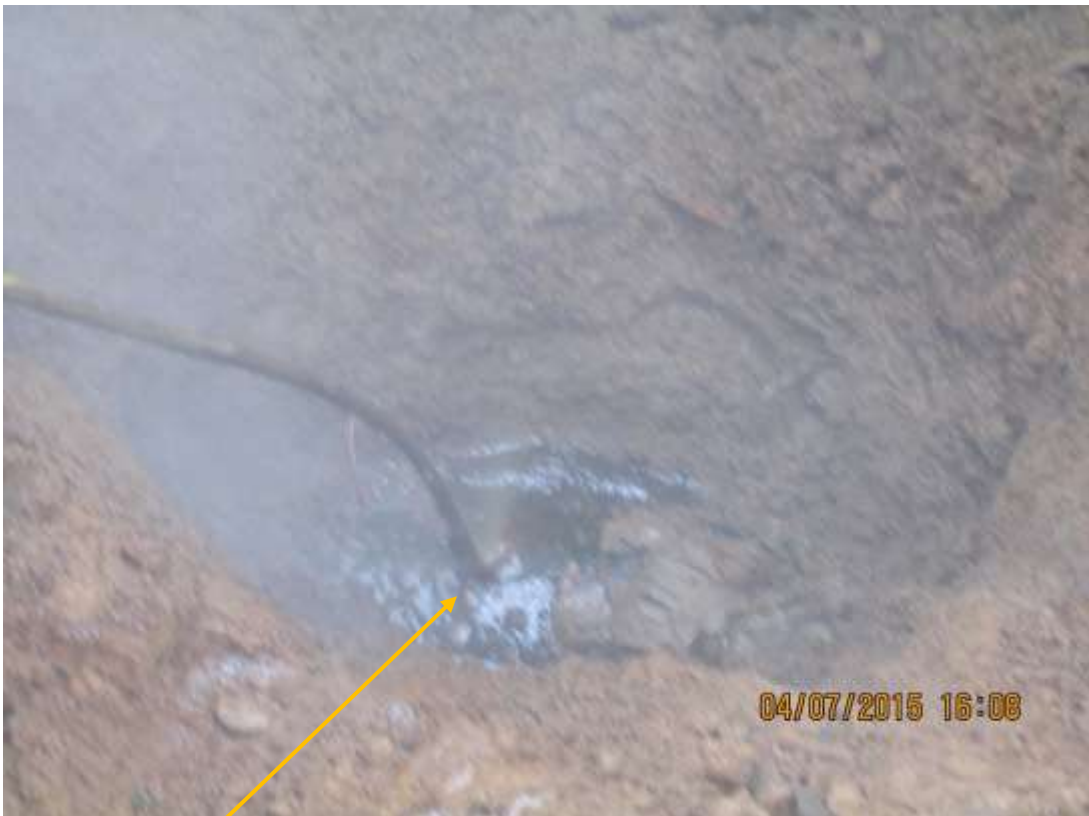
Close-up: Position of drilled hole pointed out by JIT member with stick on 8" Afam Well2 Flowline at Egberu. Hazing effecting picture clarity is due to gas leaking from drill hole.
