# JOINT INVESTIGATION REPORT

INCIDENT NO: 1434642 JIV report S/N: Nº 0008035

1. Spill incident Number: 1434642 2. Type of incident\* OIL SPILL  
3. Name of Location 10" DIEBEN CREEK - NUNRIVER PIPELINE  
4. Name of nearest community OPOROMA 5. State: BAYELSA 6. LGA SOUTHERN ITAMU.  
7. Type of Production facility/Installation OIL PIPELINE  
8. Asset owner/District SPDC / PIPELINE

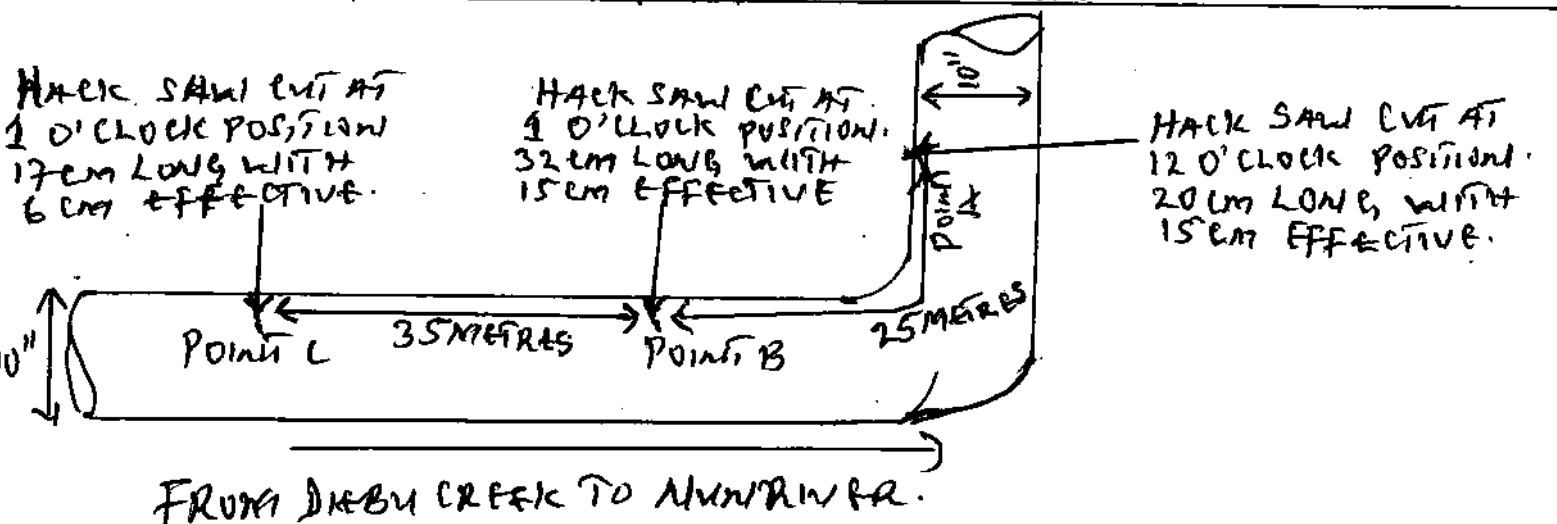
| <input type="checkbox"/> Drilled hole | <input checked="" type="checkbox"/> Hack saw cut | <input type="checkbox"/> Tear ( _____ ). |

- Third party interference (Sabotage  crude theft ; Line theft ; Accidental 3<sup>rd</sup> party damage   
 Operational  Others (including Mystery spills) \_\_\_\_\_

SECTION OF 10" DIEBU CREEK - NUN RIVER PIPELINE AT OPOROMA SHOWING POSITION OF HACK SAW CUTS.

REPAIR WORK WAS DONE BY  
CLAMPING.
