INCIDENT NO: 1434746 JIV report S/N: (Note: As practicable as possible the JIT report is to be signed in the field by all the participating parties) A. GENERAL INFORMATION: 1. Spill incident Number: 1434746 2. Type of incident* OIL SPILL 3. Name of Location 10" DIEBU CREEK - NUN RIVER PIPELINE 4. Name of nearest community OPOROMA 5. State: BAYELSA 6. LGA SONTHERN IJAM 7. Type of Production facility/Installation OIL PIPELINE 8. Asset owner/District SPDL/PIPELINE. **B. INCIDENT INFORMATION:** 9. Details of incident

INCID	ENT NO: <u>//</u>	34746	JIV report S/	N: Nº	0000036
g. Spill point coordina	ates .	10.6 0	1		
h. Measuring unit	V	VYS D.	4		
Northing: (上をイバナの る)	Easting: CLONG	(304TI

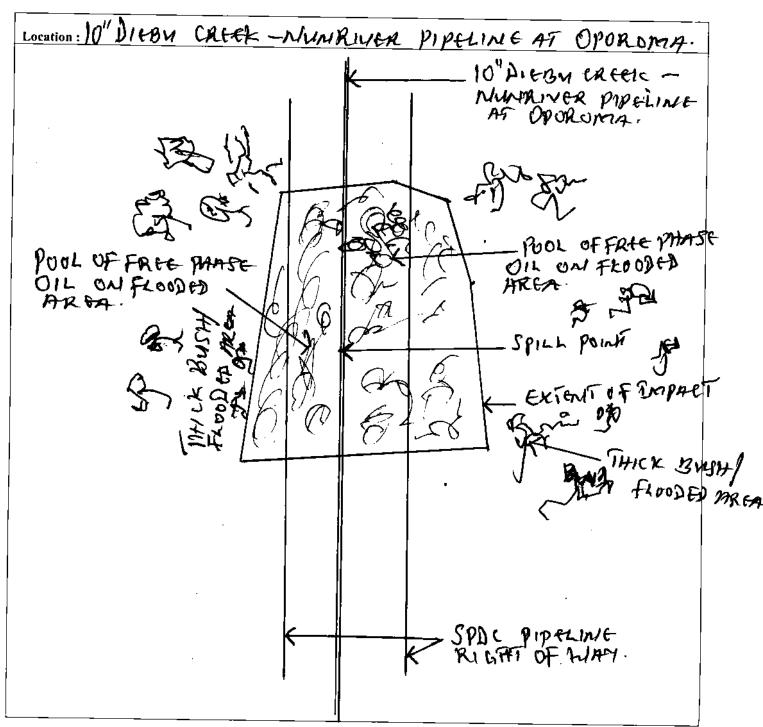
f. Appendix 1: Overview sketch of the site

•	•	,
18. Fishing Nets/Fi		<u></u>			
Nets/Ponds	Description	_ +	Quantity/Size (Comments	
DN€	MITHIN	nati	1 OF 2	IMPA	LCT.
_ [
19. Others (Specify					
Others	Description		Quantity/Size	Comments	
NONE	JiTHA	AR	€A OF	Imp	ACT
GRAPHIC DESCR leak report, overview 1004 OF 11		l be added as a	a ammondia ti		uld be contained in
HACK SAMI 11 0 CLOCK 30 CM LUNG UM FFFECTIVE	POSITION :	11	c SAMO C S'ELDUE ING LONG M EFFCTI	pusiansm	
1	12	cin	·		7/10
