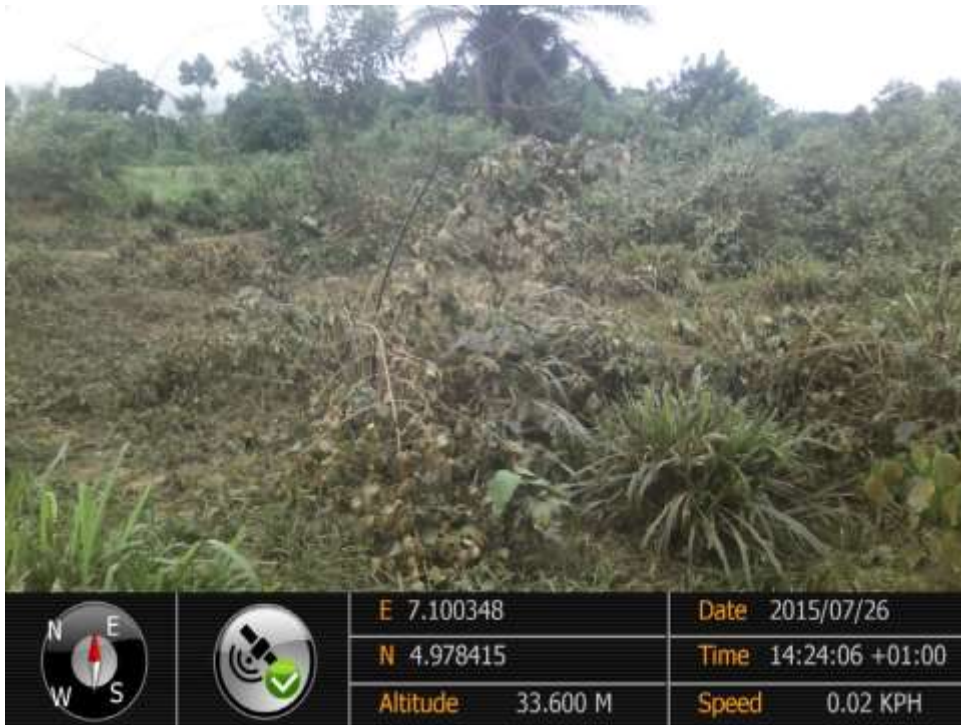
Overview: Part of superficial impact (spray) on vegetation on Nkali Well 10L Flowline at Odagwa. Picture was taken during Joint Investigation of 26th July 2015.

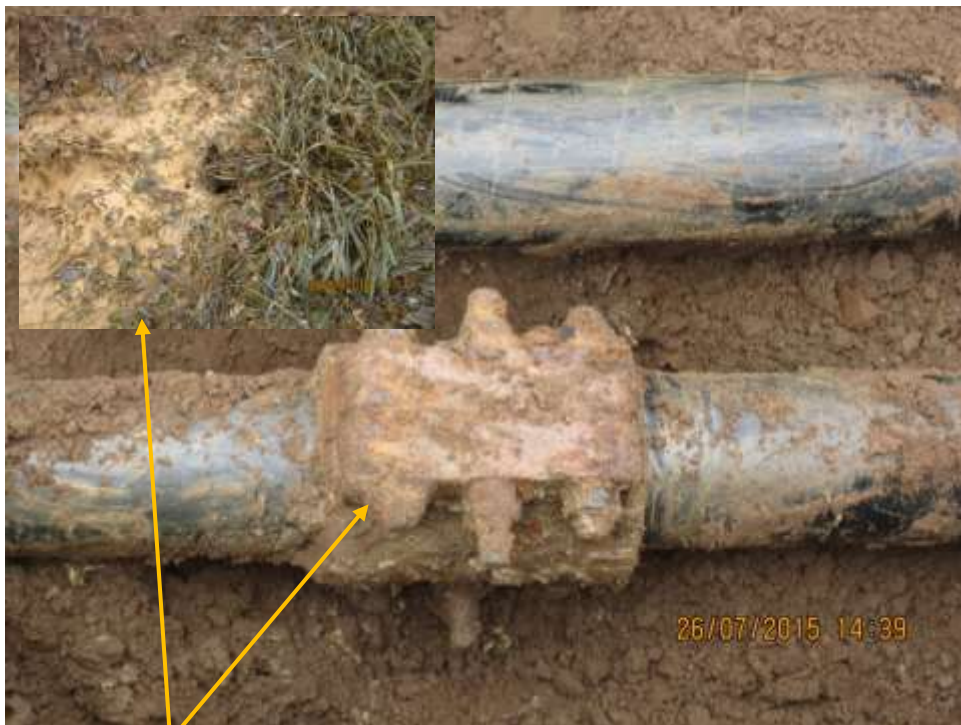
Close-up: Hole created by gas release and Failed clamp on Nkali Well 10L Flowline at Odagwa. Picture was taken during Joint Investigation of 26th July 2015.
