JOINT INVESTIGATION REPORT

INCIDENT NO: 1434675 JIV report S/N: Nº 0000034

1. Spill incident Number: 1434675 2. Type of incident* OIL SPILL
3. Name of Location 10" DIEBU CREEK - NUNRIVER PIPELINE
4. Name of nearest community OYOROMA 5. State: BAYELSA 6. LGA SOUTHERN IJAW
7. Type of Production facility/Installation OIL PIPELINE
8. Asset owner/District SPDC / PIPELINE

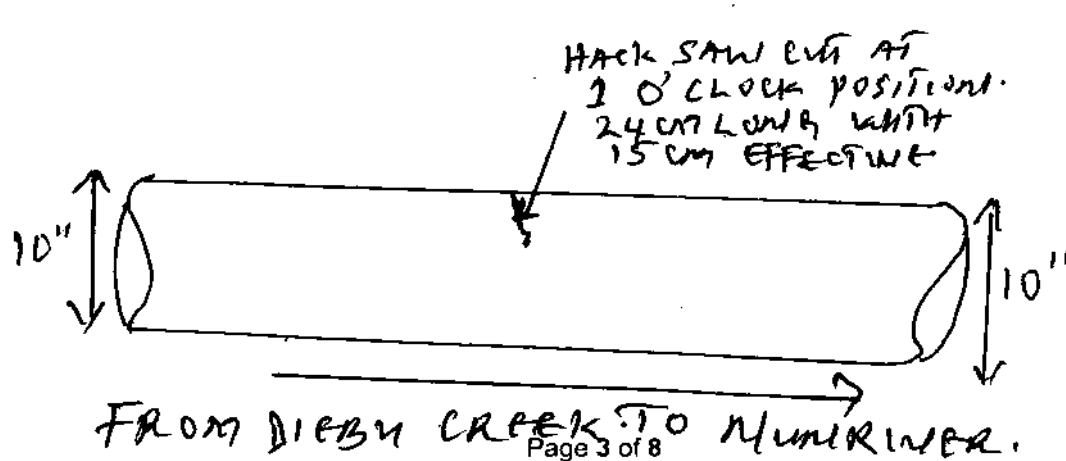
| <input type="checkbox"/> Drilled hole | <input checked="" type="checkbox"/> Hack saw cut | <input type="checkbox"/> Tear (_____). |

SECTION OF 10" DIEBY CREEK - NUMIRIVER PIPELINE AT OPOKOROMA SHOWING POSITION OF HACK SAW CUT.

HACK SAW CUT AT
2 O'CLOCK POSITION.
24CM LONG WITH
15CM EFFECTIVE

RELEVANTY ACTIVITIES ON BOILING.
 REPAIR WORK WAS DONE BY CLAMPING.

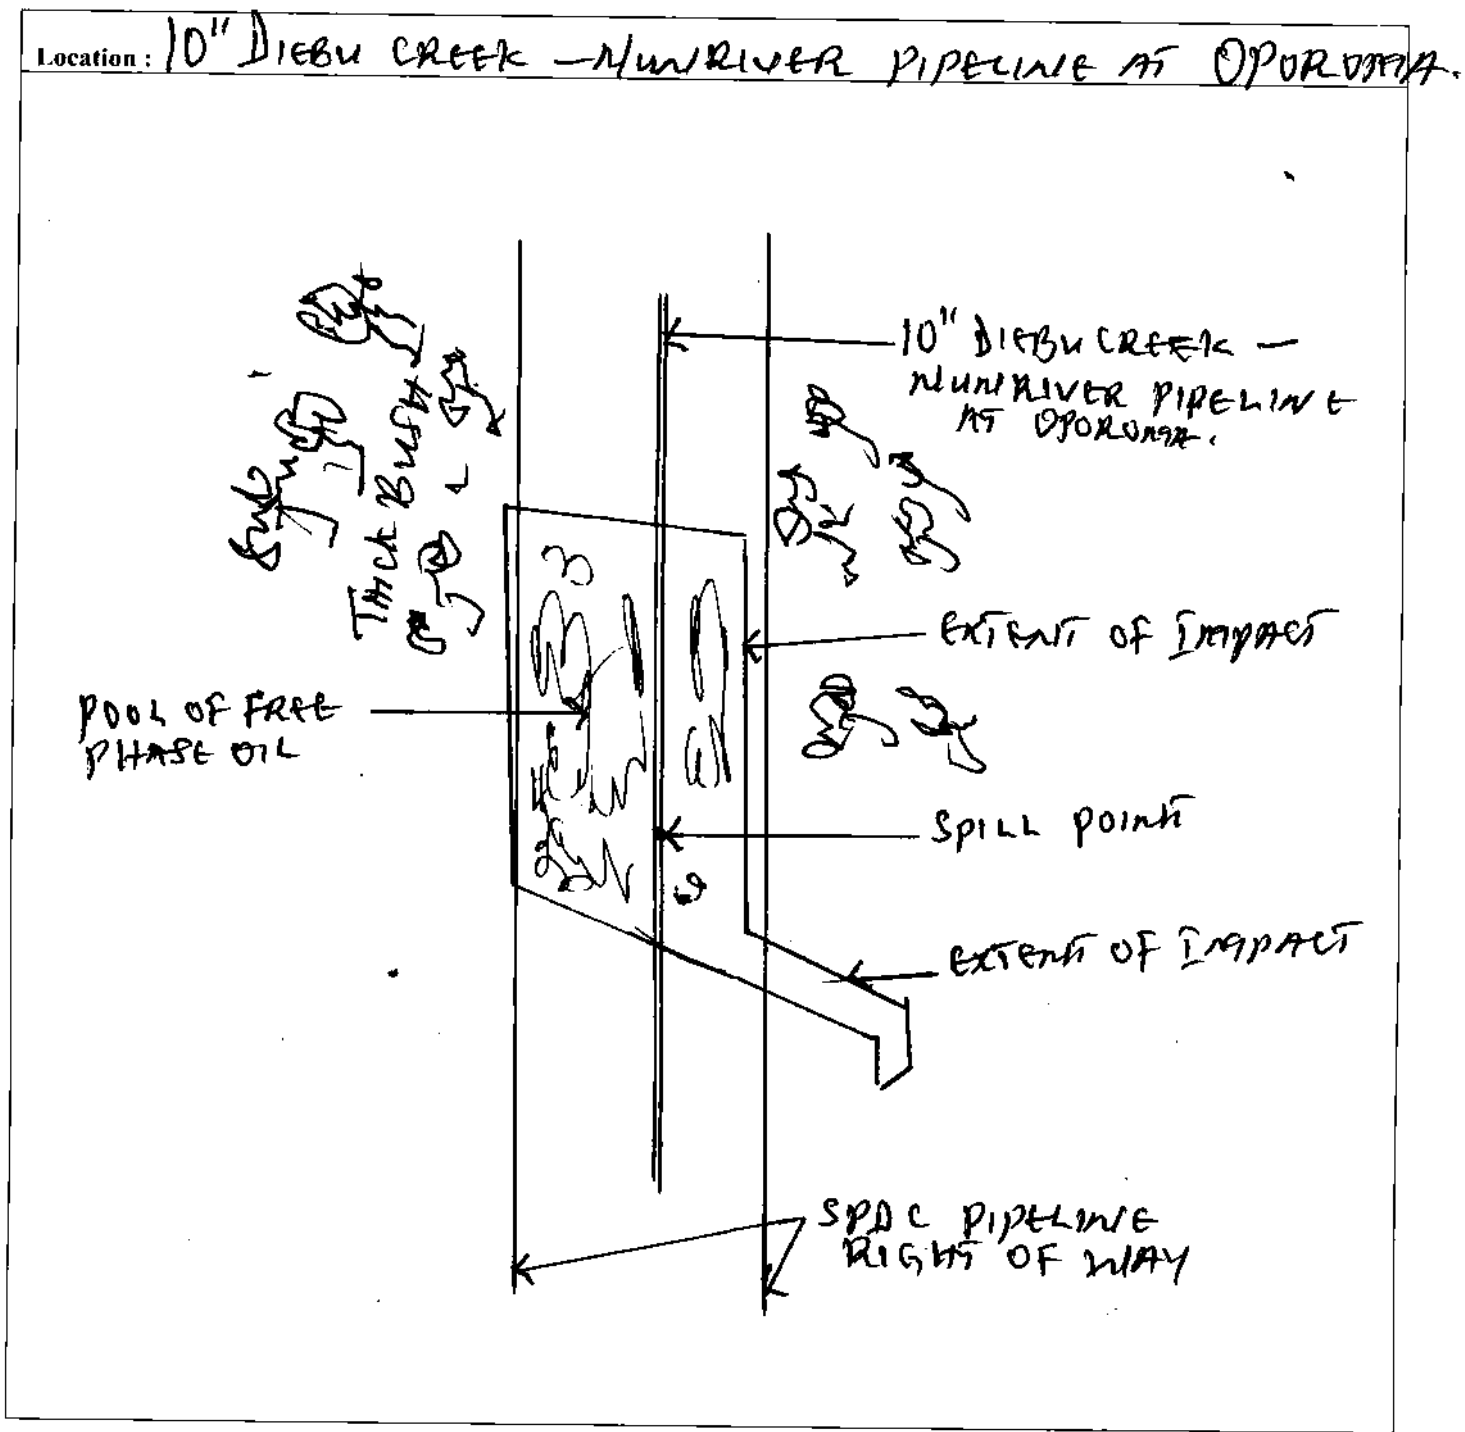
f. Appendix 1: Overview sketch of the site

Additional observations around the spill point: JOINT INVESTIGATION TEAM NOTICED CHANNEL THAT APPARENTLY AID THE SPREAD OF OIL INTO THE BUSH.
