JOINT INVESTIGATION REPORT

INCIDENT NO: 1449657 JIV report S/N: Nº 0000043

1. Spill incident Number: 1449657 2. Type of incident* OIL SPILL
3. Name of Location 28" BOMU - BONNY PIPELINE
4. Name of nearest community BODO-CITY 5. State: RIVERS 6. LGA GOKANA
7. Type of Production facility/Installation OIL PIPELINE
8. Asset owner/District THE SHELL PETROLEUM DEVELOPMENT COMPANY OF NIGERIA LIMITED/PIPELINE

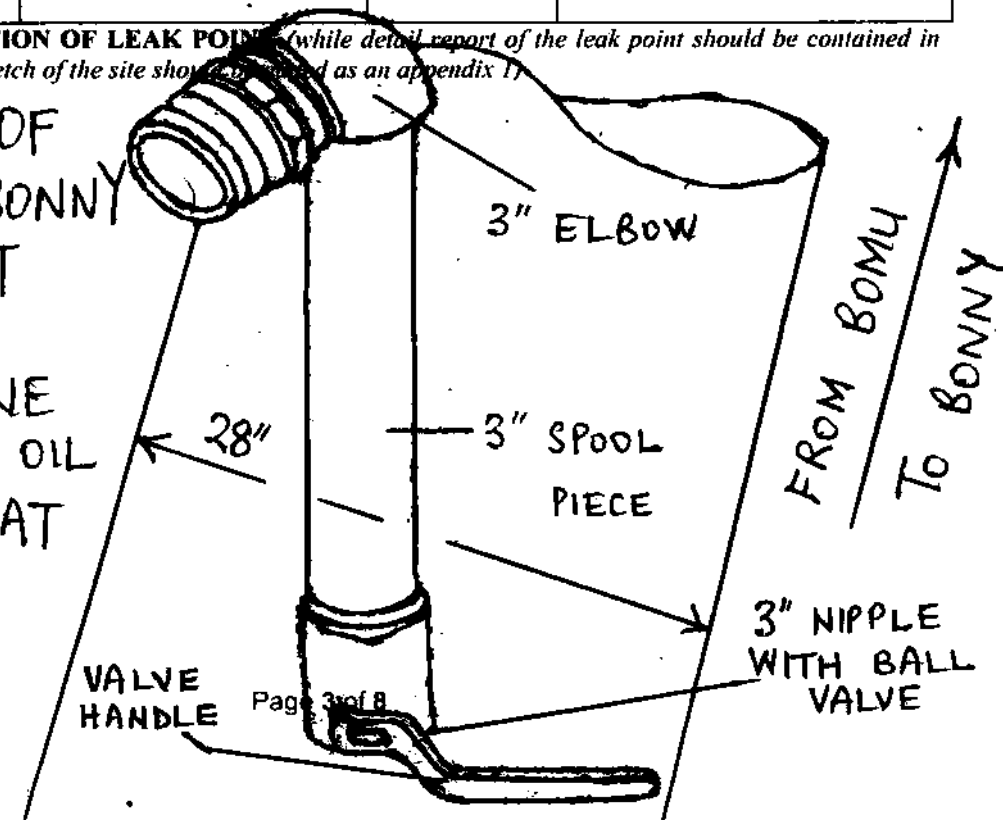
E. GRAPHIC DESCRIPTION OF LEAK POINT (while detail report of the leak point should be contained in the leak report, overview sketch of the site showing the leak point as an appendix 1)

Additional observations around the spill point: ON ARRIVAL AT SITE, THE JOINT INVESTIGATION TEAM OBSERVED SEVERAL SECTIONS OF HOSES SUSPECTED TO HAVE BEEN USED AND LEFT ON SITE BY CRUDE OIL THIEVES WITHIN THE VICINITY OF THE SPILL POINT. AT THE SPILL POINT WAS NOTICED A DITCH EXCAVATED BY UNKNOWN PERSON(S) WITH CRUDE OIL CONTENT ON WATER. A METALLIC BUCKET AND A PLASTIC BUCKET WERE ALSO NOTICED WITHIN THE SPILL POINT VICINITY (AS LEFT BY UNKNOWN PERSON(S)).

| <input checked="" type="checkbox"/> Crude oil theft (illegal bunkering) point, | <input type="checkbox"/> Saver-pit over flow | <input type="checkbox"/> Third party tampering with Clamp |

SECTION OF 28" BOMU-BONNY PIPELINE AT BODO-CITY SHOWING ONE NO. 3" CRUDE OIL THEFT POINT AT 12 O' CLOCK POSITION.

RECOVERY OF FREE-PHASE OIL WITHIN OBSERVED DITCH EXCAVATED AROUND SPILL POINT WAS DONE TO ENABLE EXPOSURE OF SPILL POINT AFTER WHICH PIPELINE REPAIR WAS TEMPORARILY DONE BY DISABLING THE OBSERVED CRUDE OIL THEFT POINT AND BLINDING IT OFF WITH A 3" SCREW PLUG.
