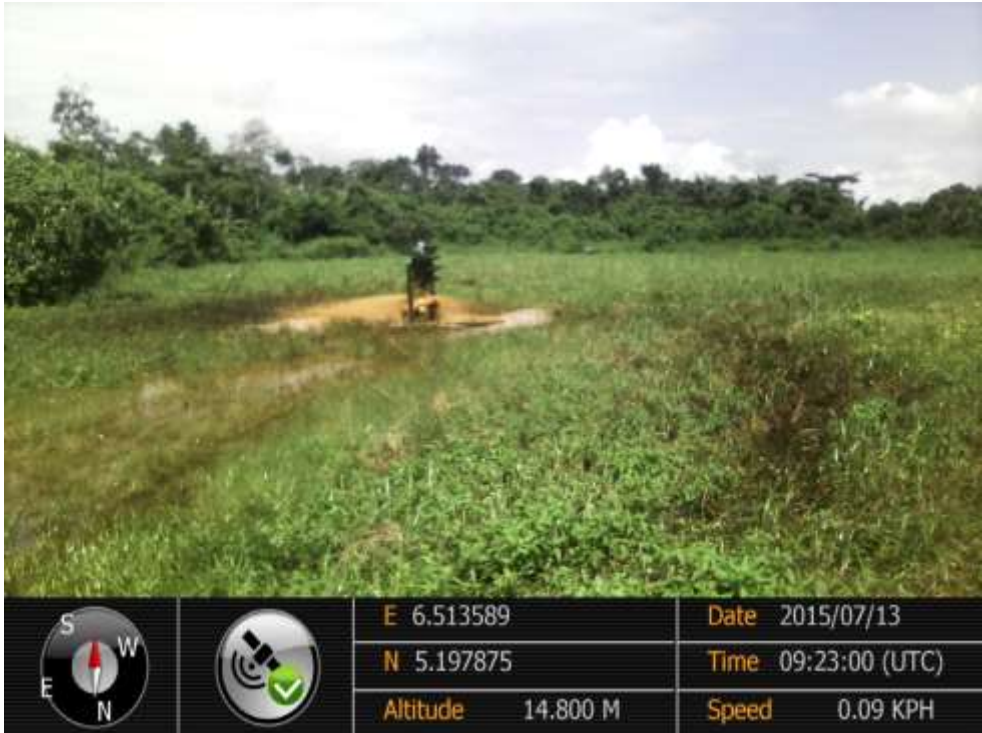
Overview: Part of spill impact on Adibawa Well8SL Right of Way at Edagberi. Picture was taken during Joint Investigation of 13th July 2015.

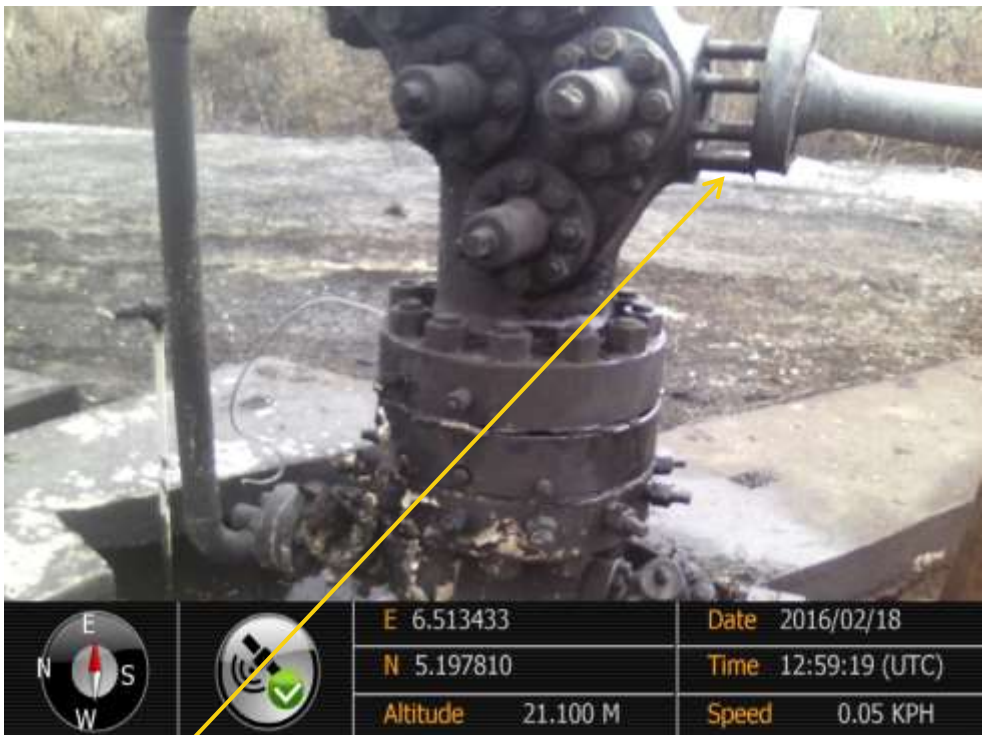
Close-up: Tampered Flange on Adibawa Well8SL Right of Way at Edagberi. Picture was taken during Joint Investigation of 13th July 2015.

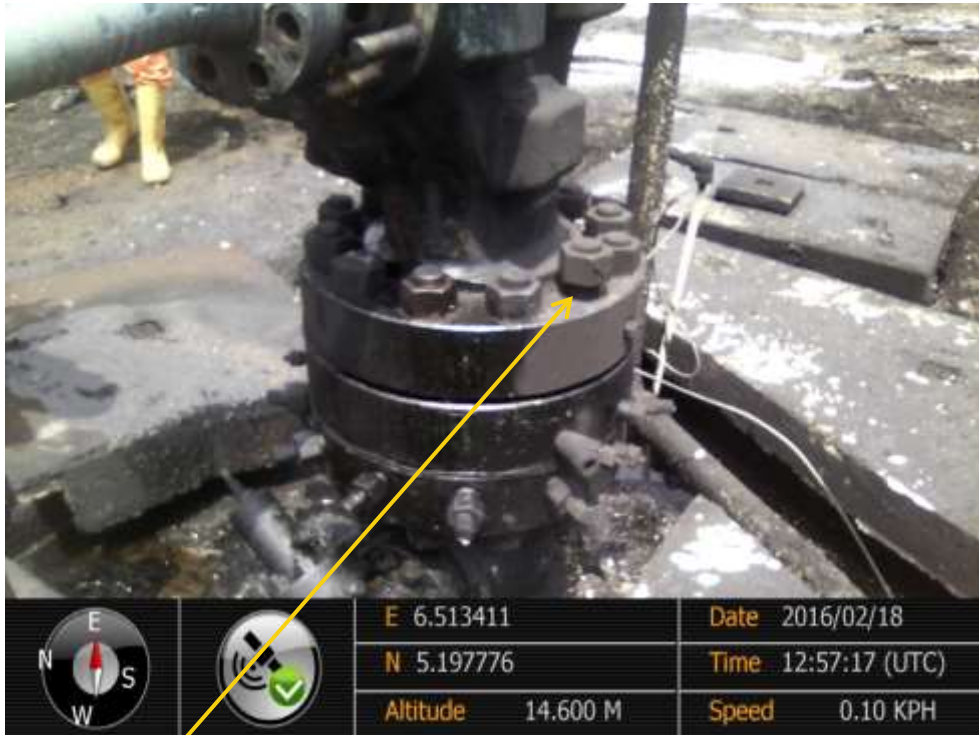
Close-up: Loosened bolts on Adibawa Well8SL at Edagberi. Picture was taken during Joint Investigation of 18th February 2016.
