JOINT INVESTIGATION REPORT

INCIDENT NO: 1440709 JIV report S/N: Nº 0000040

1. Spill incident Number: 1440709 2. Type of incident* OIL SPILL
3. Name of Location ADIBAWA WELL 8 S/L WELL HEAD
4. Name of nearest community EDAGBERI 5. State: RIVERS 6. LGA AHOABA WEST
7. Type of Production facility/Installation WELL HEAD
8. Asset owner/District THE SHELL PETROLEUM DEVELOPMENT COMPANY OF NIGERIA LTD, LAND 2

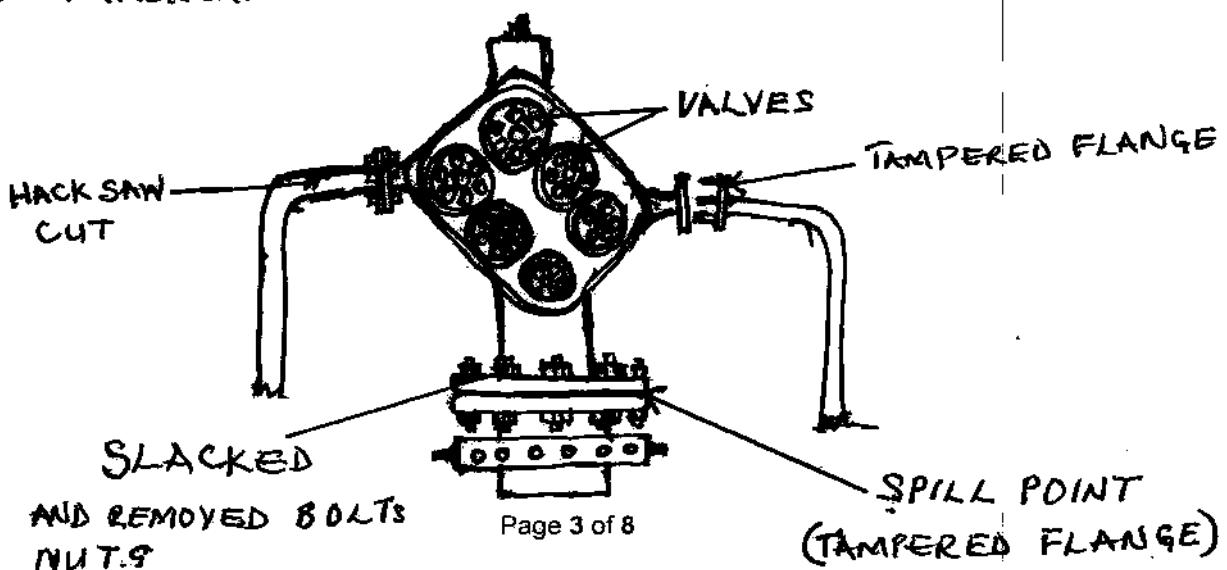
Additional observations around the spill point: THE TEAM OBSERVED ① TAMPERED FLANGES. ② SLACKED AND REMOVED BOLTS AND NUTS ③ A HACKSAW CUT ④ THAT THE SPILL SITE WAS BURNT.

E. GRAPHIC DESCRIPTION OF LEAK POINT (while detail report of the leak point should be contained in the leak report, overview sketch of the site should be added as an appendix I) A SECTION OF ADIBAWA WELL & WELL HEAD AT EDAGBERI SHOWING TAMPERED FLANGES AND A HACKSAW CUT DONE BY UNKNOWN PERSONS.

LEAK REPAIRED
