JOINT INVESTIGATION REPORT

INCIDENT NO: 1426074 JIV report S/N: N^o 000005

1. Spill incident Number: 1426074 2. Type of incident* OIL SPILL
3. Name of Location 18" ASSA - RUMUEKPE PIPELINE
4. Name of nearest community ELELE-ALIMINI/ IHUABA 5. State: RIVERS 6. LGA EMOHUA/AHOADA-EAST
7. Type of Production facility/Installation OIL PIPELINE
8. Asset owner/District THE SHELL PETROLEUM DEVELOPMENT COMPANY OF NIGERIA LIMITED / PIPELINE

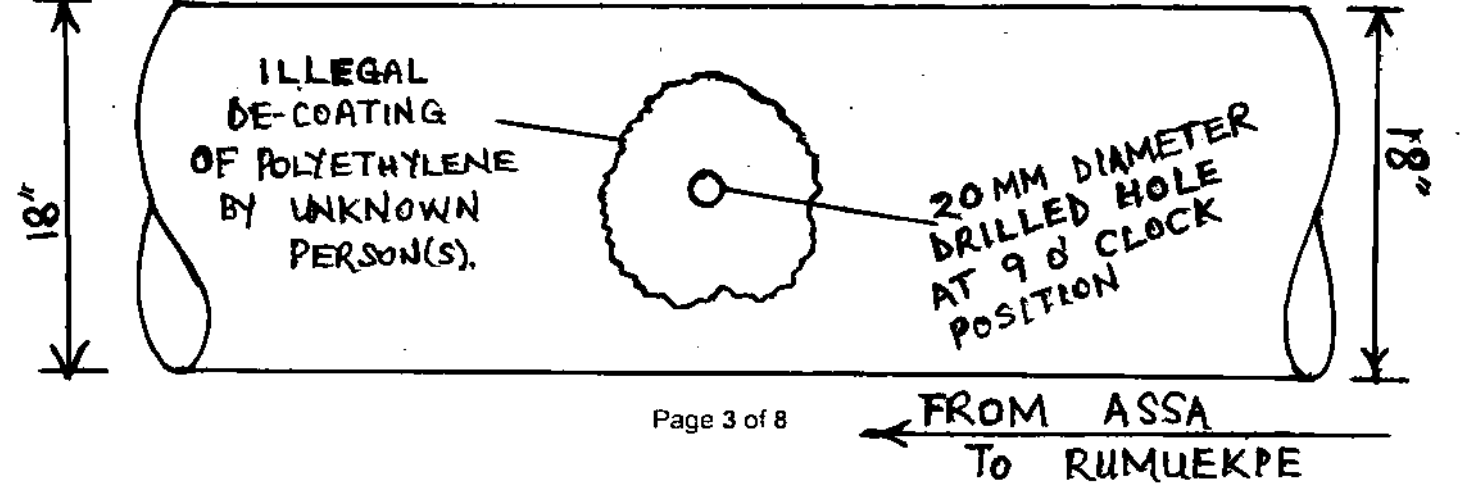
Additional observations around the spill point: ON ARRIVAL AT SITE, THE JOINT INVESTIGATION TEAM OBSERVED FIVE (5) NO. MATTRESS FOAMS AT AND AROUND THE SPILL POINT. ON REMOVAL OF THE MATTRESS FOAMS AND EXCAVATION AROUND THE SPILL POINT, IN THE COURSE OF JIV TO REVEAL SPILL CAUSE, A SECTION OF THE PIPELINE POLYETHYLENE COATING AROUND THE SPILL POINT WAS OBSERVED REMOVED BY UNKNOWN PERSON(S). IMPACTED SOIL ON SITE IS LIGHT BROWN SILTY CLAY.

SECTION OF 18" ASSA - RUMUEKPE PIPELINE AT ELELE-ALIMINI/IHUABA SHOWING DRILLED HOLE (LEAK POINT) AT 9 O' CLOCK POSITION.
