JOINT INVESTIGATION REPORT

INCIDENT NO: 1430229 JIV report S/N: Nº 0000013

1. Spill incident Number: 1430229 2. Type of incident* OIL SPILL
3. Name of Location 12" IMO RIVER - OGALE TRANS NIGER PIPELINE
4. Name of nearest community UZUAKU 5. State: ABIA 6. LGA UKWA WEST
7. Type of Production facility/Installation OIL PIPELINE
8. Asset owner/District THE SHELL PETROLEUM DEVELOPMENT COMPANY OF (NIG) LTD

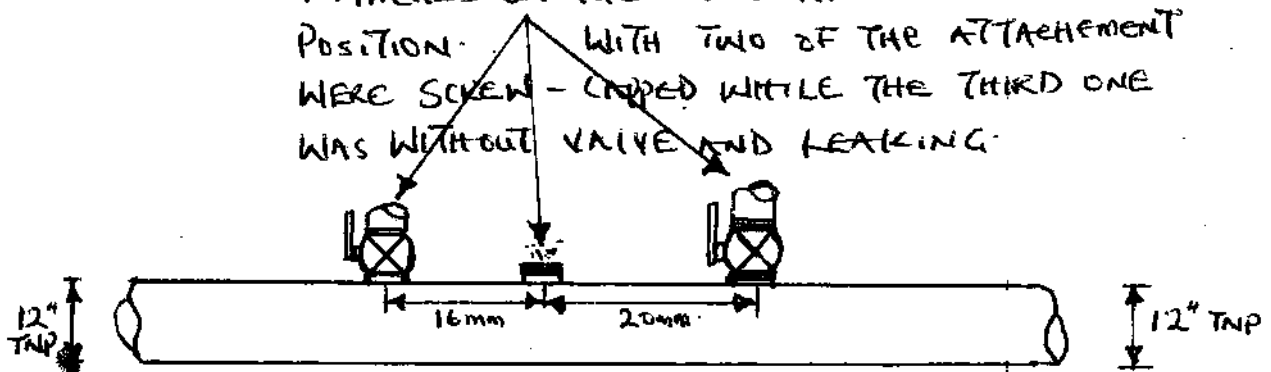
IMO RIVER - OGARE PIPELINE.

Additional observations around the spill point: ON EXCAVATION, SAND BAGS WERE FOUND AROUND THE SPILL POINT. REINFORCED CONCRETE CAST WAS AS WELL FOUND ATOP THE LINE AND ON REMOVAL OF THE CAST, 3 THEFT POINTS WERE FOUND ATTACHED ON THE LINE. TWO (2) OF THE ATTACHMENT WERE SCREW-CAPPED WHILE THE THIRD ONE WAS WITHOUT VALVE AND LEAKING

SECTIONAL VIEW OF 12" IMO RIVER - OGARE TRANS NIGER PIPELINE AT

UZYAKU SHOWING :- FAILED ILLEGAL THEFT POINT.

THREE (3) THEFT POINTS WERE ATTACHED ON THE LINE AT 12° CLOCK POSITION. WITH TWO OF THE ATTACHEMENT WERE SCREW - CAPED WHILE THE THIRD ONE WAS WITHOUT VALVE AND LEAKING.

REPAIR WORK BY CLAMPING
ONGOING
