JOINT INVESTIGATION REPORT

INCIDENT NO: 1432011 JIV report S/N: Nº 0000028

1. Spill incident Number: 1432011 2. Type of incident* OIL SPILL
3. Name of Location 28" Nkyoku - BOMU PIPELINE
4. Name of nearest community B-DERE 5. State: RIVERS 6. LGA GOKANA
7. Type of Production facility/Installation OIL PIPELINE
8. Asset owner/District SPDC / PIPELINE

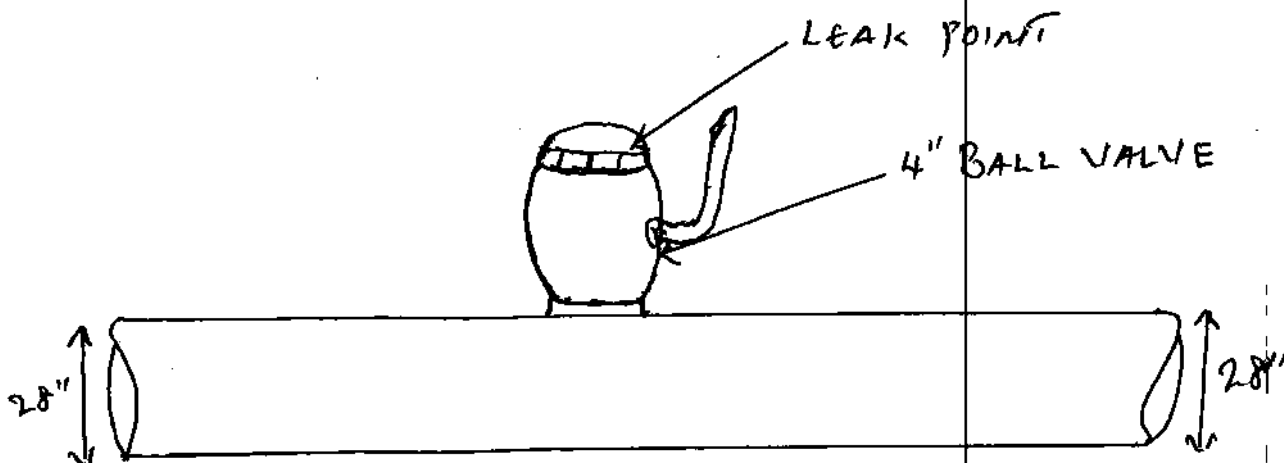
| <input checked="" type="checkbox"/> Failed Weld-on illegal hot tap valve | <input type="checkbox"/> Failed Clamp, | <input type="checkbox"/> Missing Pipeline/Flowline |
| <input checked="" type="checkbox"/> Crude oil theft (illegal bunkering) point, | <input type="checkbox"/> Saver-pit over flow | <input type="checkbox"/> Third party tampering with Clamp |

SECTION OF 28" NKPOKU - BOMU PIPELINE AT B-DERE SHOWING CRUDE OIL THEFT POINT AT 12 O'CLOCK POSITION

RECOVERY ACTIVITIES ONGOING. REPAIR WORK WAS DONE BY CLAMPING.

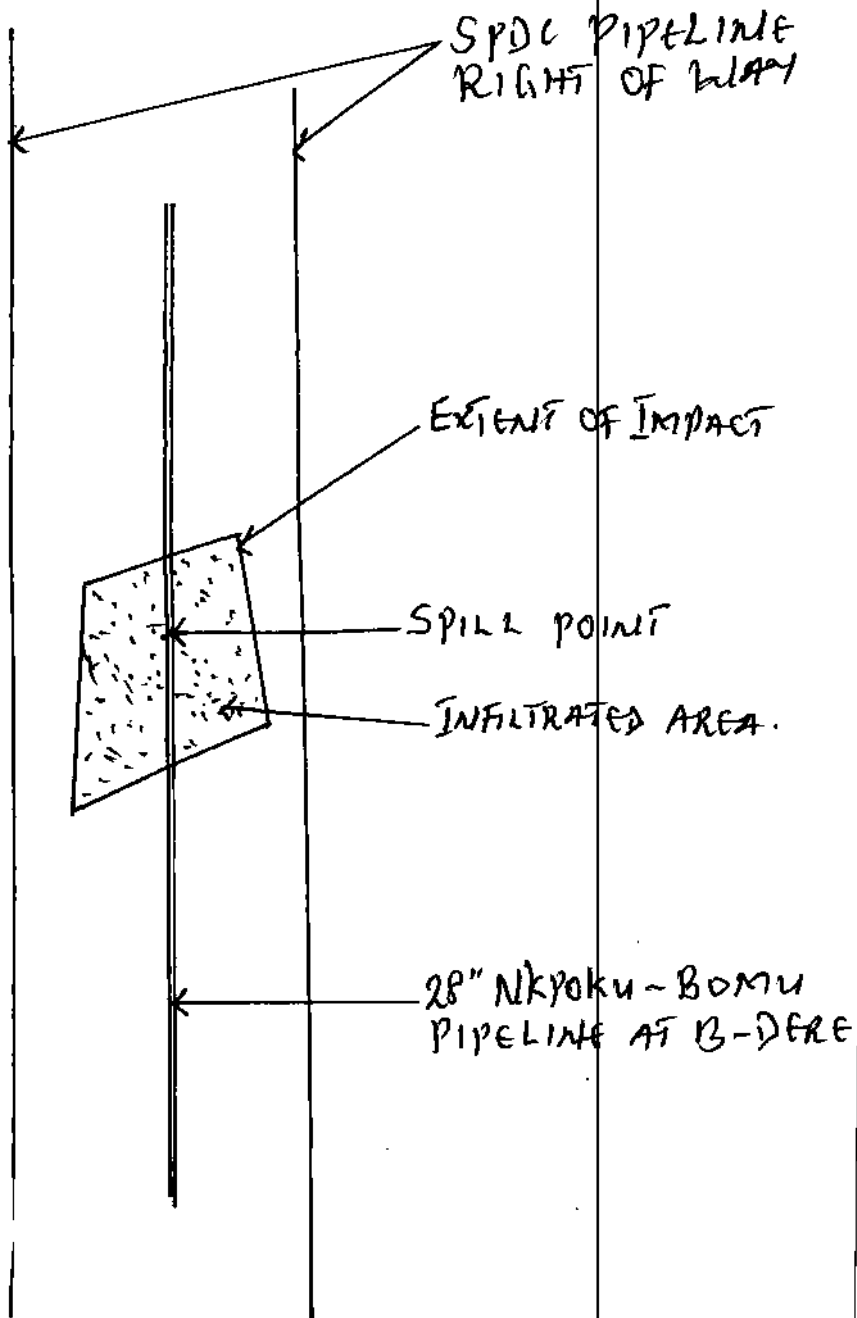
f. Appendix 1: Overview sketch of the site

Location: 28" Nkpoku-Bomu Pipeline AT B-DERE.
