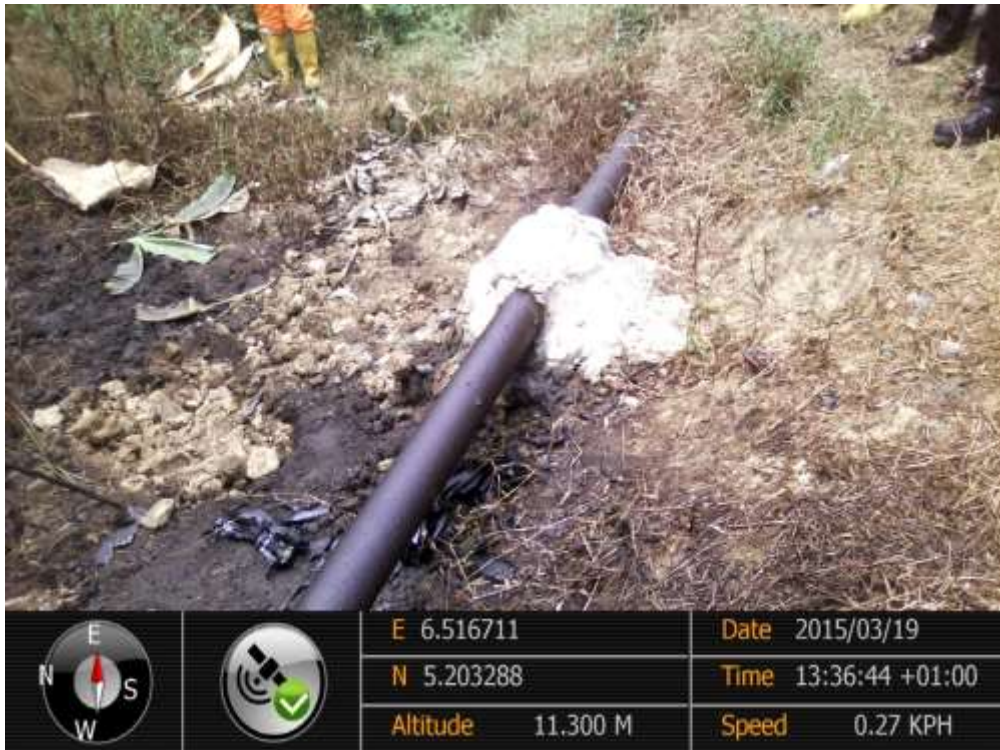
Overview: Part of spill impact on Adibawa Well10S Flowline Right of Way at Edagberi/Betterland. Picture was taken during Joint Investigation of 19th of March 2015.

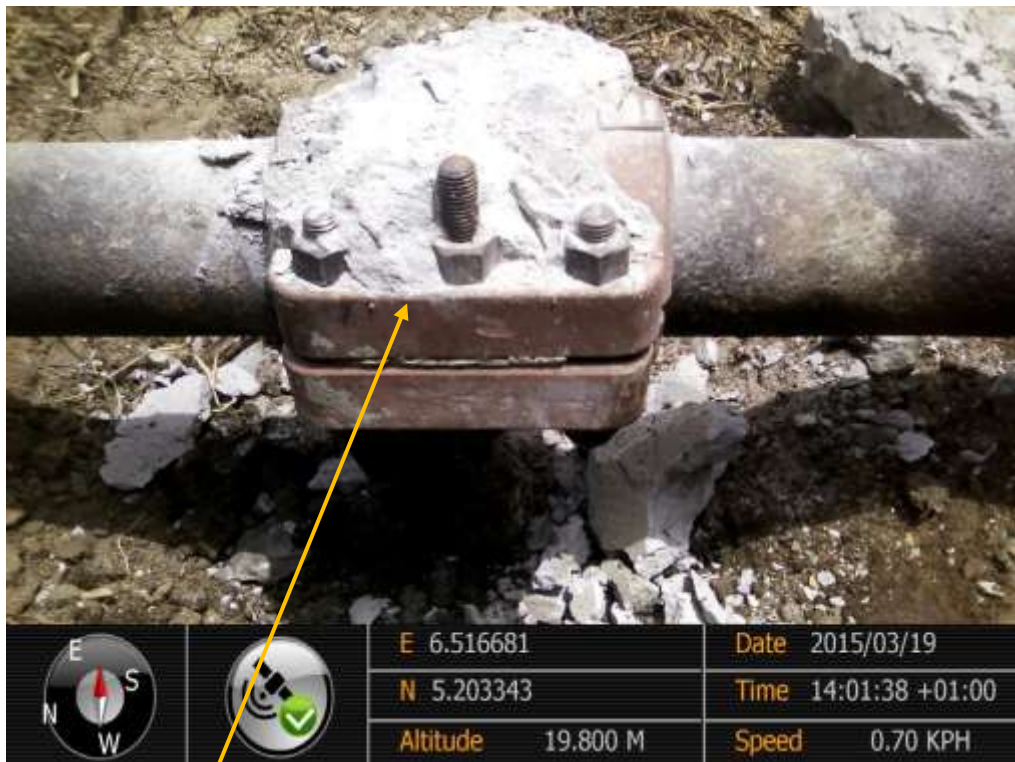
Close-up: Failed clamp on Adibawa Well10S Flowline at Edagberi/Betterland. Picture was taken during Joint Investigation of 19th of March 2015.
