JOINT INVESTIGATION REPORT

INCIDENT NO: 1350803 JIV report S/N: Nº 0000344

1. Spill incident Number: 1350803 2. Type of incident* OIL SPILL
3. Name of Location TUNU WELL-6T FLOWLINE
4. Name of nearest community AGBIDIAMA 5. State: BAYELSA 6. LGA EKEREMOR
7. Type of Production facility/Installation FLOWLINE
8. Asset owner/District THE SHELL PETROLEUM DEVELOPMENT COMPANY OF NIG. LIMITED

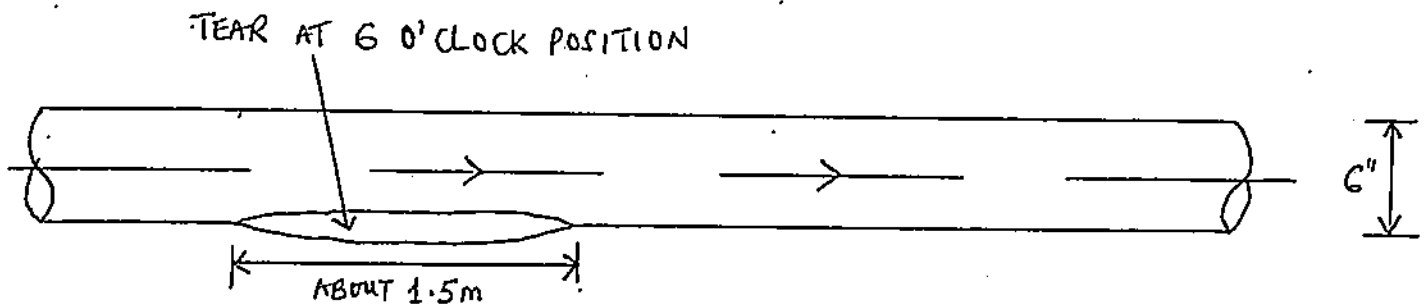
TUNU WELL-GT FLOWLINE AT AGBIDIAMA

Additional observations around the spill point: ON ARRIVAL AT SITE, THE LEAK POINT WAS OBSERVED TO BE SUBMERGED IN WATER. WHEN THE FLOWLINE WAS LIFTED, THE JOINT INVESTIGATION TEAM OBSERVED A TEAR (ABOUT 1.5M LONG) ON THE FLOWLINE AT 6 O'CLOCK POSITION.

SECTION OF TUNU WELL-GT FLOWLINE AT AGBIDIAMA. SHOWING; A TEAR (ABOUT 1.5M LONG) AT 6 O' CLOCK POSITION

REPAIR IS BEING PLANNED BY THE
ASSET ENGINEERING TEAM
