JOINT INVESTIGATION REPORT

1399337

1. Spill incident Number: 1399337 2. Type of incident* OIL SPILL
3. Name of Location NKALI WELL II WELL HEAD
4. Name of nearest community OKORONGU 5. State: RIVERS 6. LGA ETCHE
7. Type of Production facility/Installation WELL HEAD
8. Asset owner/District SHELL PETROLEUM DEVELOPMENT COMPANY OF (NIG) LTD.

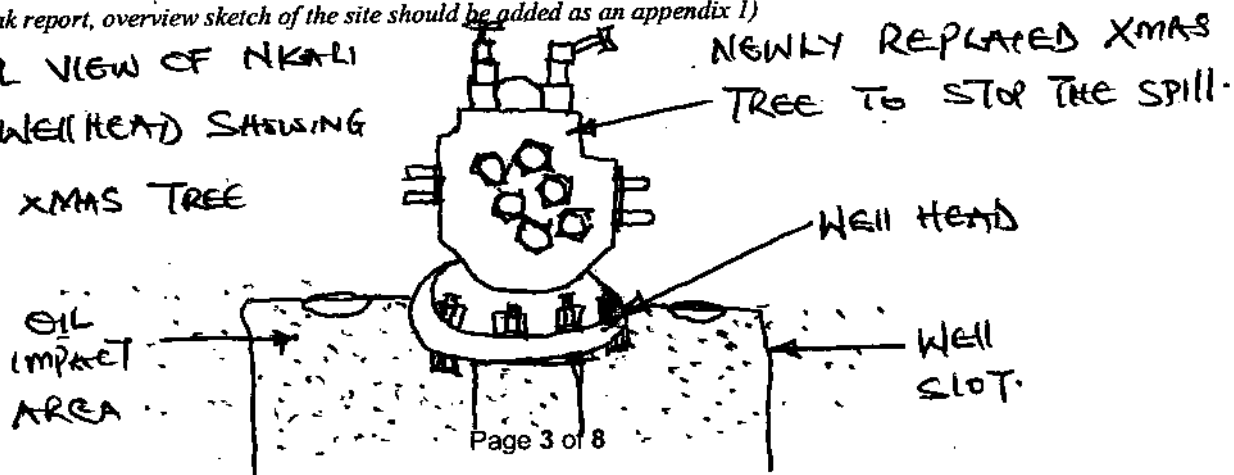
SECTIONAL VIEW OF NKALI
WELL II WELL HEAD SHOWING
STOLEN XMAS TREE

Additional observations around the spill point: JIV TEAM OBSERVED THE STOLEN XMAS TREE WAS REPLACED WITH A NEW ONE TO STOP THE SPILL.

| <input checked="" type="checkbox"/> Others (specify) <u>STOLEN XMAS TREE BY UNKNOWN PERSON.</u> | | |

THE STOLEN XMAS TREE WAS REPLACED WITH A NEW ONE TO STOP THE SPILL

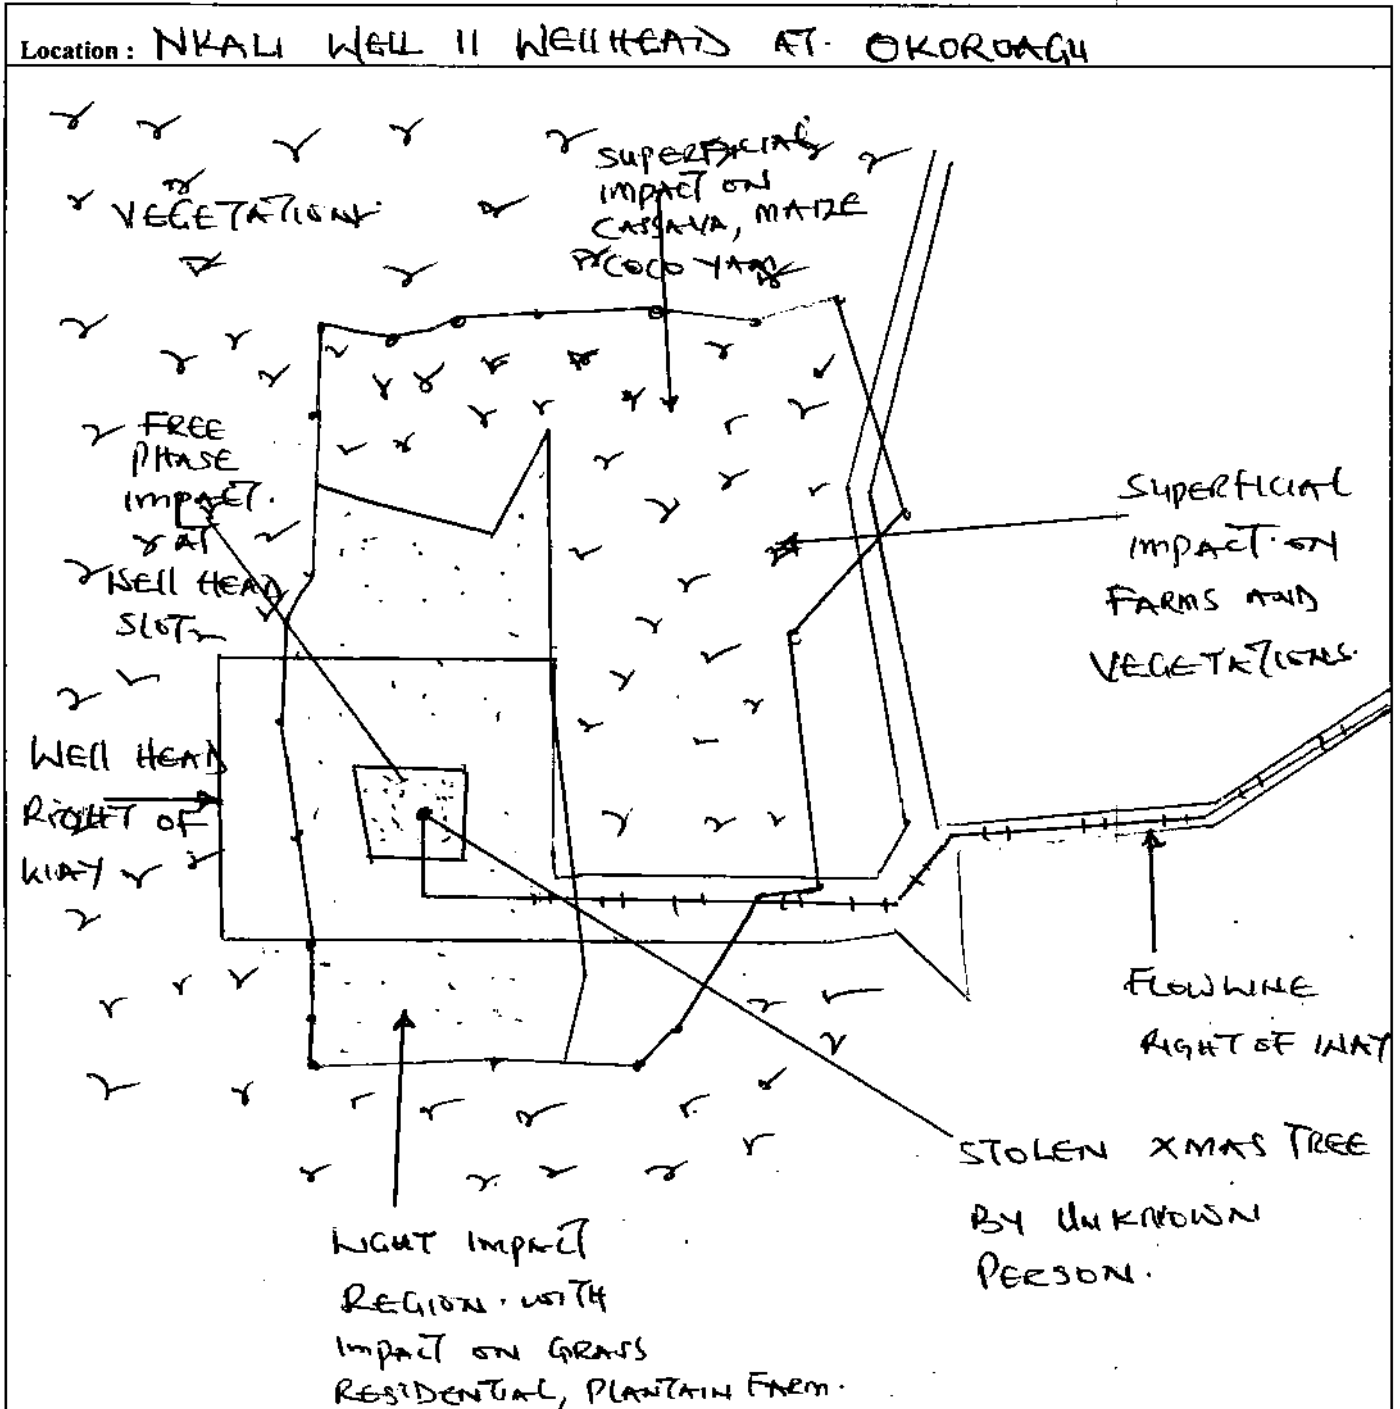
f. Appendix 1: Overview sketch of the site

- Total calculated area of impact LIGHT IMPACT = 4.19HA, SUPERFICIAL IMPACT = 4.4
- Impact within R.O.W YES
- Impact outside R.O.W YES
