JOINT INVESTIGATION REPORT

INCIDENT NO: 1519547 JIV report S/N: Nº 0000107

1. Spill incident Number: 1519547 2. Type of incident* OIL SPILL
3. Name of Location 16" EGBEMA - ASSA PIPELINE
4. Name of nearest community EKPEAGAH 5. State: RIVERS 6. LGA ONELGA
7. Type of Production facility/Installation OIL PIPELINE
8. Asset owner/District SPDC / PIPELINE

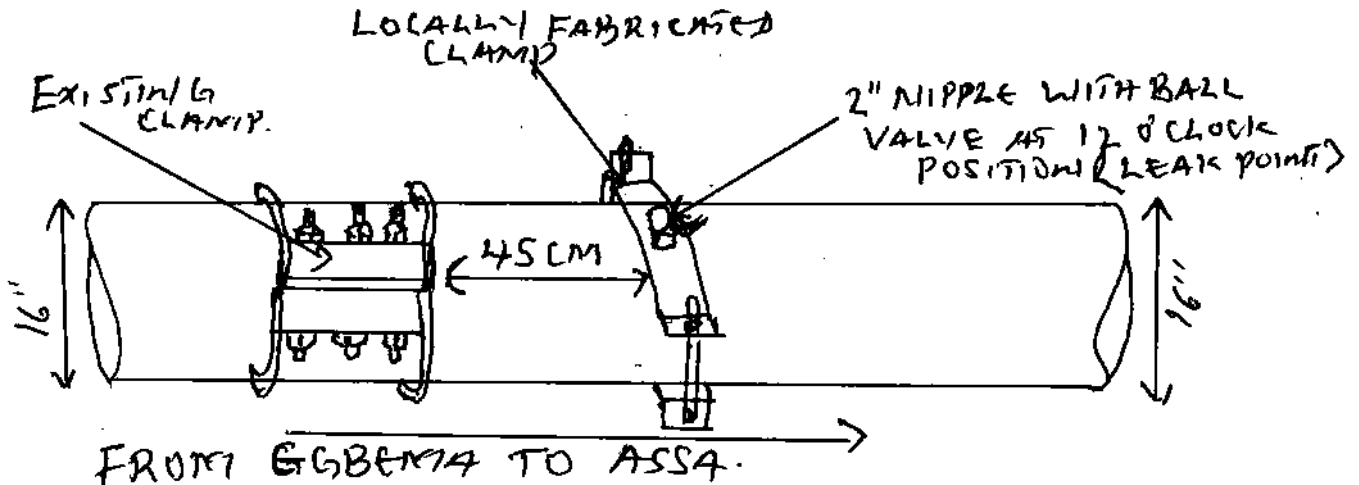
SAND BAGS WERE OBSERVED AT SPILL POINT DURING THE JOINT INVESTIGATIONAL VISIT.

| <input checked="" type="checkbox"/> Crude oil theft (illegal bunkering) point, | <input type="checkbox"/> Saver-pit over flow | <input type="checkbox"/> Third party tampering with Clamp |

SECTION OF 16" EGBEMA-ASSA PIPELINE AT EKPEAGAN SHOWING POSITION OF CRUDE OIL THERY POINT AT 12 O'CLOCK POSITION.

RECOVERY COMPLETED. REPAIR WORK WAS DONE BY CLAMPING.
