# JOINT INVESTIGATION REPORT

INCIDENT NO: 1526099 JIV report S/N: Nº 0000117

1. Spill incident Number: 1526099 2. Type of incident\* OIL SPILL  
3. Name of Location 28" BOMU - BONNY PIPELINE  
OTOKOLOMABIE  
4. Name of nearest community (OLOMA) 5. State: RIVERS 6. LGA BONNY  
7. Type of Production facility/Installation OIL PIPELINE  
8. Asset owner/District THE SHELL PETROLEUM DEVELOPMENT COMPANY  
OF NIGERIA LIMITED / PIPELINE

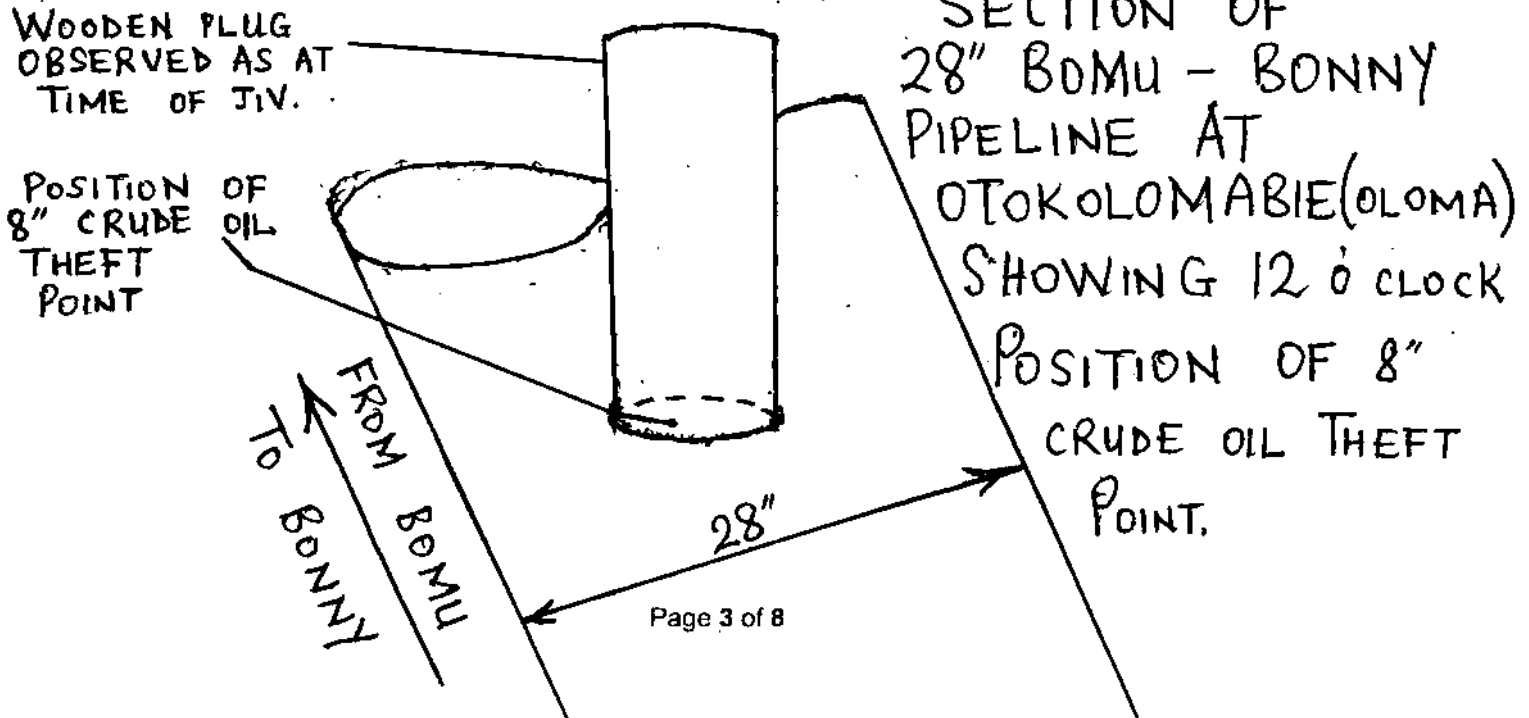
**E. GRAPHIC DESCRIPTION OF LEAK POINT** (while detail report of the leak point should be contained in the leak report, overview sketch of the site should be added as an appendix 1)

| <input checked="" type="checkbox"/> Crude oil theft (illegal bunkering) point, | <input type="checkbox"/> Saver-pit over flow | <input type="checkbox"/> Third party tampering with Clamp |

- Third party interference (Sabotage ; crude theft ; Line theft ; Accidental 3<sup>rd</sup> party damage   
 Operational  Others (including Mystery spills) SPILL INCIDENT OCCURRED DURING THE REPAIR OF CRUDE OIL THEFT POINT ON THE PIPELINE.

If yes to item 15 give brief description: JIV OF 30TH NOVEMBER 2015 WAS INCONCLUSIVE AS THE JOINT INVESTIGATION TEAM COULD NOT REACH A CONSENSUS ON THE CAUSE OF SPILL. FURTHER J.I.T. MEETINGS WERE HELD AND CONSEQUENTLY, THE CAUSE OF SPILL WAS AGREED AS 'OTHERS'.

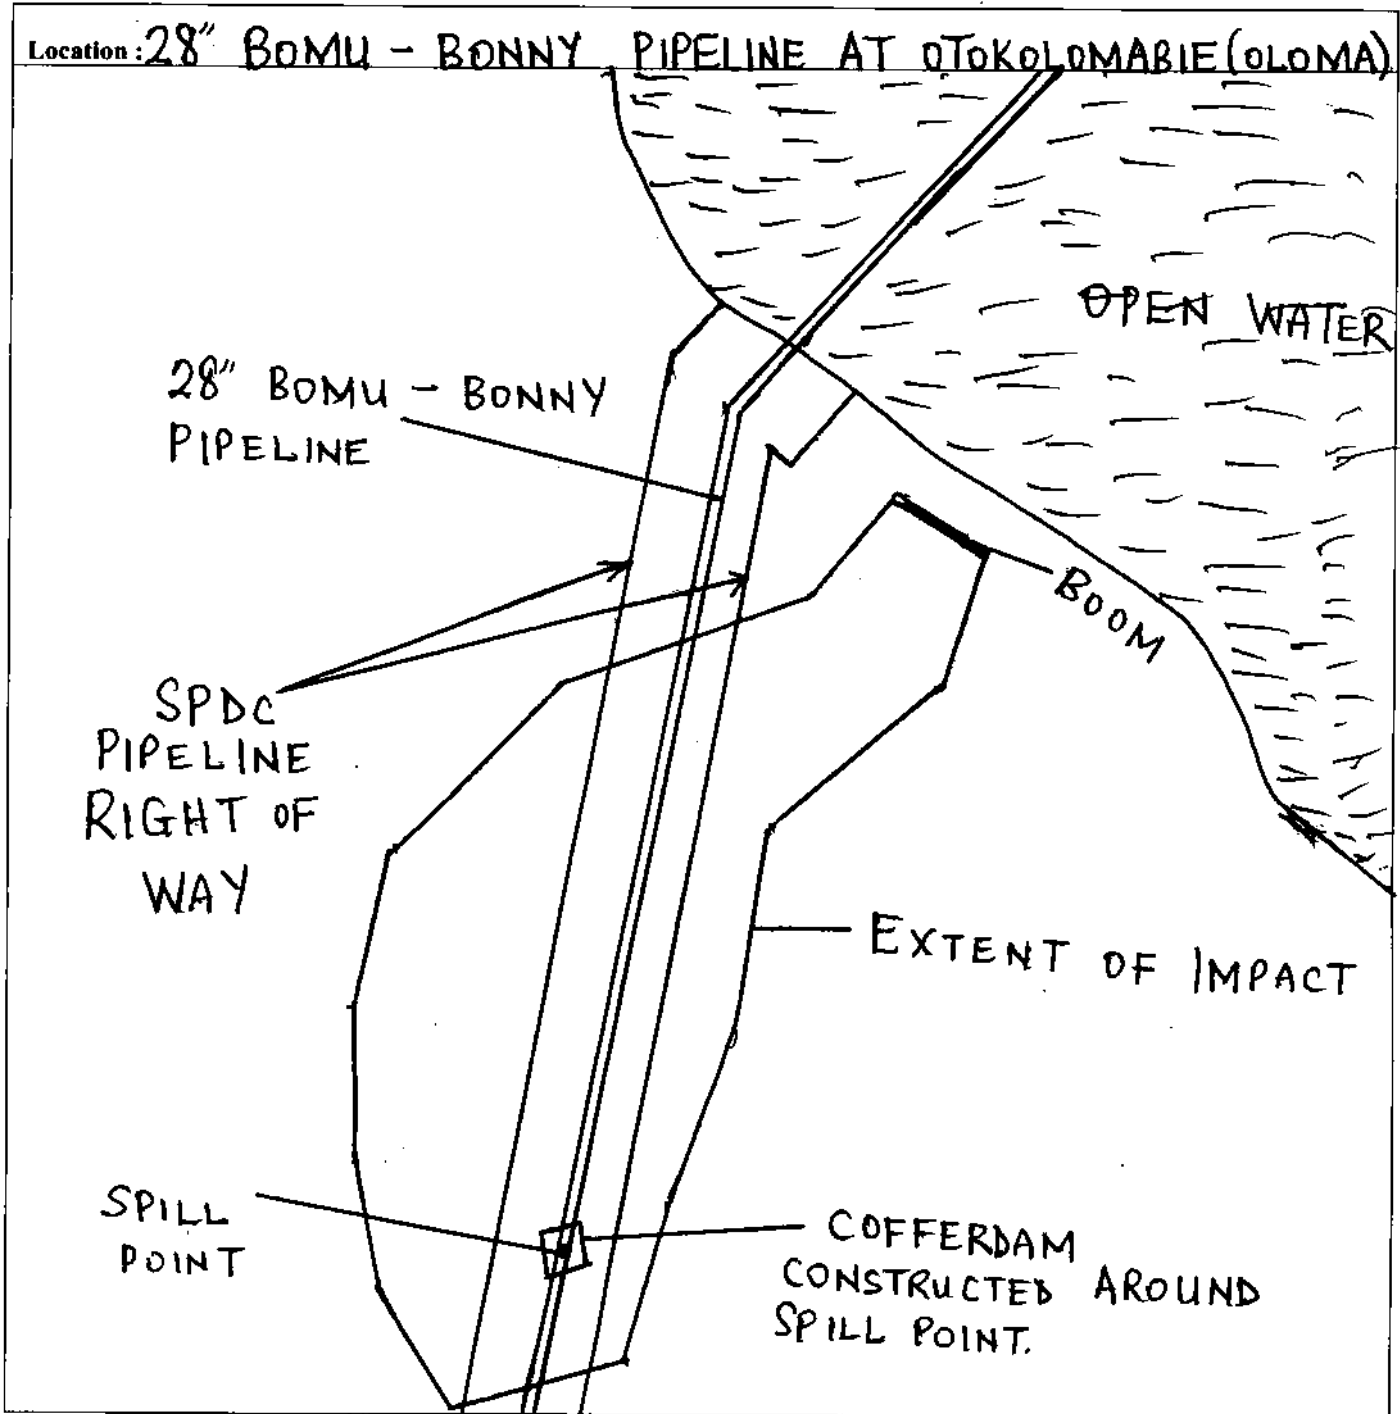
f. Appendix 1: Overview sketch of the site

Additional observations around the spill point: A COFFERDAM PREVIOUSLY INSTALLED BY THE SPDC ASSET OWNER WAS OBSERVED AROUND THE SPILL POINT.

- Booms                     
  Trench    
  Dyke    
  Natural depression    
  Pit    
  None
- Others: CONSTRUCTED COFFERDAM AROUND SPILL POINT.
