JOINT INVESTIGATION REPORT

INCIDENT NO: 1506818 JIV report S/N: Nº 0000095

1. Spill incident Number: 1506818 2. Type of incident* OIL SPILL
3. Name of Location 36" NKPOKU - BOMU PIPELINE
4. Name of nearest community ATALI 5. State: RIVERS 6. LGA OBIO/AKPOR
7. Type of Production facility/Installation OIL PIPELINE
8. Asset owner/District THE SHELL PETROLEUM DEVELOPMENT COMPANY OF NIGERIA LIMITED / PIPELINE

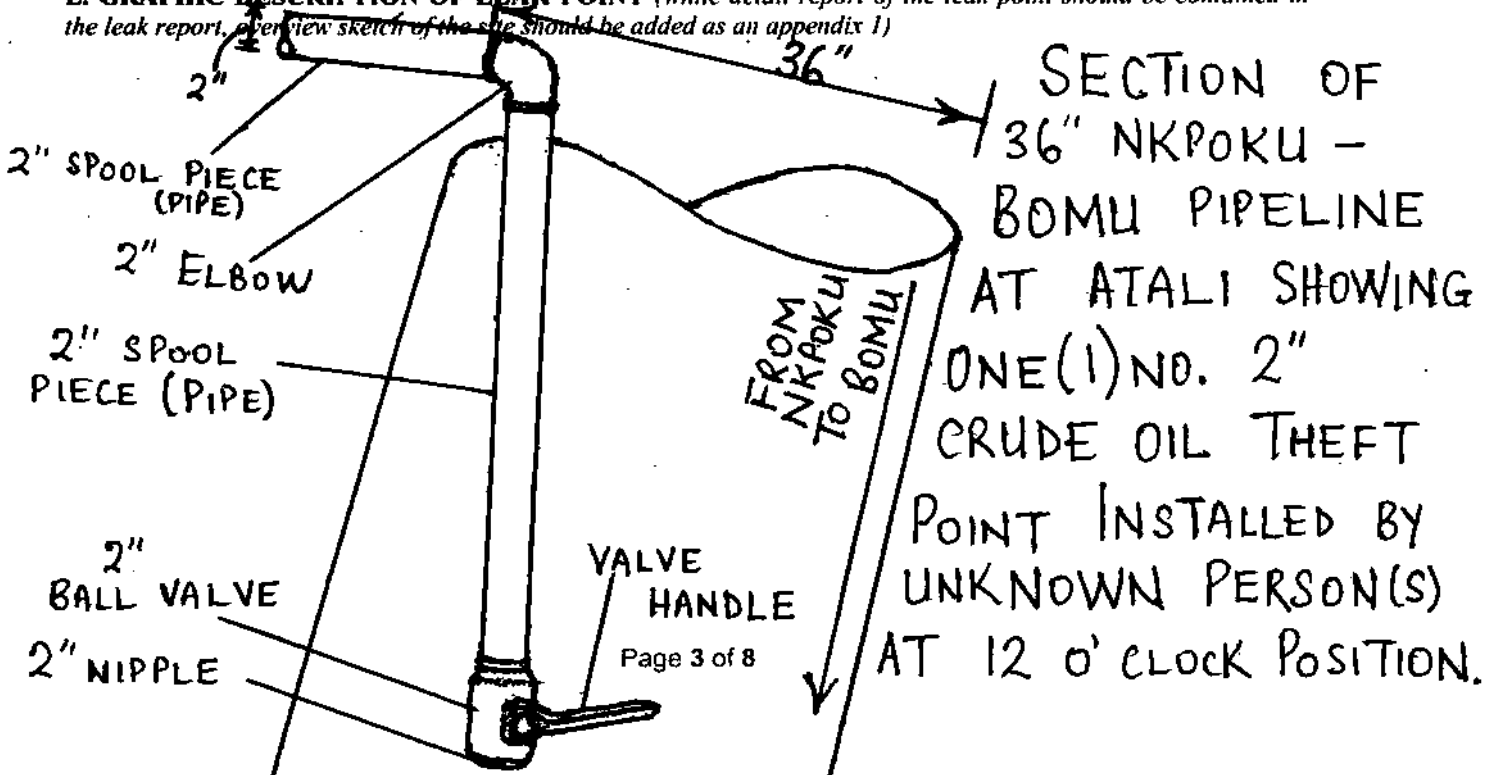
E. GRAPHIC DESCRIPTION OF LEAK POINT (while detail report of the leak point should be contained in the leak report, a *perspective sketch of the site* should be added as an appendix 1)

Additional observations around the spill point: THE JOINT INVESTIGATION TEAM ON ARRIVING SITE, OBSERVED A BUND WALL (SERVING AS A CONTAINMENT MEASURE) AROUND THE SPILL POINT. A HOSE LEFT BY UNKNOWN PERSON(S) WAS NOTICED WITHIN THE SURROUNDING BUSH. ALSO NOTICED WERE POOLS OF FREE-PHASE OIL ON THE BUSH PATH, SUSPECTED TO BE AS A RESULT OF ILLEGAL HOSE CONNECTIONS TO THE SPILL POINT.

| <input checked="" type="checkbox"/> Crude oil theft (illegal bunkering) point, | <input type="checkbox"/> Saver-pit over flow | <input type="checkbox"/> Third party tampering with Clamp |

RECOVERY OF FREE-PHASE OIL AROUND LEAK POINT WAS DONE. AS AT TIME OF CONCLUDING JIV NO FURTHER LEAK WAS OBSERVED AND REPAIR BY CLAMPING WAS PLANNED.
