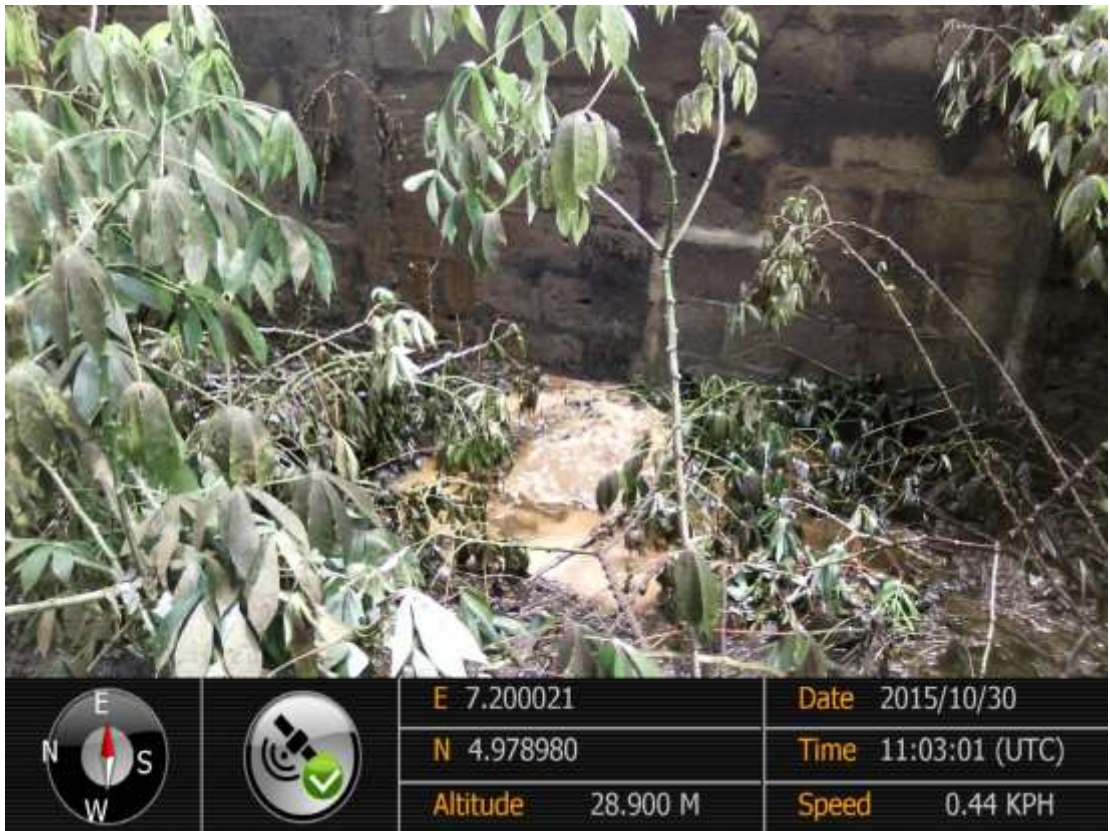
**Overview:** Part of spill impact on Imo River Well 33L Flowline Right of Way at Ipu West. Picture was taken during Joint Investigation of 30<sup>th</sup> October 2015.

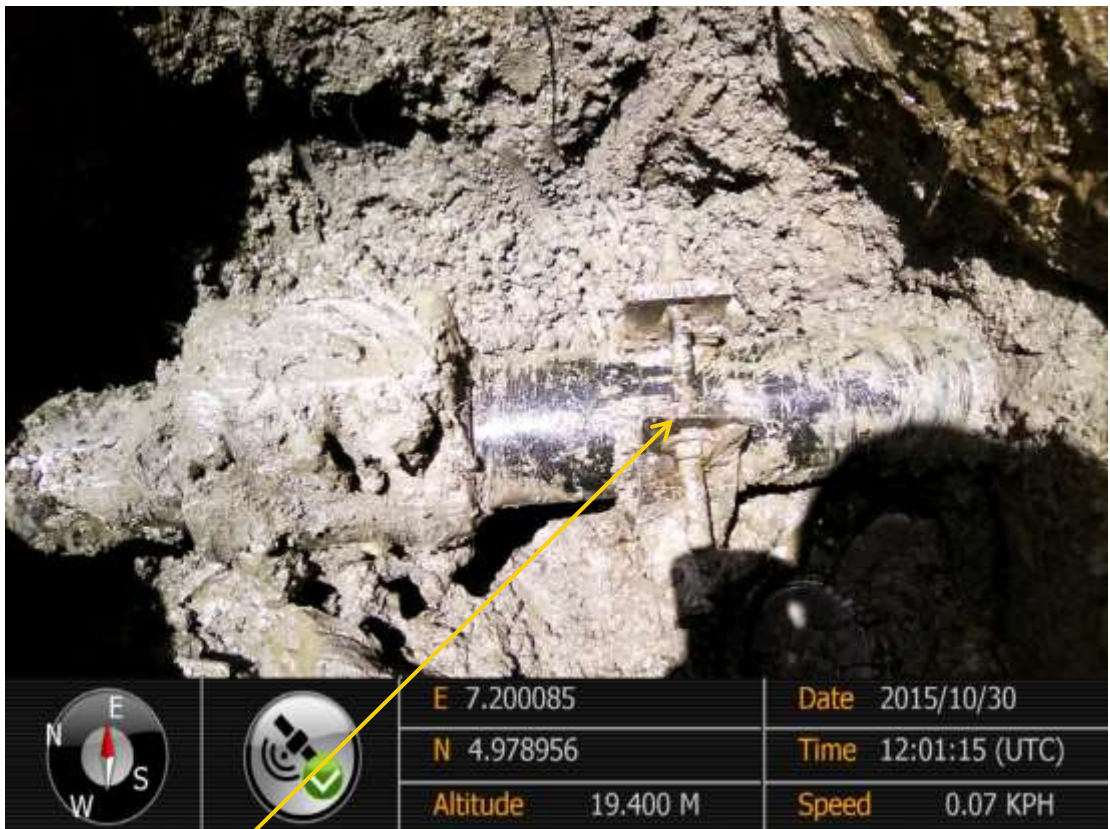
**Close-up:** Illegal fitting on Imo River Well 33L Flowline at Ipu West. Picture was taken during Joint Investigation of 30<sup>th</sup> October 2015.
