JOINT INVESTIGATION REPORT

INCIDENT NO: 1476660 JIV report S/N: Nº 000058

1. Spill incident Number: 1476660 2. Type of incident* OIL SPILL
3. Name of Location 20" RUMUEKPE - NKPOKU PIPELINE
4. Name of nearest community DMUIGWOR-IBAA 5. State: RIVERS 6. LGA EMOHUA
7. Type of Production facility/Installation OIL PIPELINE
8. Asset owner/District THE SHELL PETROLEUM DEVELOPMENT COMPANY OF NIGERIA LIMITED / PIPELINE

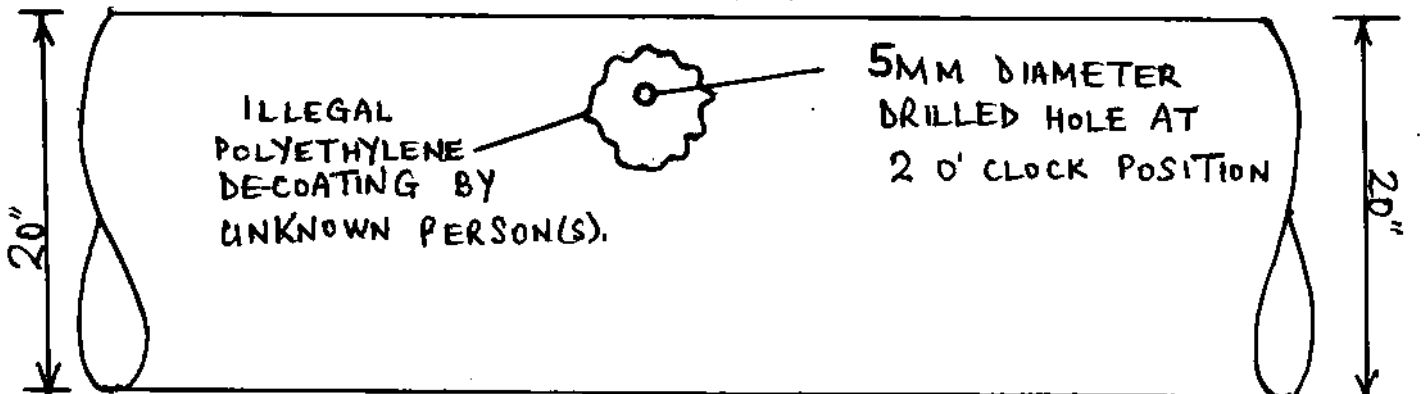
| <input checked="" type="checkbox"/> Drilled hole | <input type="checkbox"/> Hack saw cut | <input type="checkbox"/> Tear (_____). |

SECTION OF 20" RUMUEKPE - NKPOKU PIPELINE AT OMIIGWOR-IBAA SHOWING DRILLED HOLE (LEAK POINT) AT 2 O' CLOCK POSITION

REPAIR ON THE AFFECTED SECTION OF PIPELINE WAS DONE BY CLAMPING.
