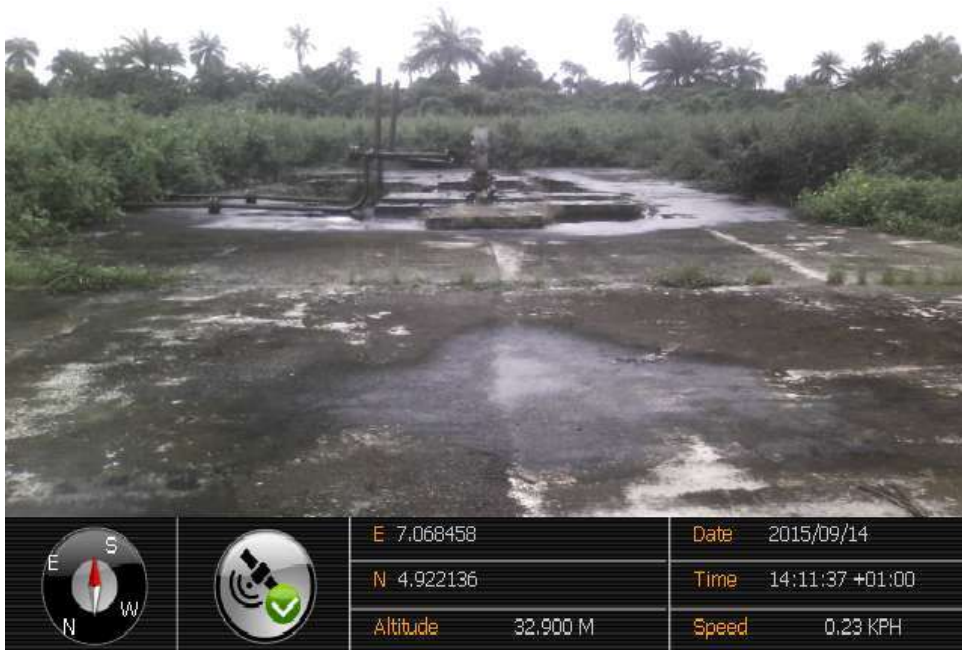
Overview: Part of spill impact on Obigbo North Well28L Wellhead Right of Way at Imeh. Picture was taken during Joint Investigation of 14th September 2015.

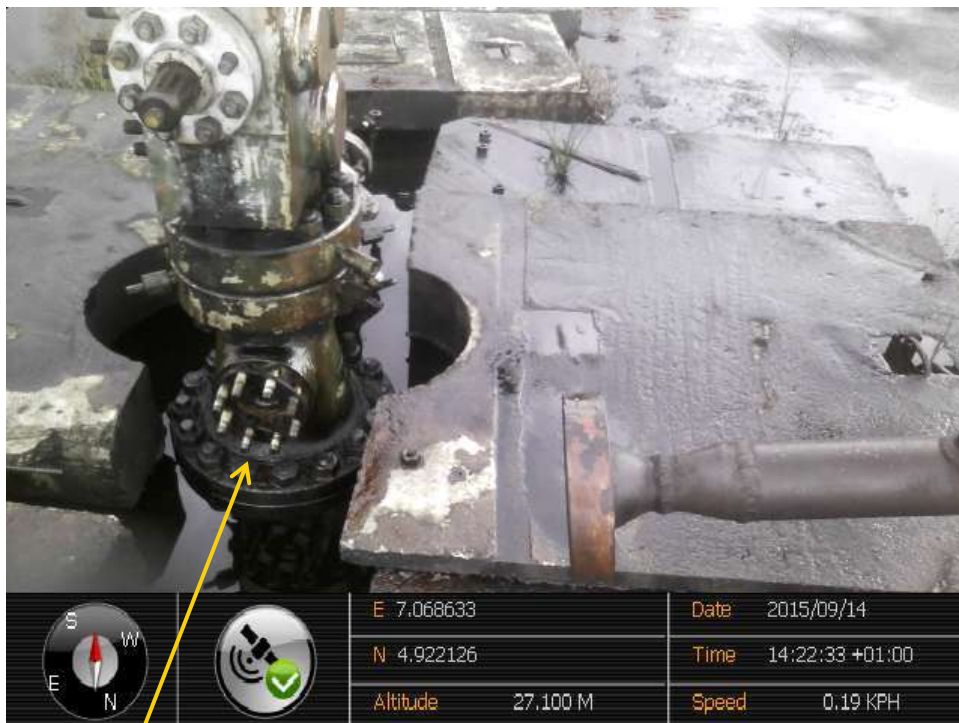
Close-up: Initial position of missing Christmas Tree Casing Head valves on Obigbo North Well28L Wellhead at Imeh. Picture was taken during Joint Investigation of 14th September 2015.
