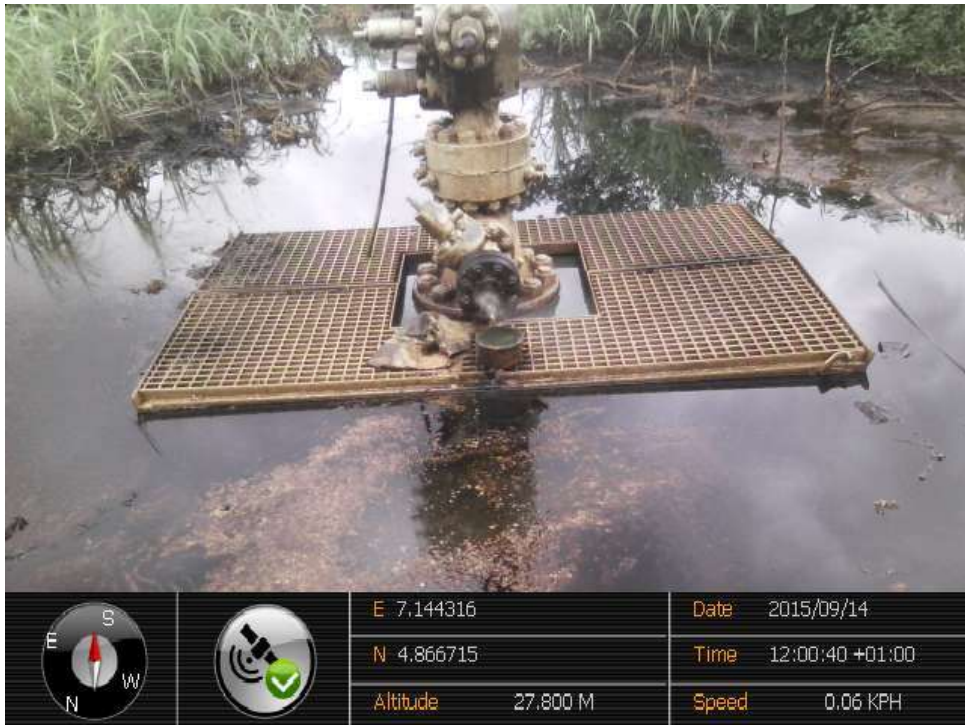
**Overview:** Part of spill impact on Obigbo South Well3L Wellhead Slot at Umusia. Picture was taken during Joint Investigation of 14<sup>th</sup> September 2015.

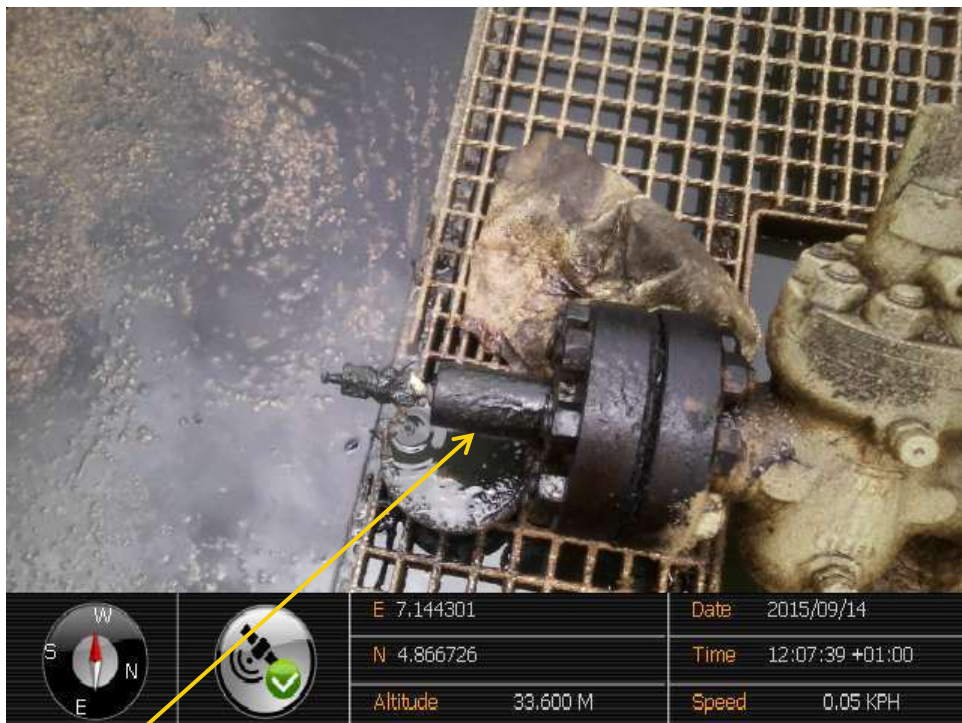
**Close-up:** Leak due to corrosion on Kerotex Needle valve at Obigbo South Well3L Wellhead at Umusia. Picture was taken during Joint Investigation of 14<sup>th</sup> September 2015.
