JOINT INVESTIGATION REPORT

INCIDENT NO: 1483075 JIV report S/N: Nº 000053

1. Spill incident Number: 1483075 2. Type of incident* OIL SPILL
3. Name of Location DIEBU CREEK WELL 15T WELL HEAD
4. Name of nearest community PEREMABINI 5. State: BAYELSA 6. LGA SOUTHAN IJAWI
7. Type of Production facility/Installation WELL HEAD
8. Asset owner/District SPDC / LAND 2

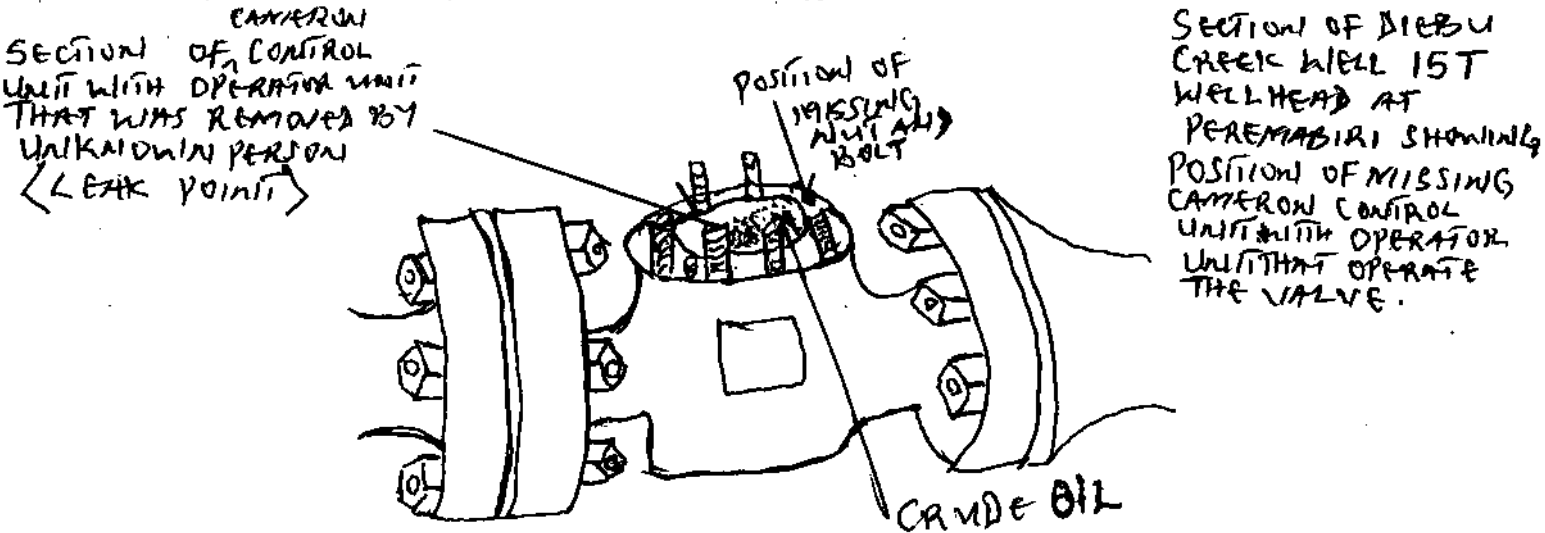
E. GRAPHIC DESCRIPTION OF LEAK POINT (while detail report of the leak point should be contained in the leak report, overview sketch of the site should be added as an appendix 1)

Additional observations around the spill point: DURING THE JOINT INVESTIGATION VISIT, OIL STAINS WERE OBSERVED ON THE BODY OF THE WELL HEAD. LIGHT OIL SHEEN WAS ALSO NOTICE.

Others(specify) CAMERON CONTROL UNIT WITH OPERATOR UNIT THAT OPERATE THE VALVE WAS REMOVED BY UNKNOWN PERSON.

REPAIR WORK PLANNED.
