JOINT INVESTIGATION REPORT

INCIDENT NO: 1484216 JIV report S/N: Nº-0000042

1. Spill incident Number: 1484216 2. Type of incident* OIL SPILL
3. Name of Location 28" NKPOKU - BOMU PIPELINE
4. Name of nearest community KPORGHOR 5. State: RIVERS 6. LGA TAI
7. Type of Production facility/Installation OIL PIPELINE
8. Asset owner/District THE SHELL PETROLEUM DEVELOPMENT COMPANY OF NIGERIA (SPDC)

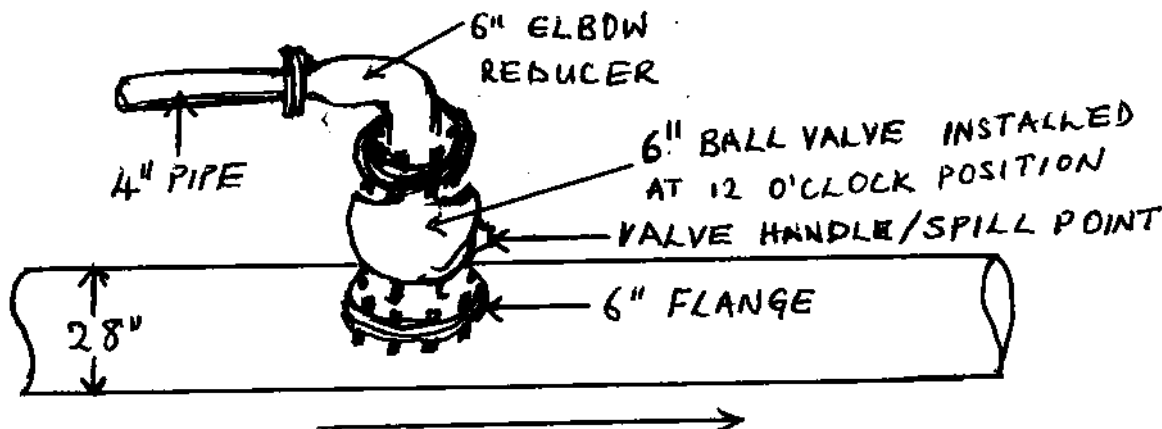
Additional observations around the spill point: THE TEAM OBSERVED A 6" VALVE INSTALLED AT 12 O'CLOCK POSITION WITH A 6" ELBOW REDUCER CONNECTED TO A 4" PIPE RUNNING OVER 2 KILOMETRES INTO THE BUSH.

| <input checked="" type="checkbox"/> Crude oil theft (illegal bunkering) point, | <input type="checkbox"/> Saver-pit over flow | <input type="checkbox"/> Third party tampering with Clamp |

A SECTION OF 28" NKPOKU-BOMU PIPELINE AT KPORGHOR SHOWING 6" VALVE INSTALLED AT 12 O'CLOCK 12 O'CLOCK POSITION BY UNKNOWN PERSON(S)

REPAIR COMMENCED

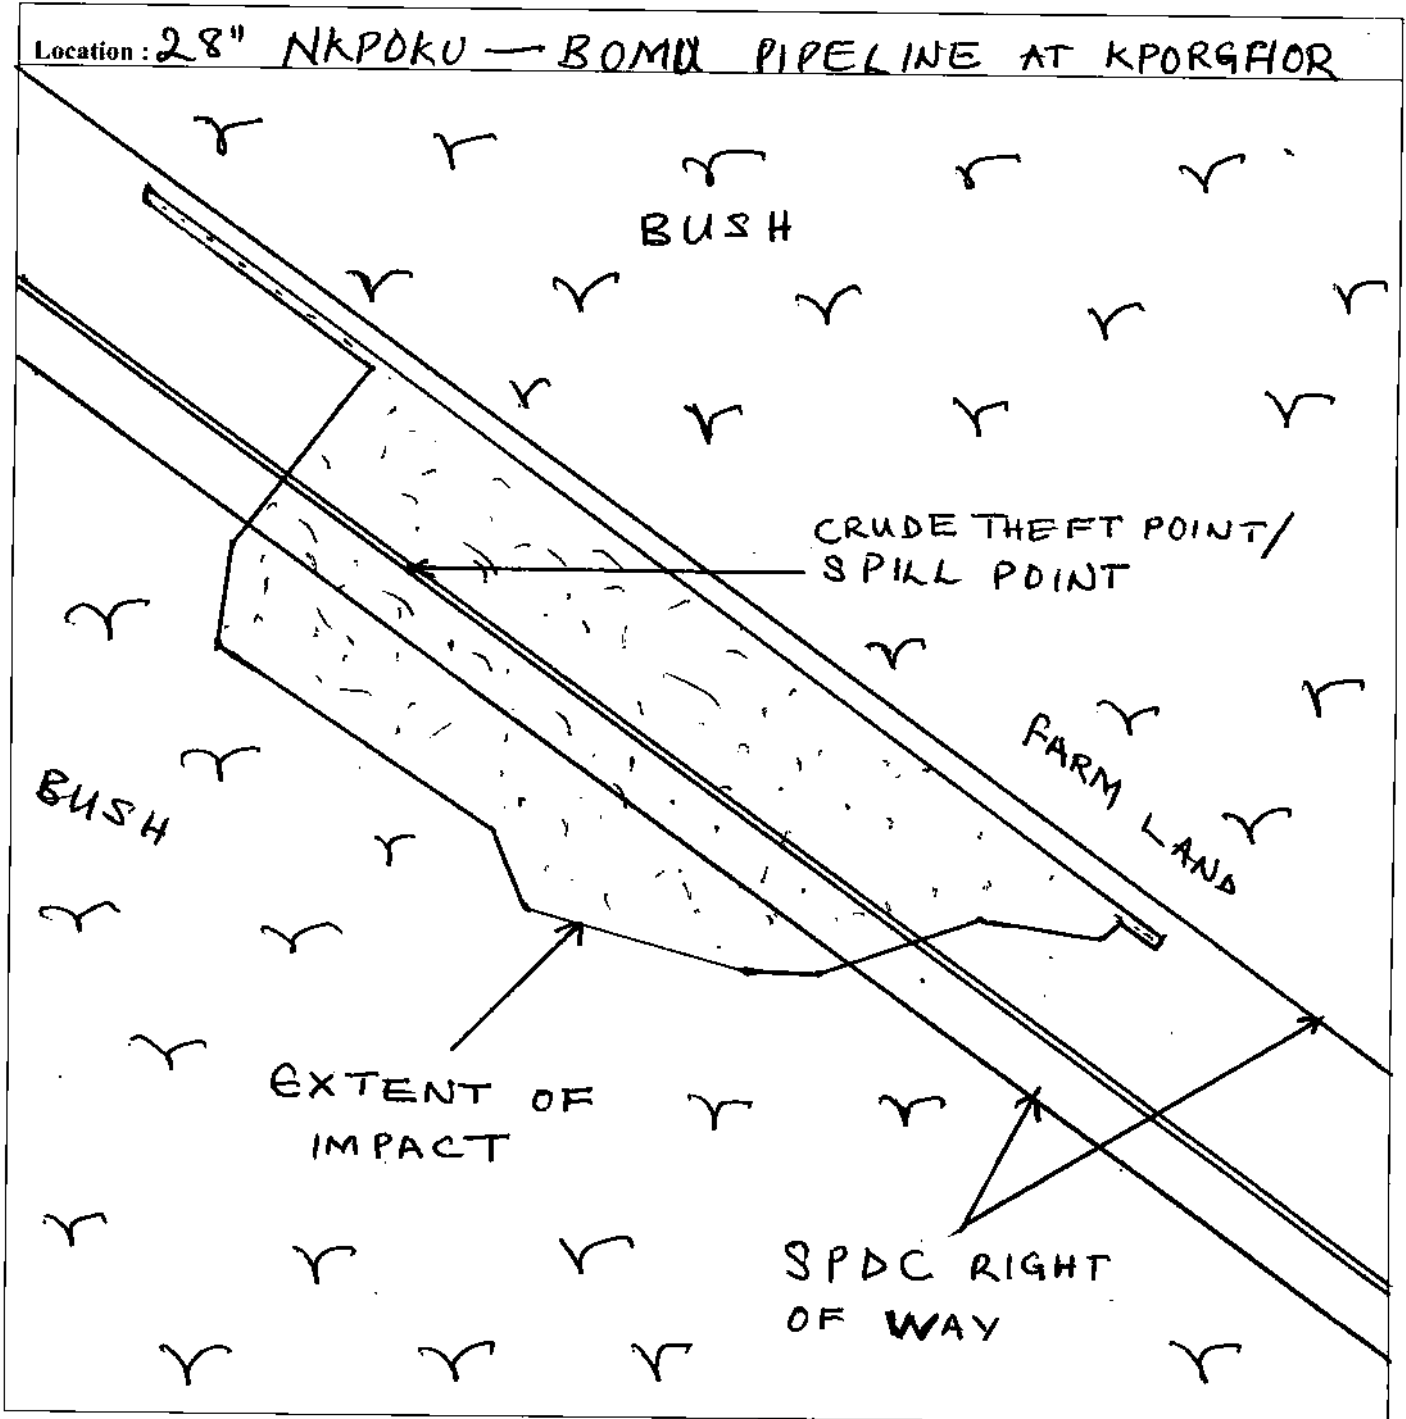
f. Appendix I: Overview sketch of the site

- Total calculated area of impact 0.4619 Ha
- Impact within R.O.W YES
- Impact outside R.O.W YES
