JOINT INVESTIGATION REPORT

INCIDENT NO: 1489792 JIV report S/N: Nº 0000072

1. Spill incident Number: 1489792 2. Type of incident* OIL SPILL
3. Name of Location 12" ADIBAWA - OKORDIA PIPELINE
4. Name of nearest community IKARAMA 5. State: BAYELSA 6. LGA YENAGOA
7. Type of Production facility/Installation OIL PIPELINE
8. Asset owner/District THE SHELL PETROLEUM DEVELOPMENT COMPANY OF NIGERIA LIMITED / PIPELINE

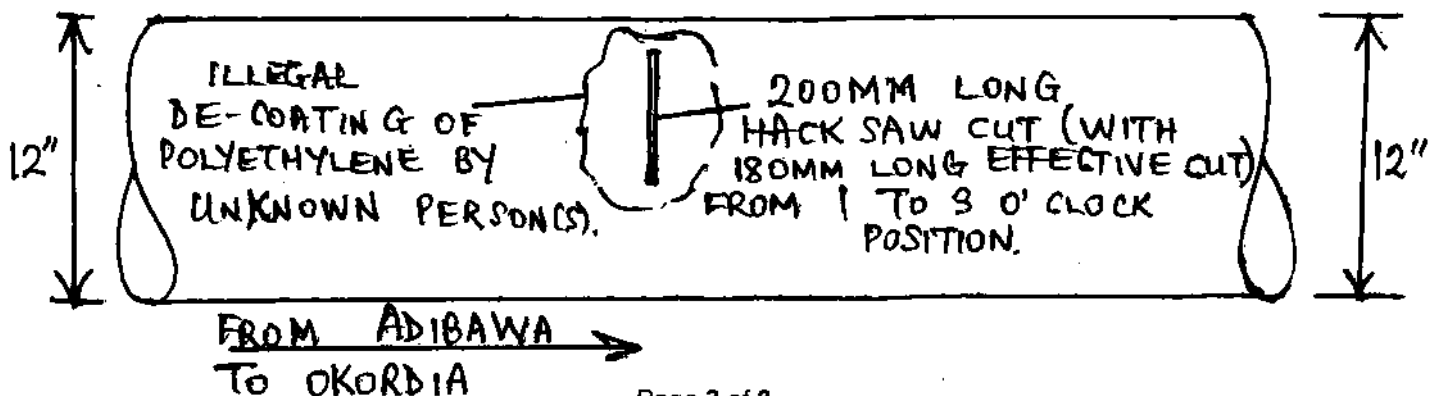
Additional observations around the spill point: A DITCH DUG BY UNKNOWN PERSON(S) WAS OBSERVED AROUND THE SPILL POINT WITH SOME CRUDE OIL CONTENT. ALSO, THE JOINT INVESTIGATION TEAM OBSERVED, APPROXIMATELY 5 METRES FROM THE SPILL POINT, A SECOND DITCH SUSPECTED TO HAVE BEEN DUG BY UNKNOWN PERSON(S) IN AN ATTEMPT TO CAUSE SABOTAGE ON THE 12" PIPELINE.

| <input type="checkbox"/> Drilled hole | <input checked="" type="checkbox"/> Hack saw cut | <input type="checkbox"/> Tear (_____), |

SECTION OF 12" ADIBAWA - OKORDIA PIPELINE AT IKARAMA SHOWING POSITION OF HACK SAW CUT.

SOURCE OF SPILL WAS STOPPED AND REPAIRS WERE EFFECTED ON THE AFFECTED PIPELINE SECTION BY CLAMPING.
