JOINT INVESTIGATION REPORT

INCIDENT NO: 1489844 JIV report S/N: Nº 0000078

1. Spill incident Number: 1489844 2. Type of incident* OIL SPILL
3. Name of Location 14" OKORDIA - RUMUEKPE PIPELINE
4. Name of nearest community IKARAMA 5. State: BAYELSA 6. LGA YENAGOA
7. Type of Production facility/Installation OIL PIPELINE
8. Asset owner/District THE SHELL PETROLEUM DEVELOPMENT COMPANY OF NIGERIA LIMITED/ PIPELINE

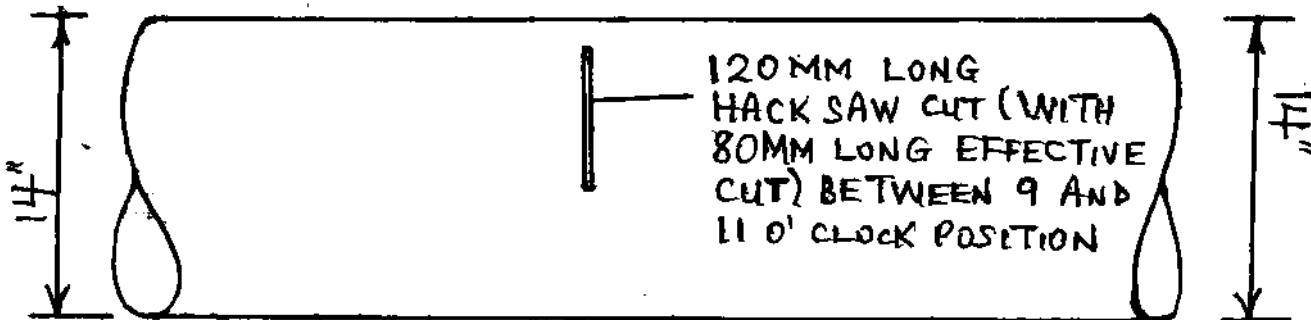
Additional observations around the spill point: A DITCH DUG BY UNKNOWN PERSON(S) WAS OBSERVED AROUND THE SPILL POINT BY THE JOINT INVESTIGATION TEAM ON ARRIVING SITE.

| <input type="checkbox"/> Drilled hole | <input checked="" type="checkbox"/> Hack saw cut | <input type="checkbox"/> Tear (_____). |

SECTION OF 14" OKORDIA - RUMUEKPE PIPELINE AT IKARAMA SHOWING POSITION OF HACK SAW CUT.

SOURCE OF SPILL WAS STOPPED, AFTER WHICH REPAIR WAS EFFECTED ON THE AFFECTED SECTION OF PIPELINE BY CLAMPING.
